May 2019

Safety Recall V53 / NHTSA 19V-348

Power Steering Assist

2017-2019 (RU) Chrysler Pacifica

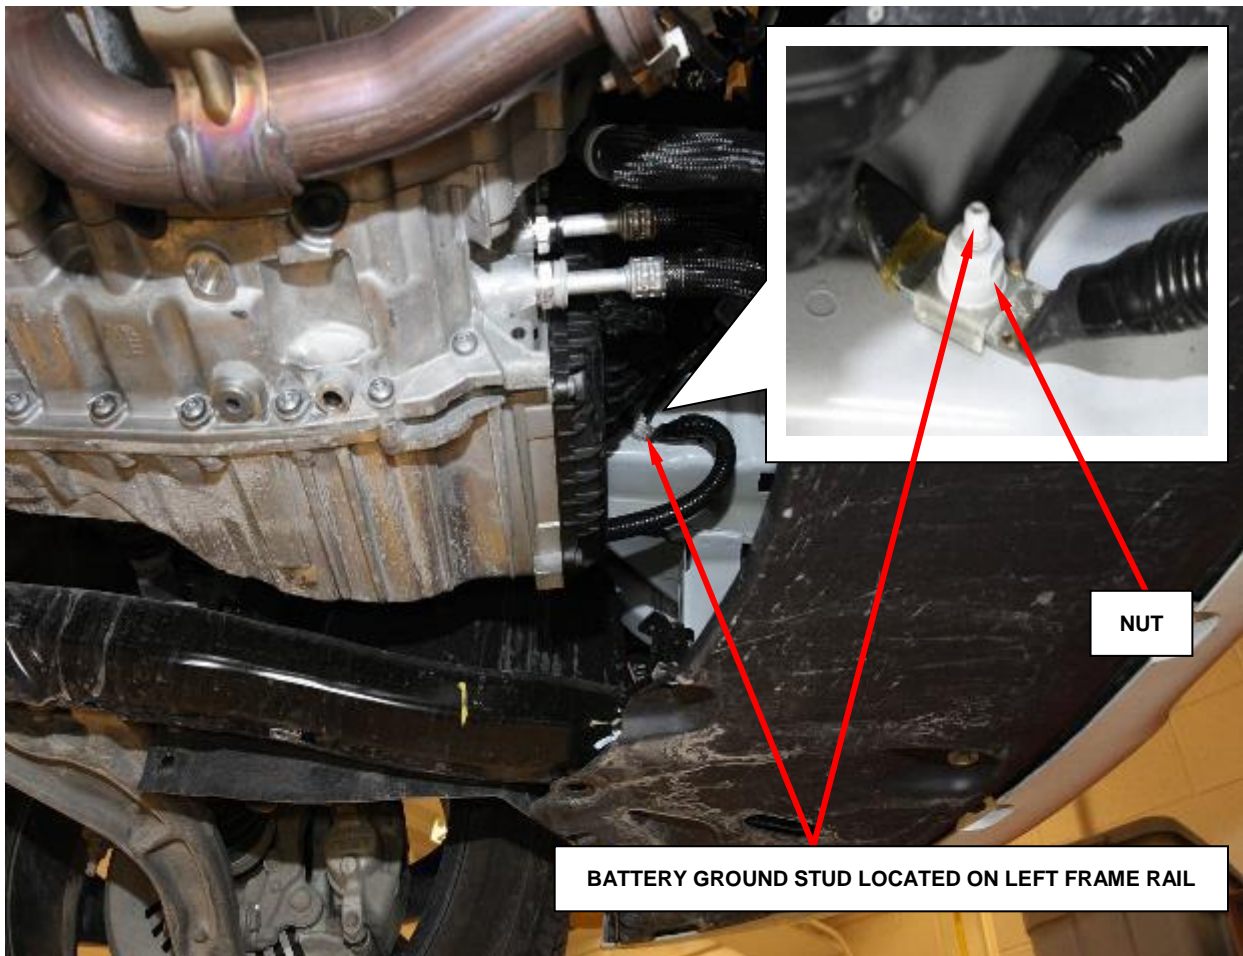
Figure 4 - Battery Ground Stud Location

9. Locate the battery ground stud located on the left frame rail toward the front of the vehicle (Figure 4).

10. Remove the ground nut from the ground stud (Figure 4).
