CONDITION OF CONCERN

PARTS AND WARRANTY INFORMATION
Recall Campaign 3319E

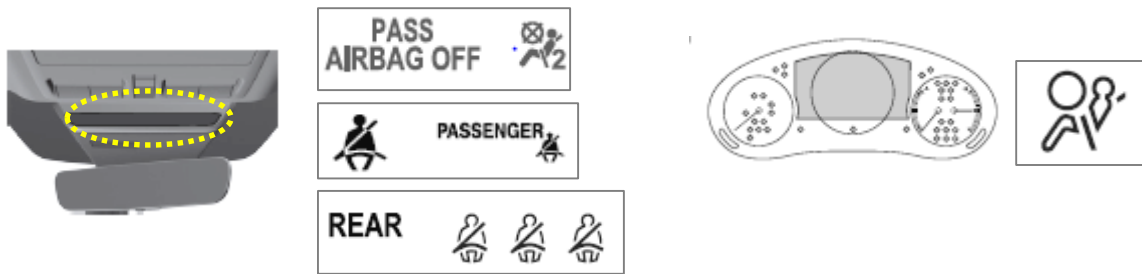
Certain vehicles may exhibit any one or all of the following concerns, due to a faulty indicator assembly:

- Passenger air bag deactivation indicator light may turn off, even though the passenger air bag is deactivated.
- Seat belt status indicator of the front passenger seat may turn off, even though the front passenger seat belt is unfastened.
- Seat belt status indicators of rear passenger seats may turn green, even though the rear seat belt(s) are unfastened.

These false indicator concerns can be detected by illumination of the air bag system malfunction warning light in the instrument cluster and an audible warning.

Dealers are instructed to replace the Indicator Assembly with a modified one. The repair must be performed on all subject vehicles at no charge to the vehicle owners.
