MAZDA DEALER EMAIL

Subject: Launch of Safety Recalls: 3319E 2019 Mazda3 Indicator Concern and

3519F - 2019 Mazda 3 Wheel Lug Nuts Loosening Concern

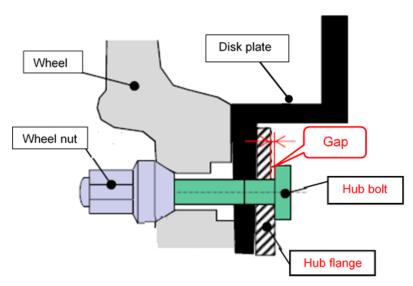
On certain subject vehicles, the wheel lug nuts may loosen and fall off during normal driving. Continuous use in such condition may lead to a wheel falling off the vehicle and there could be a loss of vehicle control.

A manufacturing process error may create a partial gap between the hub bolt head and hub flange during assembly. This gap may cause a loss of torque and eventual loosening of the wheel nut if they were tightened prior to proper seating of the hub bolt, even though they were tightened to the correct specification at the plant.

Retighten the front and rear wheel nuts with 137Nm (101 ft. lb.) to 147Nm (108 ft. lb.). Special Note - This recall repair must be done even though a pre-delivery inspection ("PDI") may have been performed or if a Port Campaign was performed.
