CONDITION OF CONCERN

Certain vehicles may exhibit any one or all of the following concerns, (please reference the following illustrations):

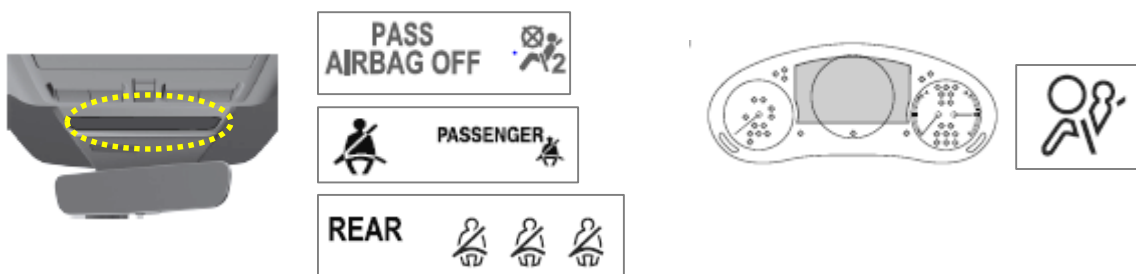
- Passenger air bag deactivation indicator light may turn off, even though the passenger air bag is deactivated.
- Seat belt status indicator of the front passenger seat may turn off, even though the front passenger seat belt is unfastened.
- Seat belt status indicators of rear passenger seats may turn green, even though the rear seat belt(s) are unfastened.

These false indicator concerns can be detected by illumination of the air bag system malfunction warning light in the instrument cluster and an audible warning.

Incorrect indicator warning lights may lead the driver and/or passengers to be unaware of deactivated air bags or unfastened seat belts, increasing the risk of injury.

Dealers are instructed to replace the Indicator Assembly with a modified one. The repair must be performed on all subject vehicles at no charge to the vehicle owners.
