August 2019
FL814A-C
NHTSA #19V-371

Subject: FCCC MT Chassis Brake Pedal Clevis Pins

Models Affected: Specific Freightliner Custom Chassis MT45 and MT55 step vans, manufactured January 12, 2011, through January 3, 2019.

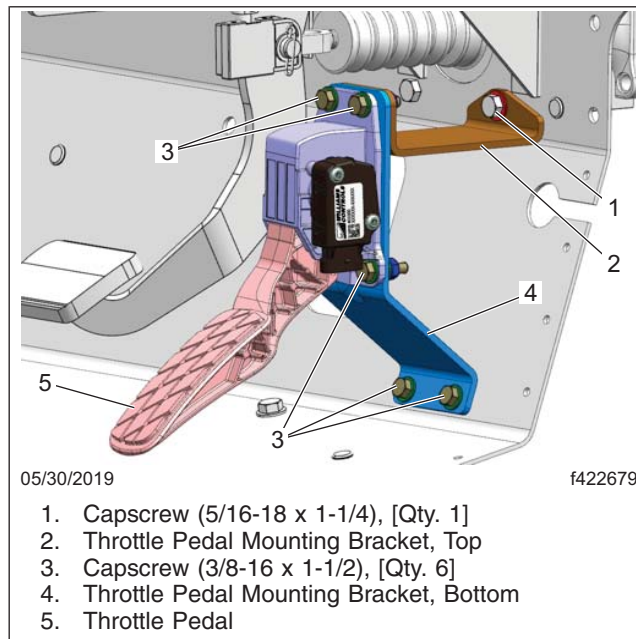
Fig. 1, Throttle Pedal Assembly

The clearance between the brake pedal clevis pin clip and the throttle pedal mounting hardware does not meet minimum clearance requirements. This could result in detachment of the brake pedal clevis pin clip. As the clevis pin works out, there will initially be loss of brake lights, and eventually the brake pedal may become detached. Both the loss of brake lights and a detached brake pedal increase the risk of a crash.

5. Disconnect the electrical connector.
6. Discard the throttle pedal assembly.
7. Connect the electrical connector.
8. Using new hardware, install the throttle pedal assembly as shown in [Fig. 1](#).

- 8.1 Tighten the nut that attaches the top accelerator mounting bracket to the firewall 19 to 24 lbf-ft (26 to 33 N-m).
- 8.2 Tighten the six nuts that attaches the bottom accelerator mounting bracket 84 to 120 lbf-in (949 to 1356 N-cm).
9. For FL814A or FL814C, clean a spot on the base label (Form WAR259). Write the recall number, FL814, on a completion sticker (Form WAR260), and attach it to the base label to indicate this recall has been completed.
10. For FL814B, go to *Brake Pedal Clevis Pin Reorientation*.
