September 2019  
FL814A-E  
NHTSA #19V-371  
REVISED NOTICE

## **Subject: FCCC MT Chassis Brake Pedal Clevis Pins**

**Models Affected: Specific Freightliner Custom Chassis MT45 and MT55 step vans, manufactured January 12, 2011, through January 3, 2019.**

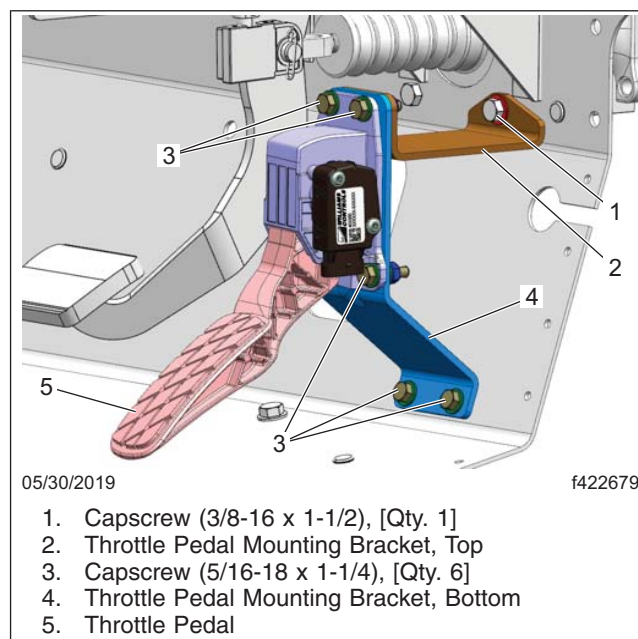
**Fig. 1, Throttle Pedal Assembly**

The clearance between the brake pedal clevis pin clip and the throttle pedal mounting hardware does not meet minimum clearance requirements. This could result in detachment of the brake pedal clevis pin clip. As the clevis pin works out, there will initially be loss of brake lights, and eventually the brake pedal may become detached. Both the loss of brake lights and a detached brake pedal increase the risk of a crash.

5. Disconnect the electrical connector.
6. Discard the throttle pedal assembly.
7. Connect the electrical connector.
8. Using new hardware, install the throttle pedal assembly as shown in [Fig. 1](#).

- 8.1 Tighten the nut that attaches the top accelerator mounting bracket to the firewall 19 to 24 lbf-ft (26 to 33 N-m).
- 8.2 Tighten the six nuts that attaches the bottom accelerator mounting bracket 84 to 120 lbf-in (949 to 1356 N-cm).
9. For FL814A or FL814C, clean a spot on the base label (Form WAR259). Write the recall number, FL814, on a completion sticker (Form WAR260), and attach it to the base label to indicate this recall has been completed.
10. For FL814B, go to *Brake Pedal Clevis Pin Reorientation* (after performing Throttle Pedal Replacement).
