Compliance Recall

Code: 97DK

Audi

Subject	LED Turn Signal/Body Control Module (BCM) Software Noncompliant
Release Date	July 11, 2019
Revision Summary	Added inspection step to check the brake light operation on page 13.
Affected Vehicles	U.S.A. & CANADA: 2016-2018 MY Audi Q3 <i>Check Campaigns/Actions screen in Elsa on the day of repair to verify that a VIN qualifies for repair under this action. Elsa is the <u>only</u> valid campaign inquiry & verification source.</i> <ul style="list-style-type: none">✓ Campaign status must show "open."✓ If Elsa shows other open action(s), inform your customer so that the work can also be completed at the same time the vehicle is in the workshop for this campaign.
Problem Description	Due to an incorrect software configuration a failure of an LED front turn signal may not be detected and the customer would not be alerted by a fast-flashing of the internal pilot indicator. The turn signals in the exterior mirrors still work as intended. Though an LED turn signal is a lifetime part and has an extremely low failure rate, the regulatory requirements are not met. Loss of turn signal function, without a warning to the driver, could increase the risk of

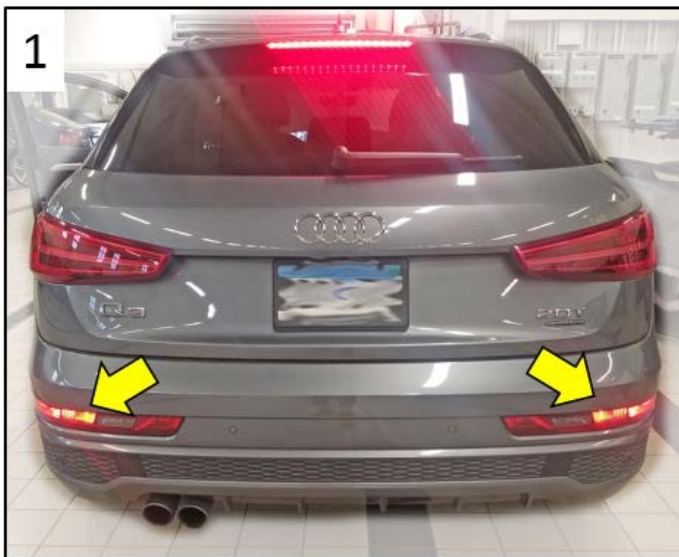
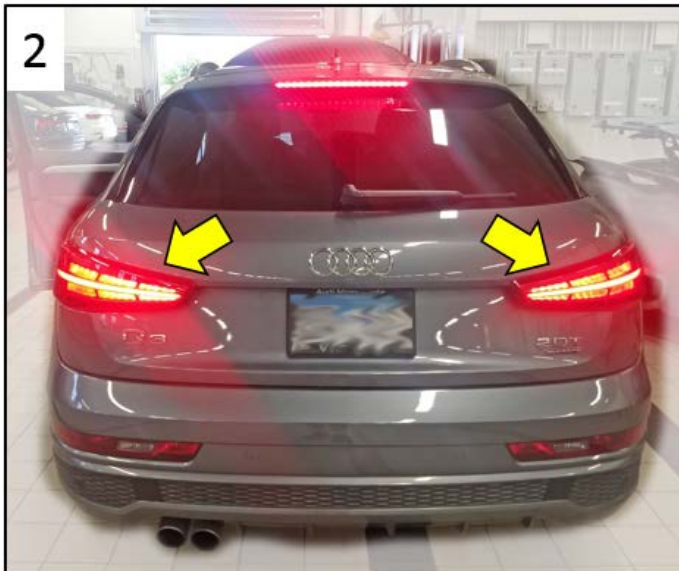
- Disconnect the scan tool from the vehicle.
- Check the operation of the rear brake lights.
- If the brake lights do not illuminate on the rear lift gate when operating the brake pedal, but do operate on the bumper <photo 1>:
 - Open the rear lift gate.
 - Close the rear lift gate.
- The rear brake lights should now operate correctly with the lift gate closed <photo 2>.
- **Proceed to Section C.**
