Keystone RV Company

SAFETY ADVISORY # 19-351

Fuzion 429 Power Center Wiring

Models Included: 2018 - 2020 Fuzion Fifth Wheel: Model 429

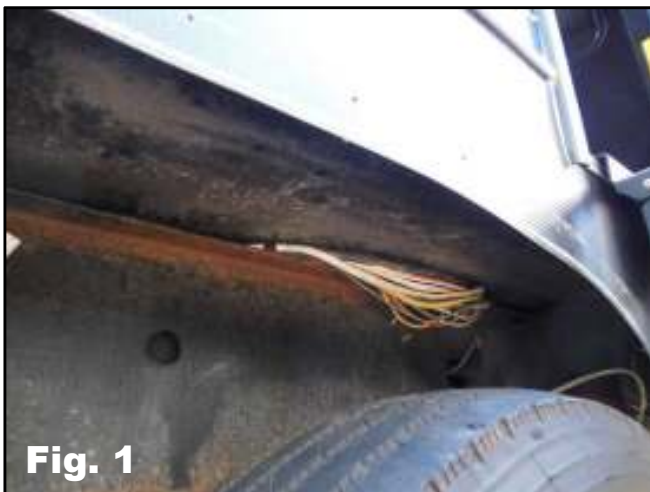
Fig. 1

Inspect the wheel well area to see if there are any wires between the floor and the frame, Figure 1.

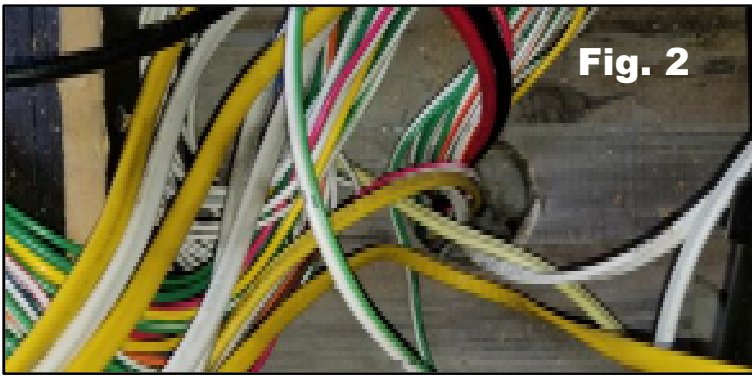
Inspect wiring that goes in to the floor directly behind the power center opening. Pull the wiring to determine if it is free and not pinched. Wiring can be pulled approximately 6 to 8 inches, Figure 2.

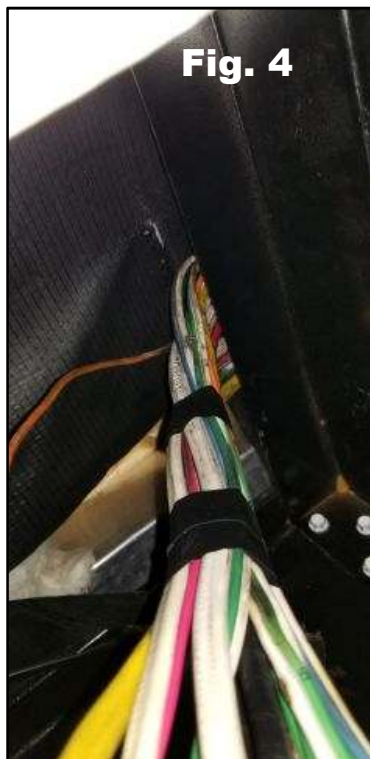
Access the wiring bundle next to the frame rail as it passes over the holding tank. Pull the wiring bundle slack back into the underbelly area that was previously pulled in through the cabinet above. Visually inspect the wiring for damage, Figure 4.
