Dealer Service Instructions for:

Safety Recall V61 / NHTSA 19V-407

Occupant Restraint Controller

2019 (DT) RAM 1500 Pickup

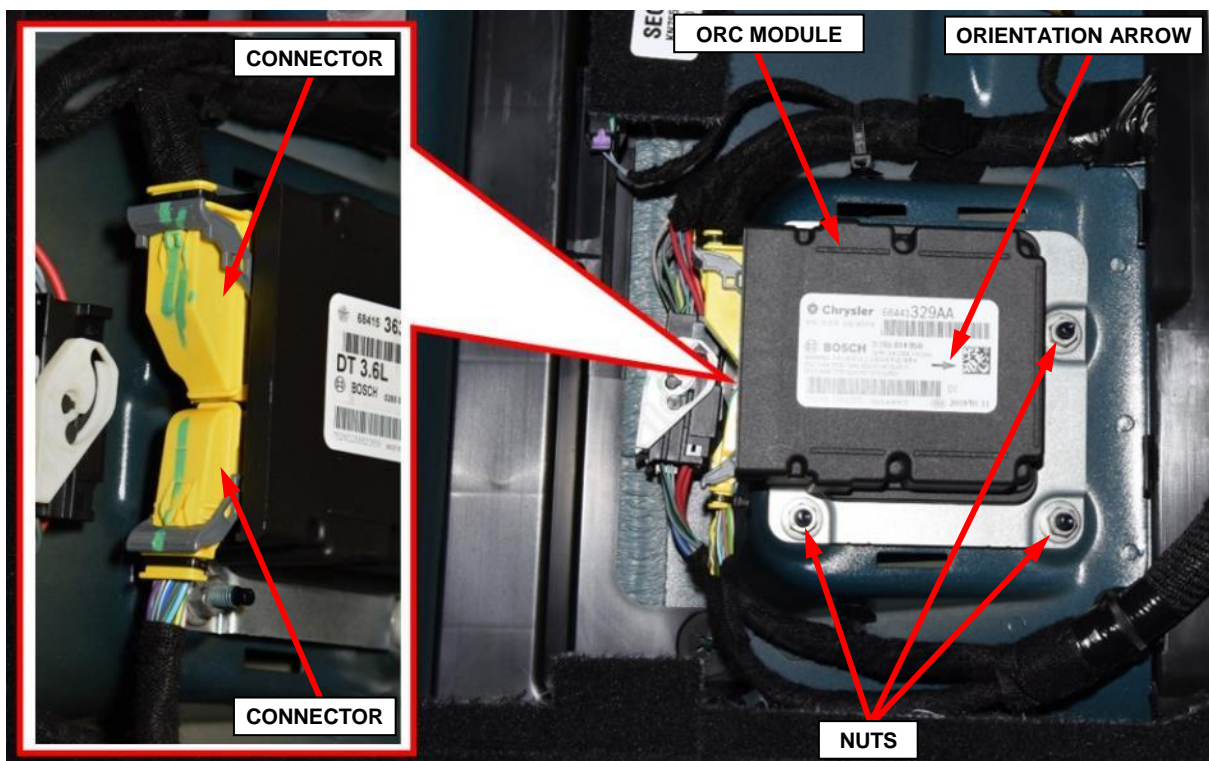
**Figure 5 – ORC Module**

The Occupant Restraint Controller (ORC) on about 153,750 of the above vehicles may contain software that has a potential vulnerability during power-down memory clean-up events which can corrupt flash memory. Once the vehicle is keyed-off, the ORC begins normal routines under its own power reserve. If the ORC powers down and interrupts a memory erase process, data corruption could occur. Memory cleanup does not occur every key-off, not all interruptions will cause corruption, reserve time will vary, and other factors make the occurrence highly variable. Corrupted ORC flash memory may result in internal fault codes, illuminated Airbag Warning Lamp, and disabled deployment of airbags and seatbelt pretensioners. Disabled airbag and seatbelt pretensioner deployment may increase the risk of injury to vehicle occupants in the event of a crash.

16. Disconnect the wire harness connectors from the ORC (Figure 5).
17. Remove the three nuts that secure the ORC to the weld studs on the floor panel center tunnel (Figure 5).
18. Remove the ORC from the vehicle (Figure 5). Render the ORC unusable and discard the ORC.
19. Carefully position the NEW ORC on the weld studs on the top of the floor panel center tunnel. When the ORC is correctly positioned, the bottom of the housing will fit flush with the top of the center floor and the orientation arrow on the label on top of the housing will be pointed forward in the vehicle (Figure 5).
20. Install the three nuts that secure the ORC to the weld studs on the top of the floor panel center tunnel. Tighten the nuts to 12 N·m (9 Ft. lbs.) (Figure 5).
21. Connect both ORC wire harness connectors. Be certain that the latch on each connector is fully engaged (Figure 5).
