Dealer Service Instructions for:

# Safety Recall V61 / NHTSA 19V-407

## Occupant Restraint Controller

#### 2019 (DT) RAM 1500 Pickup

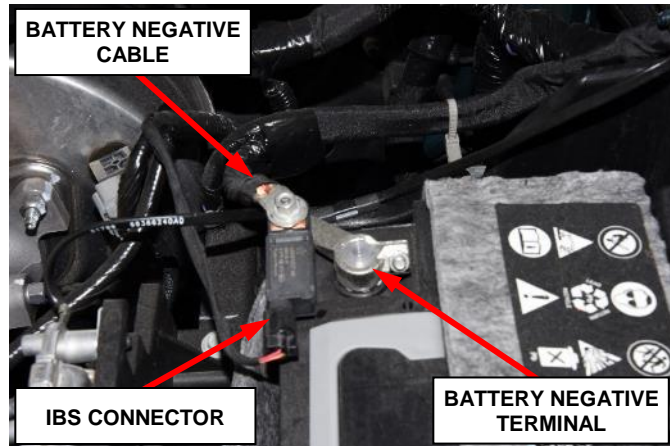
**Figure 2 – Battery Cable Negative**

**NOTE:** Failure to disconnect the IBS wire harness connector can lead to damage of the IBS wire harness connector.

5. Disconnect the Intelligent Battery Sensor (IBS) wire harness connector (Figure 2).

6. Remove the ground terminal M8 nut then remove and isolate the negative battery cable eyelet from the IBS and negative battery terminal (Figure 2).

30. **For vehicles equipped with a standard key ignition:**
  - a. Turn the ignition to the run position.
  - b. Check to be certain that nobody is in the vehicle.
  - c. Connect the 12-Volt battery. If equipped with an IBS, connect the IBS connector. Secure the negative battery cable eyelet to the IBS M8 stud using the M8 nut. Tighten the M8 nut to 7 N·m (62 In. lbs.). Overtightening of the M8 nut for the negative cable to the IBS will cause damage to the IBS or break the stud for the nut (Figure 2).

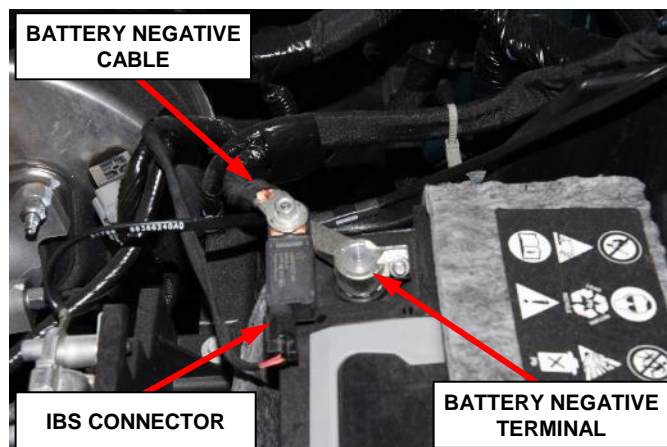
**Figure 10 – Battery Cable Negative**

**NOTE: Failure to disconnect the IBS wire harness connector can lead to damage of the IBS wire harness connector.**

8. Disconnect the Intelligent Battery Sensor (IBS) wire harness connector (Figure 10).

9. Remove the ground terminal M8 nut then remove and isolate the negative battery cable eyelet from the IBS and negative battery terminal (Figure 10).

25. **For vehicles equipped with a standard key ignition:**
  - a. Turn the ignition to the run position.
  - b. Check to be certain that nobody is in the vehicle.
  - c. Connect the 12-Volt battery. If equipped with an IBS, connect the IBS connector. Secure the negative battery cable eyelet to the IBS M8 stud using the M8 nut. Tighten the M8 nut to 7 N·m (62 In. lbs.). Overtightening of the M8 nut for the negative cable to the IBS will cause damage to the IBS or break the stud for the nut (Figure 10).
