N341NAS1

# TECHNICAL BULLETIN

Non-Compliance Recall: Front/Rear Windshield Washer Pump Fuses

MODEL:	MODEL YEAR:	VIN:	ASSEMBLY PLANT:
New Range Rover Evoque (LZ)	2020	000001-019200	Halewood

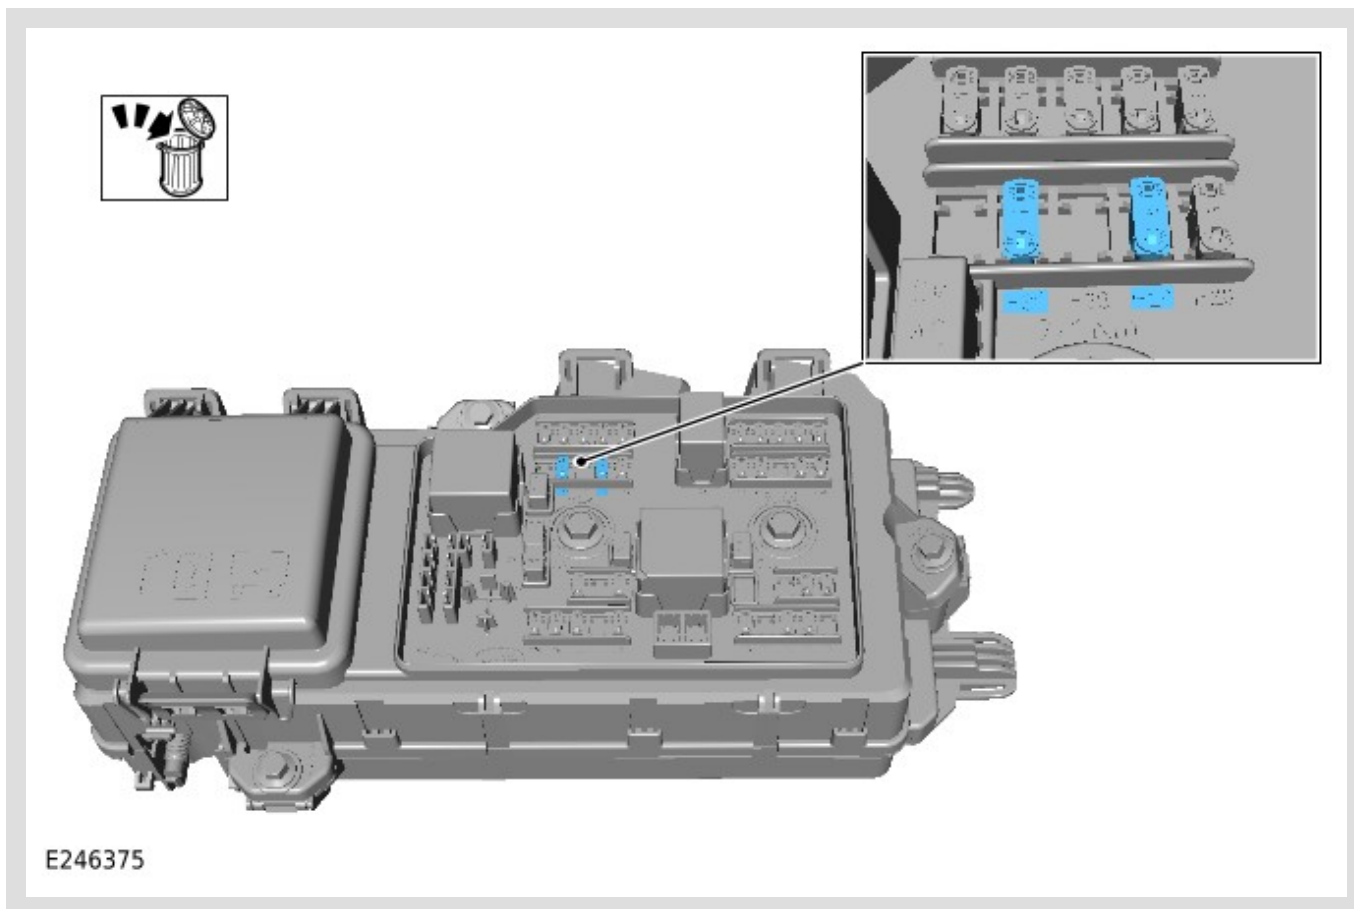
4

A potential issue has been identified on certain vehicles within the listed Affected Vehicle Range where the fuses in the Engine Junction Box (EJB) for the front and rear windshield washer pump may fail if the system is operated in freezing or blocked conditions.

Remove and discard the 15A fuses installed in 'F29' and 'F31' locations.

5 Install new 25A fuses in 'F29' and 'F31' locations.
