# Safety Recall Code: 93E8

#### **NHTSA:** 19V434

## Subject: Safety Recall 93E8 – High-Voltage (HV) Battery Charging Socket 2019 Model Year Audi e-Tron

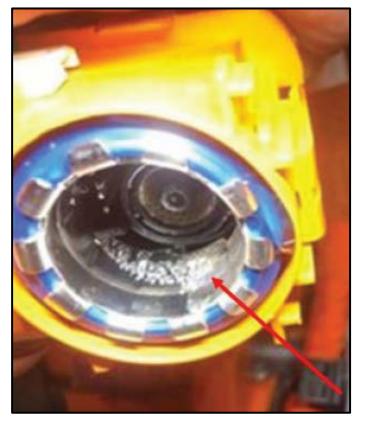
# Check for water ingress in the charging socket cables and SX6:

- Both high voltage cables and both cable connections on the SX6 must be inspected.
- If water ingress is found:
  - U.S. Dealers Take photos and create an Audi Technical Assistance phone contact.
  - Canadian Dealers Take photos and create an Audi Technical Assistance ticket.
- If no water is found:
  - o Service kit must be installed.
  - Proceed to Section C.

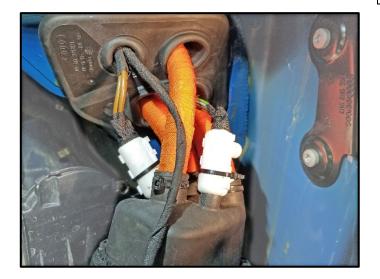
If water wicks into the wiring harnesses, at least 1 cm of wiring must be exposed so the water can leak out.

This photo illustrates how the charging socket • should look with both molds completely installed.
