**AKB2 - Replacing Rear Axle Nuts on the Drive Shafts (Stop Delivery/Recall campaign)**

Vehicle Type: **911 GT2 RS (991)**

Model Year: **2019**

Subject: **Axle nuts on the drive shafts on the rear axle**

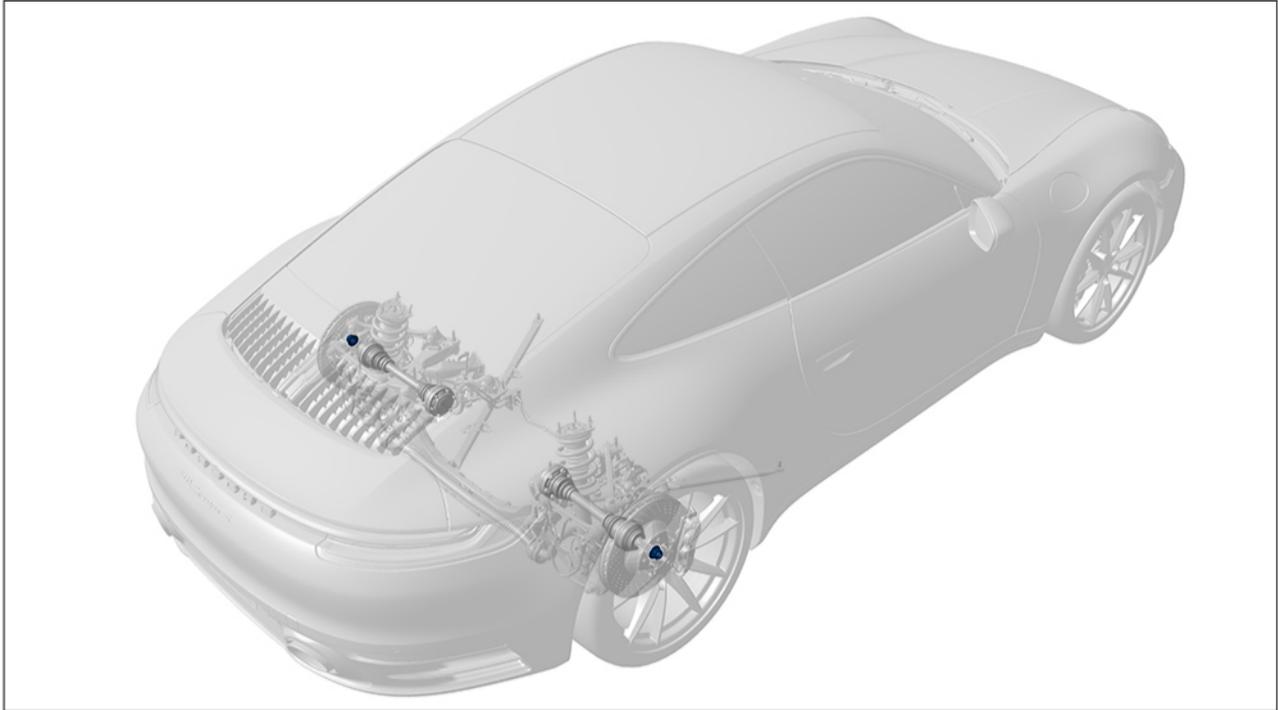
Installation  
position:

Information: **Incorrectly coated fastening nuts were used to secure the drive shaft and wheel hub on the rear axle of the affected vehicles.**

As a result, the required tightening torque was not reached while fitting the components and there is no guarantee that the threaded joint between the drive shaft and wheel hub is secure enough.

*Installation position of axle nuts on the drive shafts on the rear axle (shown on the 992)*

Remedial Action: Replace axle nuts on the drive shafts on the rear axle.

Work Procedure: 1 Replace both axle nuts on the drive shafts on the rear axle.  
For instructions, see Workshop Manual listed below.
