TO: Mercedes-Benz Dealer Principals, General Managers, Sales Managers, Service Managers, Parts Managers	FROM: Gregory Gunther, Department Manager, Vehicle Compliance and Analysis, Engineering Services
RE: Recall Campaign Launch Notification Carbon-Fiber Driveshaft Bonding – Update MY16-17 190 (GT-Class)	DATE: November 1, 2019

Campaign No. 2019090018, November 2019

SUBJECT: **Model GT-Class vehicles (190 platform)**
Model Year 2016 and 2017
Carbon-Fiber Driveshaft Bonding

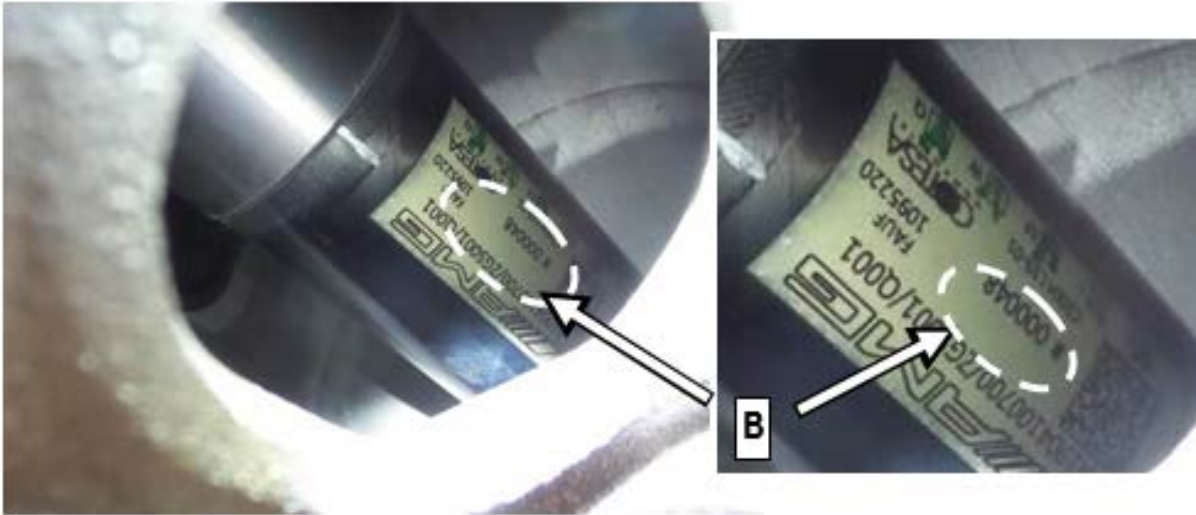
Figure 3

- a. Production number as of **000322** up to **002635** and as of **005502** up to **006655**: Perform **work procedure**
- b. Production number as of **002636** up to **005501** and as of **006656**: **End measure**

3. Check production number (**B, figure 3**) of drive shaft.
