TO: Mercedes-Benz Dealer Principals, General Managers, Sales Managers, Service Managers, Parts Managers	FROM: Gregory Gunther, Department Manager, Vehicle Compliance and Analysis, Engineering Services
RE: Recall Campaign Launch Notification Water Ingress into Right Side of Passenger Compartment MY20 167 (GLE-Class)	DATE: July 12, 2019

Campaign No. 2019060007, July 2019

SUBJECT: **Model GLE-Class vehicles (167 platform)**
Model Year 2020
Rework weld studs on vehicle floor in right footwell

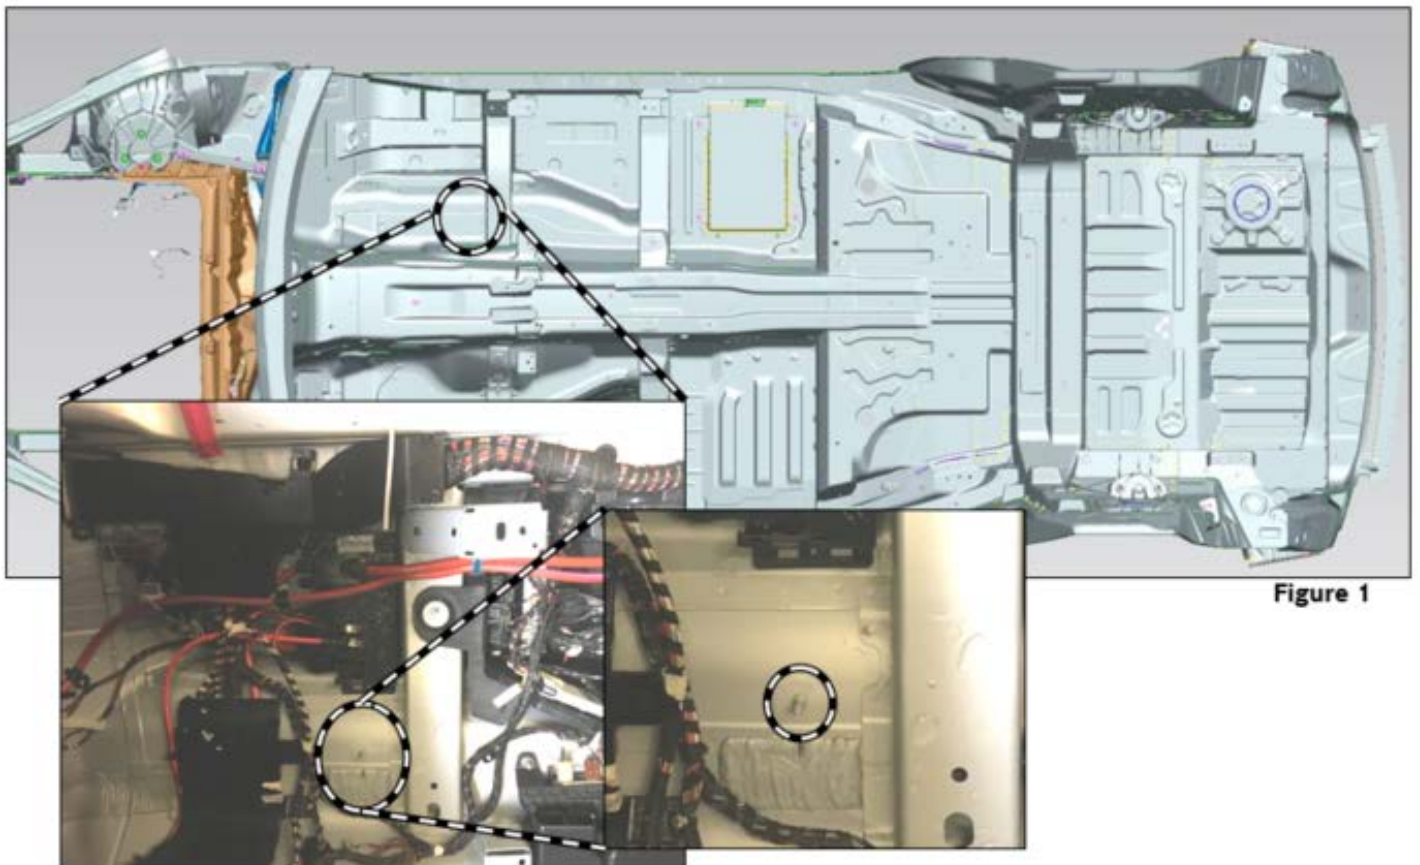
Daimler AG, the manufacturer of Mercedes-Benz vehicles, has determined that on certain Model Year ("MY") 2020 GLE-Class vehicles (167 platform), a welding stud on the main floor may not have been welded according to specification. As a result, a small hole may be present in the main floor in the vehicle's underbody. If the vehicle were to attempt to cross standing water over 15 inches deep, some water could enter the vehicle passenger compartment via the hole in the main floor on the right-side of the vehicle. If sufficient amounts of water enter the vehicle, several electrical contacts could be affected, impacting their functionality. Additionally, a risk of engine stalling cannot be ruled out, increasing the risk of a crash. An authorized Mercedes-Benz dealer will seal the hole in the main floor on the affected vehicles.

1. Remove right front floor covering.
i For basic data, see **AR68.80-P-0008ME**.
2. Remove wear protection cover.
i For basic data, see **AR54.15-P-1351ME**.
i The wear protection is marked as number 3 in the AR document.
3. Seal weld studs on vehicle floor in right footwell all around (**Figure 1**).
i Observe drying time of seam seal.
