# Campaign Service

**BULLETIN NUMBER:**  
CB19-E-001

## IMPORTANT SAFETY RECALL

**FTR STEERING STOP JAM NUT REPLACEMENT – 19V-467**  
(Transport Canada 2019-306)

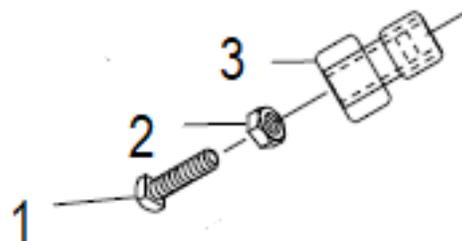
**Figure 2** – Stop Bolt Assembly

1. Stop Bolt
2. Jam Nut
3. Adapter Base

1. Apply the parking brake and block the rear wheels.
2. Start the engine and turn the steering wheel all the way to the left in order to access the right (passenger side) stop bolt. (See Figures 1 and 2.) Shut the engine off after turning the steering wheel.

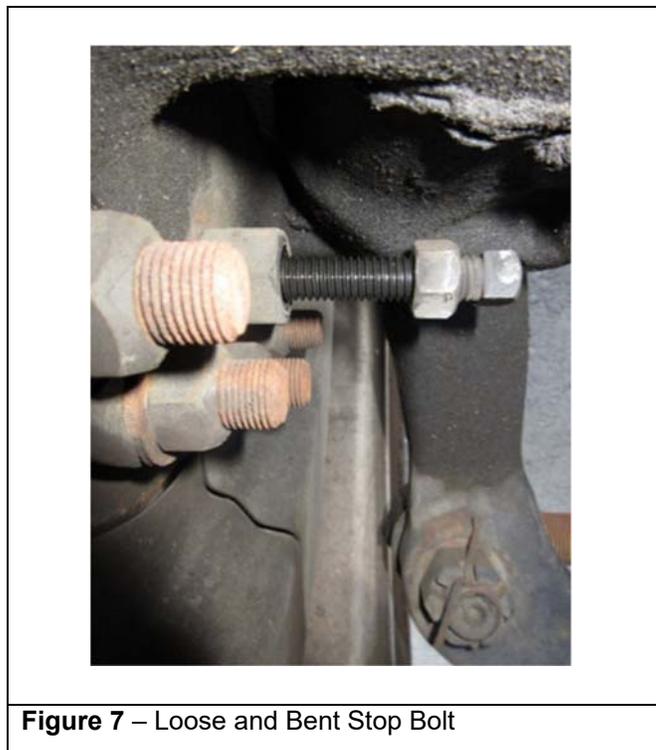
**Figure 7 – Loose and Bent Stop Bolt**

9. Start the engine and turn the steering wheel all the way to the right in order to access the left (driver side) stop bolt. (See Figure 1.) Shut the engine off after turning the steering wheel.
10. Inspect the stop bolt jam nut to determine whether (a) it is loose (i.e., if you can turn the stop bolt and jam nut by hand) or, worse, (b) the stop bolt has backed out of position, become bent or missing completely. See Figure 7. If the jam nut is loose or in any other worse condition, print the template on the next page for the steering bolt adjustment, and proceed directly to Step 11 in this procedure to replace the stop bolt adapter assembly. If the stop bolt and the jam nut are in place and tight, go to Step 3 and repeat this service procedure through Step 8 for the left (driver) side. Once both sides have been completed, proceed to Step 26.
