Vehicle Safety Recall - Technical Service Bulletin

Attention: McNeilus Product Owner
Subject: Bridgemaster V nylon reservoir filler neck replacement
Model Affected: Bridgemaster V 93
Model Years: 2008-2018
Date: June 2019

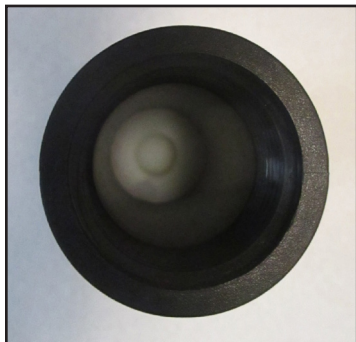
Figure 2

3. Inspect the filler neck.
 - If it has one visible hole when looking at it from the top (Figure 2), then it is the **incorrect** part. Continue with the rest of this bulletin to replace the incorrect part with the correct part.
 - If it has five visible holes (Figure 3), then it is the correct part and there is no need to replace it. Screw the cap back onto the filler neck. Proceed to Step 8 to finish the bulletin.

Incorrect Neck - 1 hole

4. Inspect all additional filler neck parts you have on hand that are not installed on a vehicle.
5. Order the new, correct filler neck part from McNeilus by calling 888-686-7278 or visiting www.streetsmartparts.com. The part number of the filler neck is 1570075. Order as many filler neck parts you need to replace all incorrect filler neck parts.
6. When you have received the correct filler neck, install it according to the following steps.
7. Remove the existing filler neck from the reservoir. Keep the existing filler neck to be returned to McNeilus Warranty following the normal warranty claim process.
8. Remove the cap from the existing filler neck.
9. Screw the cap onto the new filler neck (Figure 4).

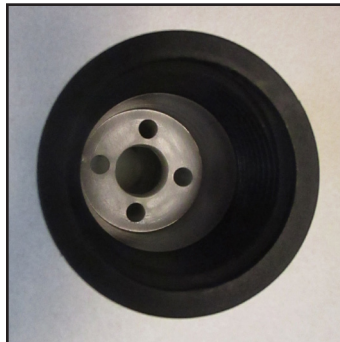
Figure 3

Correct Neck - 5 holes
