VSR-TSB-024

NHTSA Campaign Number: 19V-486

Subject: Hydraulic Steering Pump Hoses Routing Inspection

Models Affected: Oshkosh S-Series Front Discharge Mixer

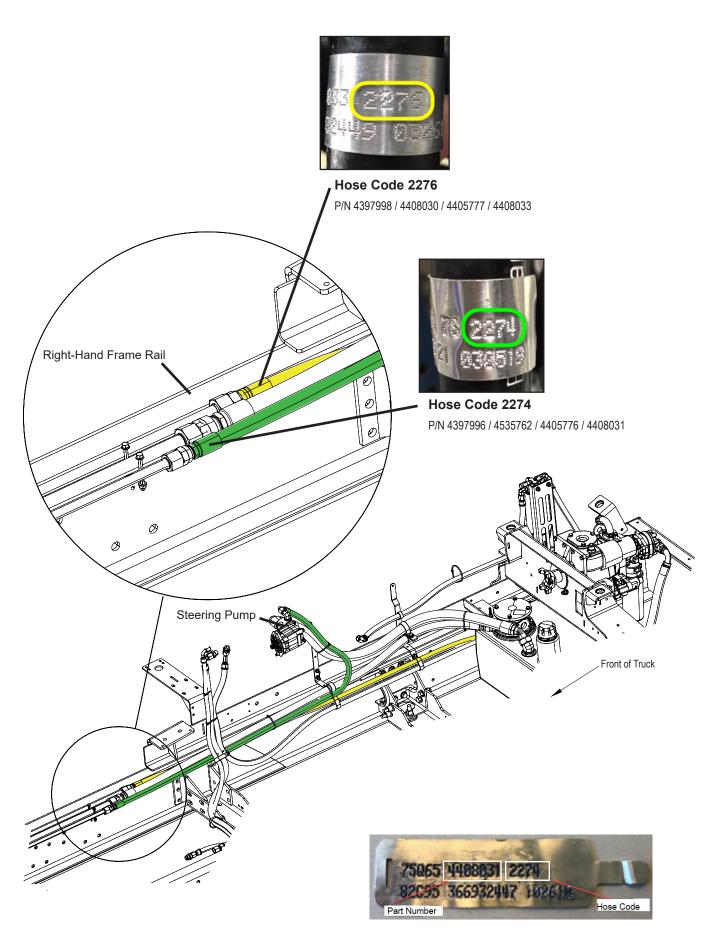
Figure 1

- 3. Locate the three hardline to hose connections located on the right-hand side frame rail next to the transmission bell housing. See Figure 1. Use the aluminum code identification tags affixed to the hose to identify the hoses.
- 4. Check that the hose <u>closest to the right-hand frame rail</u> has a "2276" hose code identification tag. Hose "2276" is shown in yellow in Figure 1.
- 5. Check that the hose <u>closest to the transmission bell housing</u> has a "2274" hose code identification tag. Hose "2274" is shown in green in Figure 1.

- A. If hoses 2274 and 2276 are installed correctly, this procedure is complete and no further action is required. Remove your company's Lockout/Tagout procedure. If your company does not have a Lockout/Tagout procedure, follow OSHA 1910.147 and 1910.146 Confined Space as appropriate. Remove the wheel chocks. Return the vehicle to service.
- B. If the hoses are incorrectly installed, **Do not run or use the vehicle**, maintain your company's Lockout/ Tagout on the vehicle, and contact S-Series Service Support at 888-686-7278 immediately.
