PRODUCT CAMPAIGN BULLETIN

APPLICABILITY: 2019MY Legacy and Outback

NUMBER: WUH-93R

SUBJECT: Front Duct Panel Spot Weld

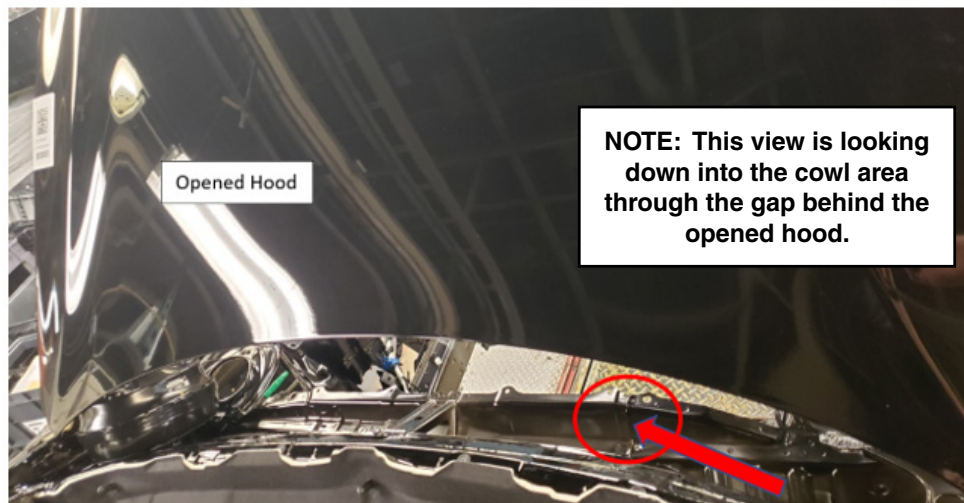
6. With the cowl trim panel removed, use the photos below to determine if the vehicle is equipped with an **A Jig** or **B Jig** part. The **B Jig** part has an identification weld to distinguish it from the **A Jig** part.

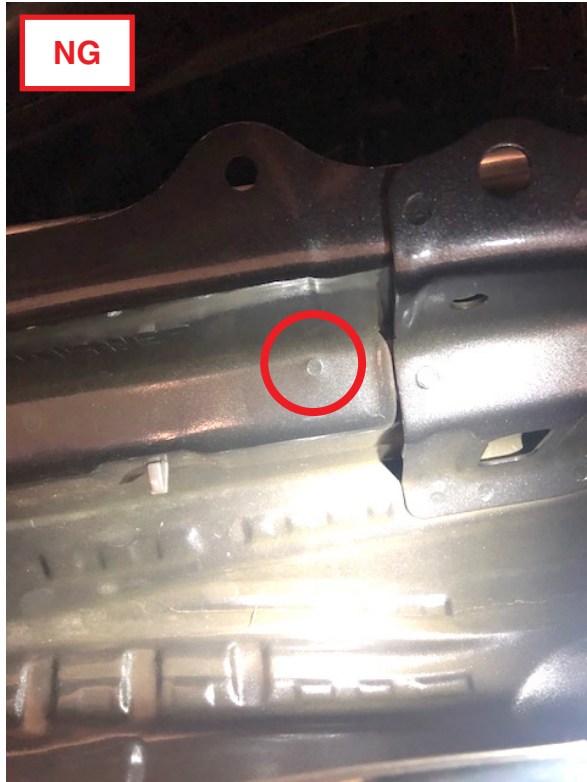
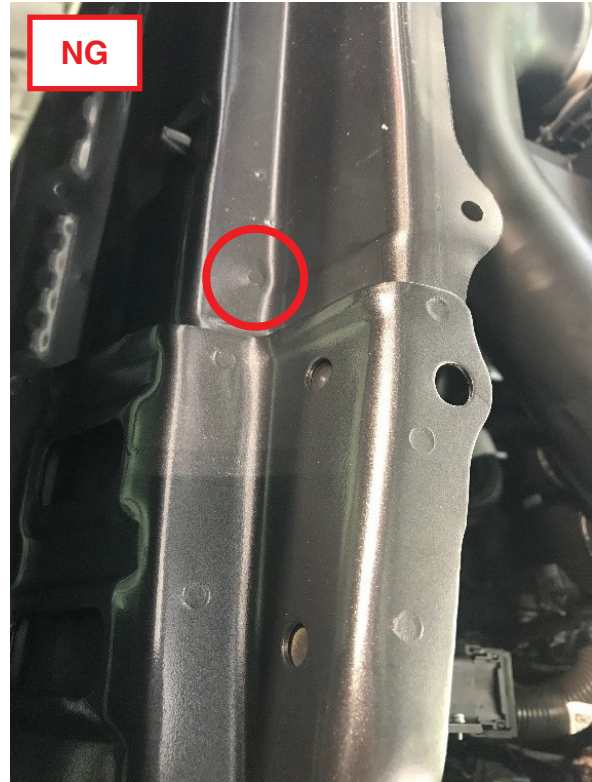
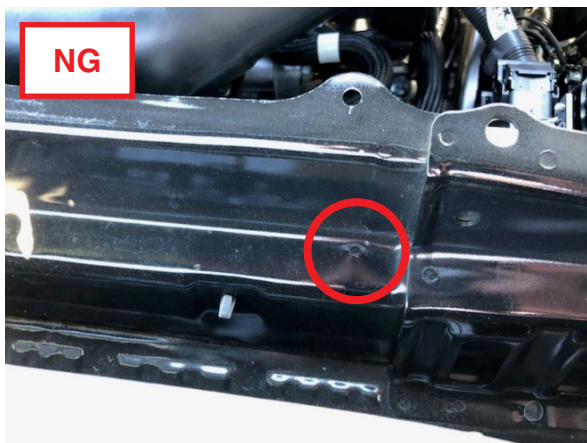
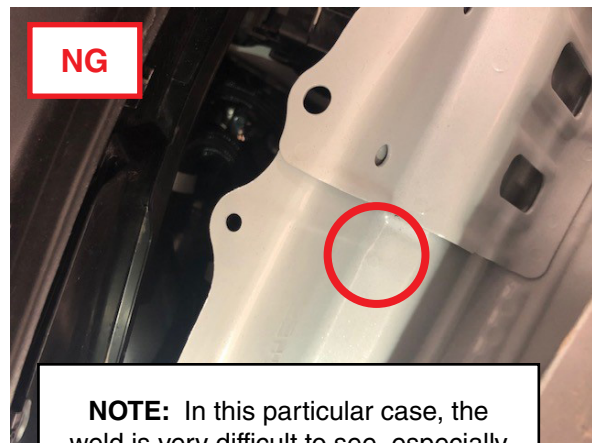
APPENDIX A: Examples of NG (“B” Jig) and OK (“A” Jig) Duct Panel Weld Inspections

NOTE: In this particular case, the weld is very difficult to see, especially in the supplied photo. Keep in mind, the vehicle's color can make the weld difficult to identify and photograph for making the OK / NG determination.
