TO: Mercedes-Benz and Freightliner Dealer Principals, General Managers, Sales Managers, Service Managers, Parts Managers	FROM: Anthony Washington, Department Manager, Regulations and Certifications
RE: <b>Launch Recall Campaign Notification</b> <b>Model 907 (Sprinter)</b> <b>Model Years 2019</b> <b>Replace Rear-side Windows</b>	DATE: November, 2019

Campaign No. 2019100008, November 2019

SUBJECT: **Model 907 (Sprinter), Model Year 2019**  
**Replace Side Window**

Approximately **876** vehicles are involved.

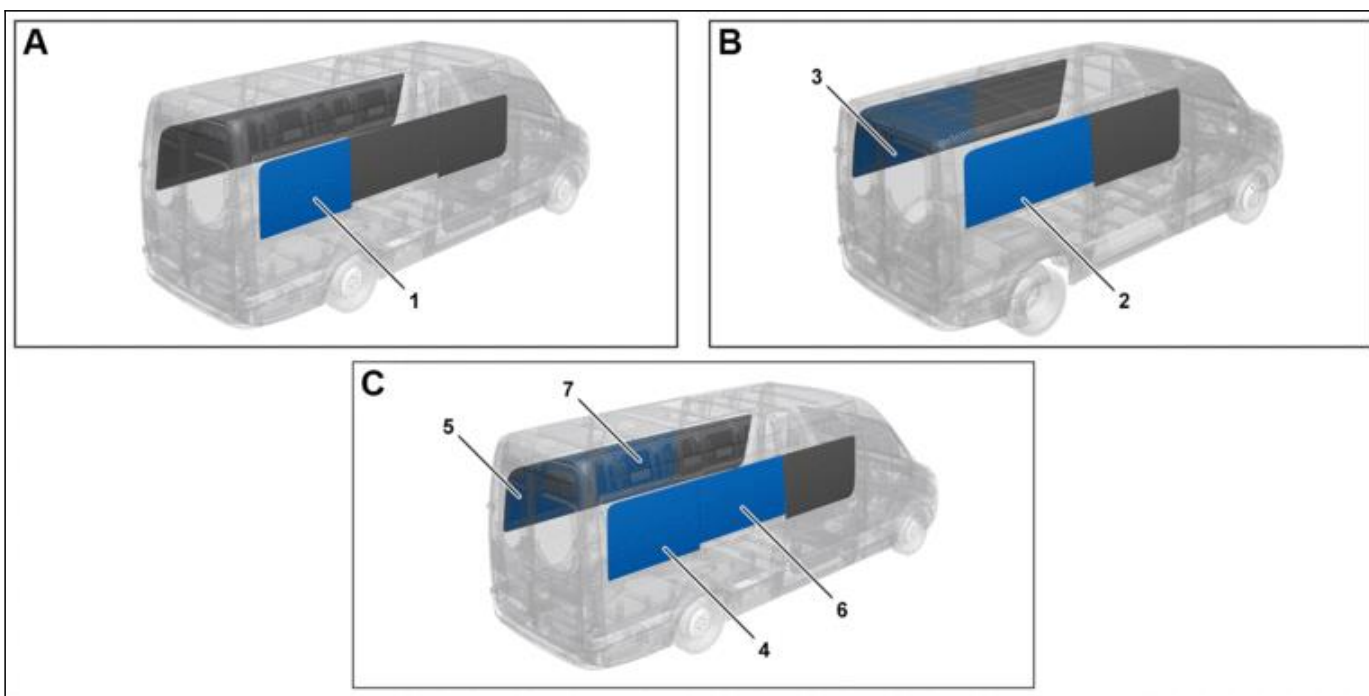
D67.30-A001-79

Mercedes-Benz AG ("MBAG"), the manufacturer of Mercedes-Benz vehicles, has determined that in certain Sprinter vehicles (model series 907), a single-pane safety glass might have been installed in the rear side windows instead of the laminated safety glass that was intended. This may result in an increased risk of injury to vehicle occupants in the event of a side rollover, particularly vehicle occupants who have not fastened their seat belts. An authorized Mercedes-Benz or Freightliner dealer will check the rear side windows in the affected vehicles and replace if necessary.

2.1	Replace rear right side window (1).	<p>Model 907.745 1P as of 021618 up to 100312 with code F43 (Side windows in rear laminated glass)</p> <p>Model 907.745 1T as of 000156 up to 005399 with code F43 (Side windows in rear laminated glass)</p> <p><b>i</b></p> <p>See picture A</p> <p><b>i</b></p> <p>Dispose of removed side window (1) properly. Observe the applicable legal requirements and specifications of the relevant country.</p>	AR67.30-D-2400TS

2.2	Replace side windows (2, 3) at rear left and right.	<p>Model 907.643 1P as of 049635 up to 124633 with code F43 (Side windows in rear laminated glass)</p> <p><b>i</b></p> <p>See picture B</p> <p><b>i</b></p> <p>Dispose of removed side windows (2, 3) properly. Observe the applicable legal requirements and specifications of the relevant country.</p>	AR67.30-D-2400TS

2.3	Replace left center, right center, rear left and rear right side windows (4, 5, 6, 7).	<p>Model 907.645 1P as of 058365 up to 107867 with code F43 (Side windows in rear laminated glass)</p> <p>Model 907.647 1P as of 103982 up to 120724 with code F43 (Side windows in rear laminated glass)</p> <p>Model 907.655 1P as of 054351 up to 124991 with code F43 (Side windows in rear laminated glass)</p> <p>Model 907.657 1P as of 073138 up to 125930 with code F43 (Side windows in rear laminated glass)</p> <p><b>i</b> See picture C</p> <p><b>i</b> Dispose of removed side windows (4, 5, 6, 7) properly. Observe the applicable legal requirements and specifications of the relevant country.</p>	AR67.30-D-2400TS
-----	--	--	------------------
