PRODUCT CAMPAIGN BULLETIN

APPLICABILITY: 2019MY Ascent

NUMBER: WUI-94

SUBJECT: Quality HOLD / STOP SALE: Propeller Shaft

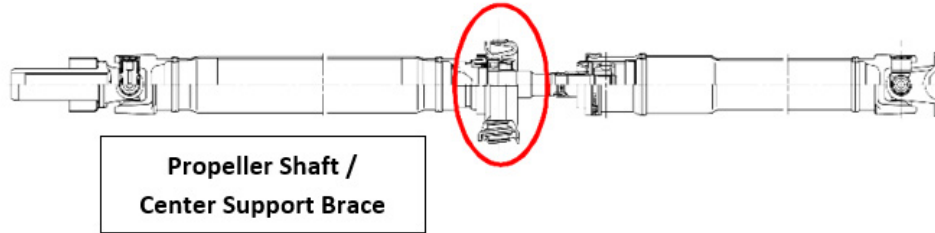
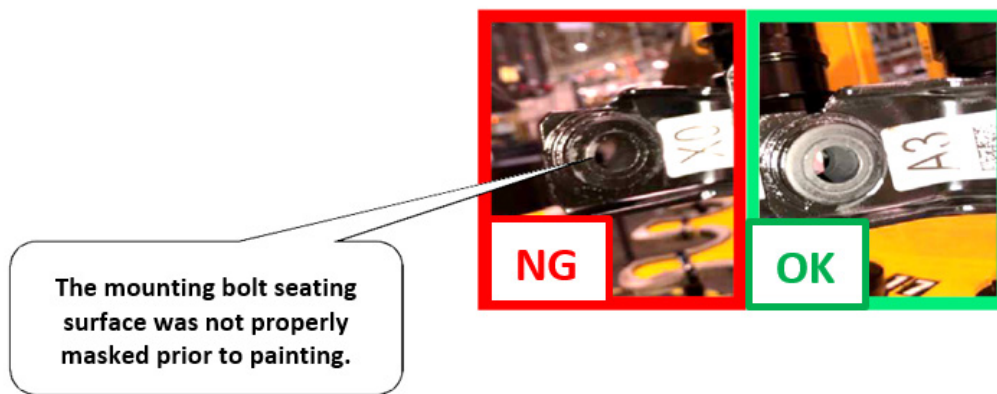
During manufacture of the propeller shaft assembly, the mounting surfaces for the two (2) center support brace bolts were inadvertently painted as shown in the **NG** example photo below. The mounting surface should be unpainted as shown in the **OK** photo. Because of this, the mounting bolt torque applied during propeller shaft installation may relax due to continued vibration. This service procedure involves replacing the propeller shaft assembly and the related hardware.

This recall involves replacement of the propeller shaft assembly. Additional information will be forthcoming.
