PRODUCT CAMPAIGN BULLETIN

APPLICABILITY: 2019MY Ascent **NUMBER:** WUI-94R
SUBJECT: STOP SALE: Propeller Shaft **DATE:** 07/02/19
NHTSA: 19V519
REVISED: 07/22/19

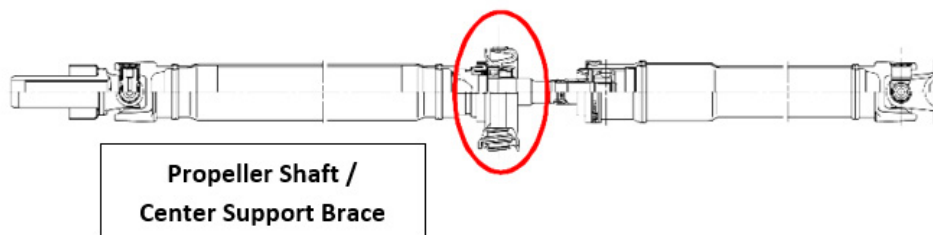
The mounting surfaces for the propeller shaft center support brace bolts may have been painted in error during the manufacturing process. If these mounting surfaces are painted, the bolts may not retain the specified torque. If both of the center support bolts completely come out due to continuous vibration, the front end of the propeller shaft could separate, increasing the risk of a crash.

During manufacture of the propeller shaft assembly, the mounting surfaces for the two (2) center support brace bolts were inadvertently painted as shown in the **NG** example photo below. The mounting surface should be unpainted as shown in the **OK** photo. Because of this, the mounting bolt torque applied during propeller shaft installation may relax due to continued vibration. This service procedure involves replacing the propeller shaft assembly and the related hardware.

Subaru will replace the propeller shaft assembly in all potentially affected vehicles.

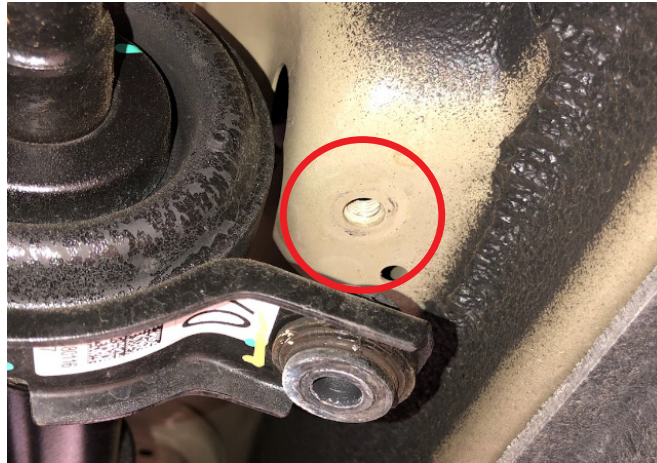
VERY IMPORTANT: After removing the original propeller shaft, confirm there is no residual **BLACK** paint remaining from the center support brace on both mounting surfaces of the body. The mounting surfaces **must be clean** as shown below. Use a mild solvent on a clean shop cloth to clean the area if necessary. **NEVER** use an abrasive disc or otherwise remove the tan-colored protective underbody finish coat. Doing so will expose bare metal making it susceptible to corrosion / rust.

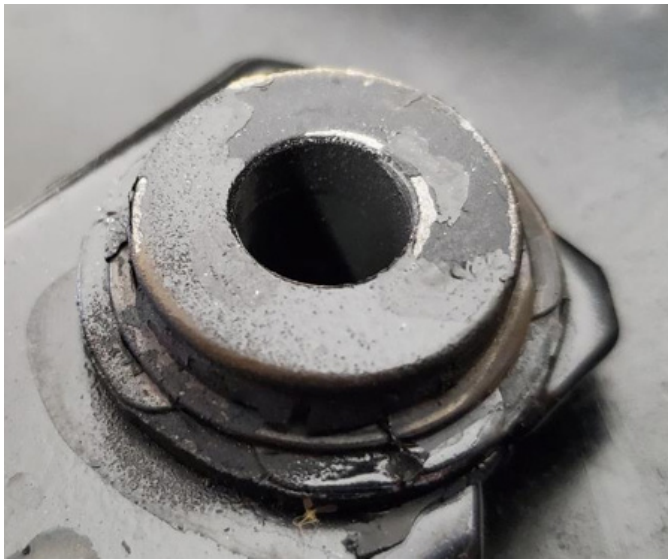
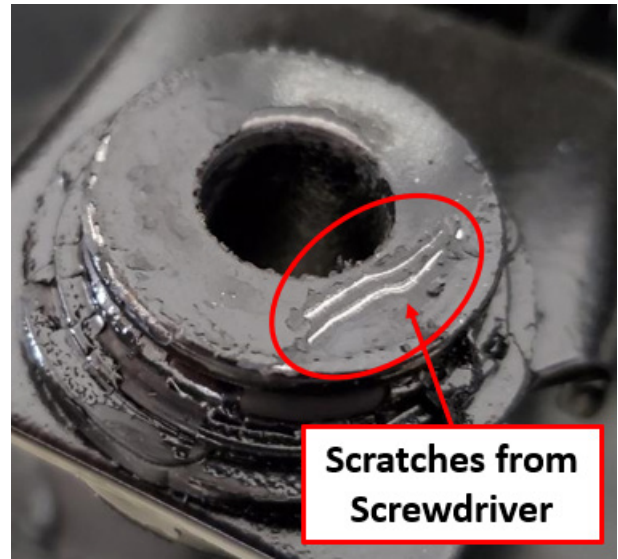
- These **NG** examples show a heavy coating of paint covering the body side mounting surface and the surrounding bracket area. The finish is thick, layered and has a heavy “orange peel” look.

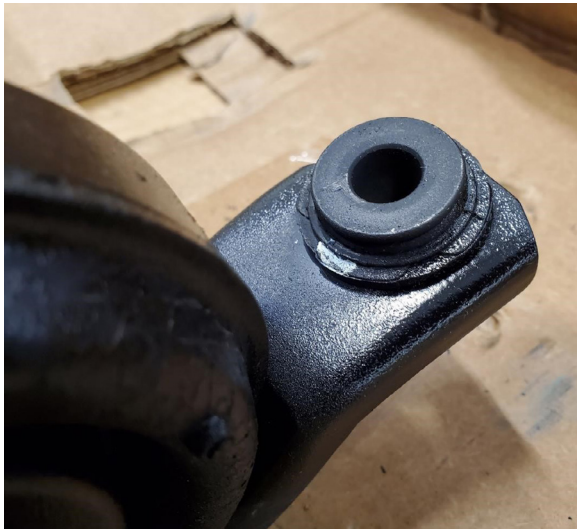
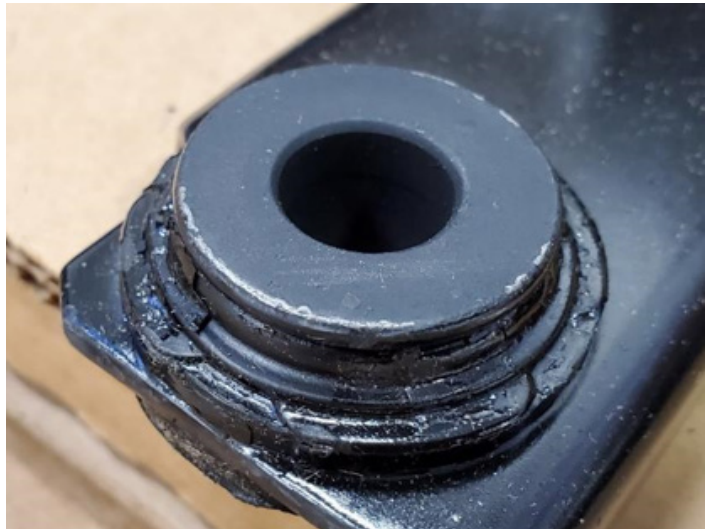
- These **OK** photos show the body side of replacement parts with a much lighter, uniform coating.

NOTE: The replacement propeller shafts for this procedure have all been confirmed to be **OK** for use. There is no need to inspect these parts for anything other than possible shipping damage and to insure the part is correct for the application.
