R19AF

DATE: January 10, 2020
TO: Blue Bird Owners
Subject: RECALL R19AF, Safe Fleet Prolo Roof Hatch Handle

IMPORTANT SAFETY RECALL NOTICE

SUBJECT: RECALL R19AF, Safe Fleet Prolo Roof Hatch Handle

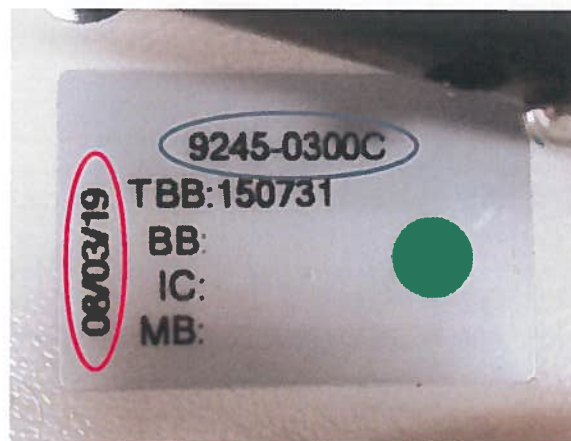
1. Check the label on the bottom of the Prolo Hatch p/n 92XX-XXXXX (circled below in blue) for dates between August 1, 2018 and May 20, 2019 (circled below in red). Units built within this date range are subject to the replacement campaign.

Replacing the outside release handle will resolve the defect. The replacement kit will include (1) replacement handle, associated hardware, and replacement instruction information.

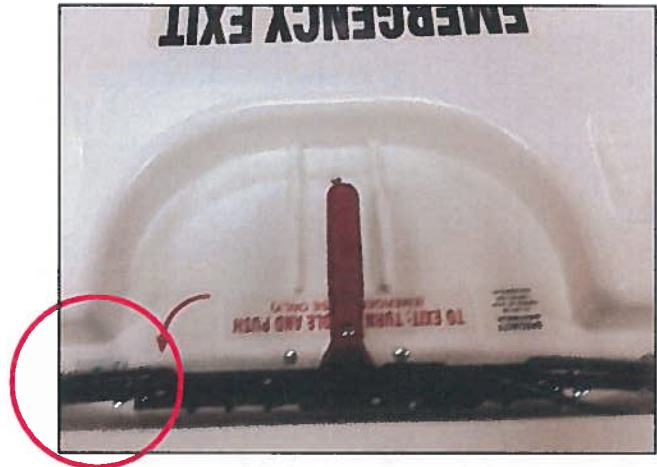
Step 2: Locate the silver "build date" sticker on the inside of the lid (located in red circle shown above)

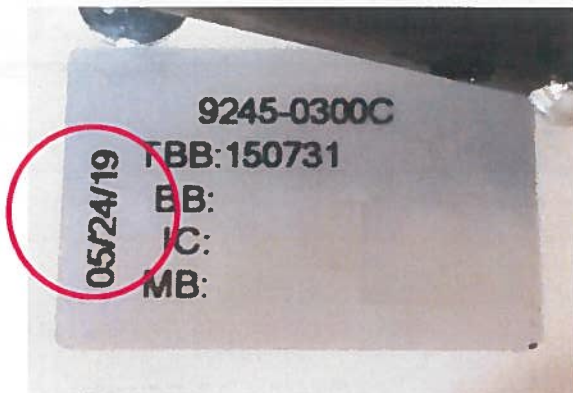
Step 3: If the date is between 8-1-18 and 5-21-19, the hatch will need to be reworked. Dates before or after that timeframe do not need rework.
