# Safety Recall

## Code: 69Z5

**Airbag Control Module**

Country	Model Year(s)	Vehicle
USA	2015-2016	TIGUAN
USA	2015-2016	CC
CAN	2015-2016	TIGUAN
CAN	2015-2016	CC

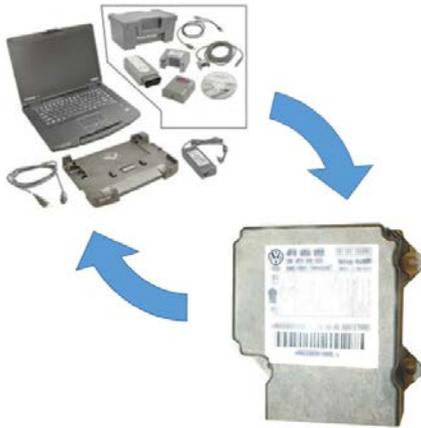
**Repair Overview**

A faulty capacitor in the airbag control module can cause the airbags in the vehicle to deactivate, or, in rare cases, lead to an unexpected deployment of the airbags and/or safety belt pretensioners, resulting in an increased risk of injury in a crash. An inadvertent airbag deployment may increase the risk of an injury due to the deployment or increase the risk of a crash without warning. A deactivated airbag in case of a crash may increase the risk of an injury in a crash where an airbag deployment would have been necessary.

- Update airbag control module software and replace module if necessary.

- Section A – Check for Previous Repair
- Section B – Airbag Control Module Software Update
- Section C – Airbag Control Module Replacement (if necessary)
- Section D – Campaign Completion Label
- Section E – Parts Return

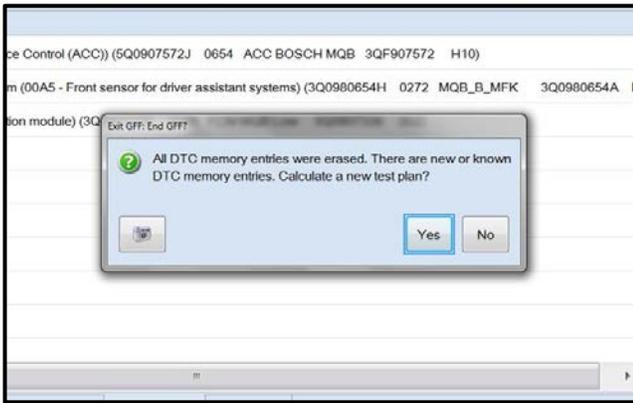
- Perform an ignition cycle.
- If the airbag warning light in the cluster is permanently illuminated, check the airbag control module fault memory.
- If fault “VAG00003: control module faulty, static” is stored in the airbag control module:
  - The airbag control module must be replaced.
  - Proceed to Section C.
