Technical Service Bulletin

NUMBER
19-01-028HG

**G80 / G90 TURBO OIL FEED PIPE REPLACEMENT
(RECALL CAMPAIGN 003G)**

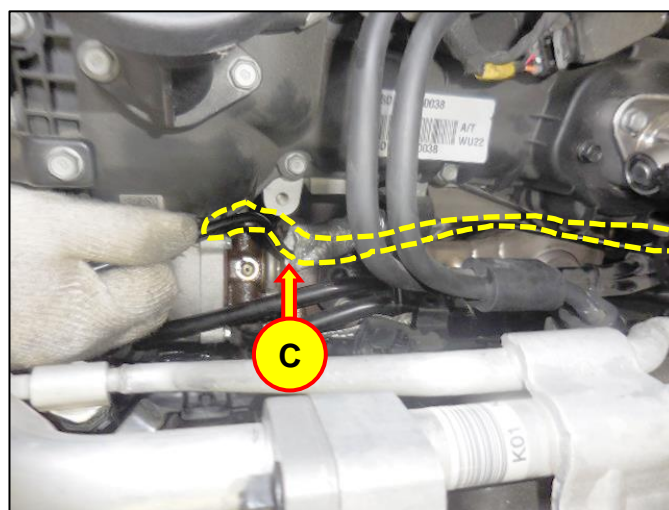
Description: The Left Hand (LH) turbocharger oil feed pipe may have a loose seal causing oil to leak onto the exhaust manifold. Oil leaking onto the exhaust manifold could increase the risk of a fire. This bulletin describes the procedure to replace the LH turbocharger oil feed pipe.

4. Remove the LH turbocharger oil feed pipe (C).
