September 2019  
FL820A  
NHTSA #19V-548  
Transport Canada #2019-364

## Subject: Airliner Suspension Brake Line Clearance

**Models Affected: Specific Model Year 2019-2020 Cascadia vehicles manufactured June 13, 2018, through July 15, 2019, and equipped with a certain 40K Light Weight Extra Duty Airliner suspension and 51 inch axle spacing configuration.**

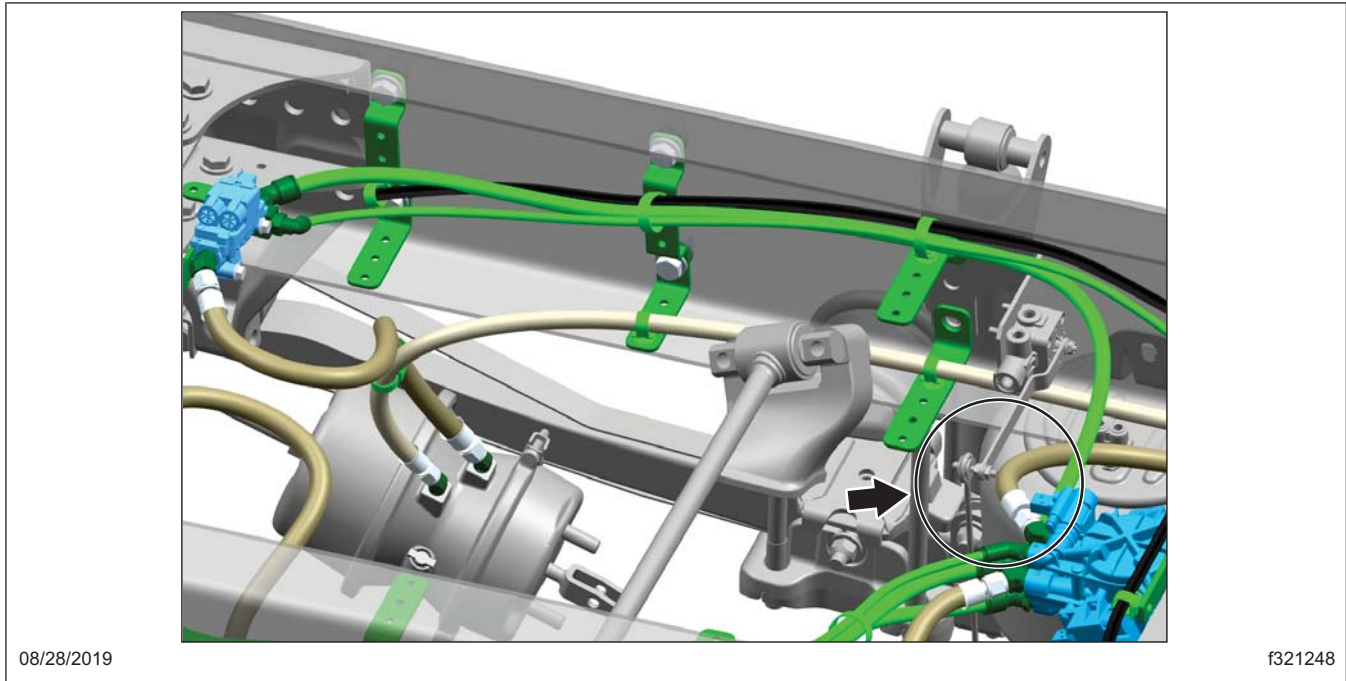
**Fig. 5, Brake Airline Inspection**

On certain vehicles, the clearance between the ride height control valve linkage and brake airlines may not be adequate and could lead to contact and chafing of the brake airline. Chafing of the brake airline may lead to an airline leak that may be undetectable during pre-trip inspection and could cause significant damage to the airline, potentially resulting in reduced brake effectiveness, increasing the risk of a vehicle crash.

19. Inspect the brake airlines just rear of the height control valve linkage. If there is any indication that the linkage has rubbed/abraded the brake air lines, replace the airlines. See **Fig. 5**.
