**SUBJECT: NEW VEHICLE DEMONSTRATION / DELIVERY HOLD  
Compliance Recall 19C06**

Certain 2020 Model Year Explorer and Aviator Vehicles  
Factory Mode Disable and Manual Park Release Cover Inspection

**NEW VEHICLE DEMONSTRATION / DELIVERY HOLD**  
**Compliance Recall 19C06**  
Certain 2020 Model Year Explorer and Aviator Vehicles  
Factory Mode Disable and Manual Park Release Cover Inspection

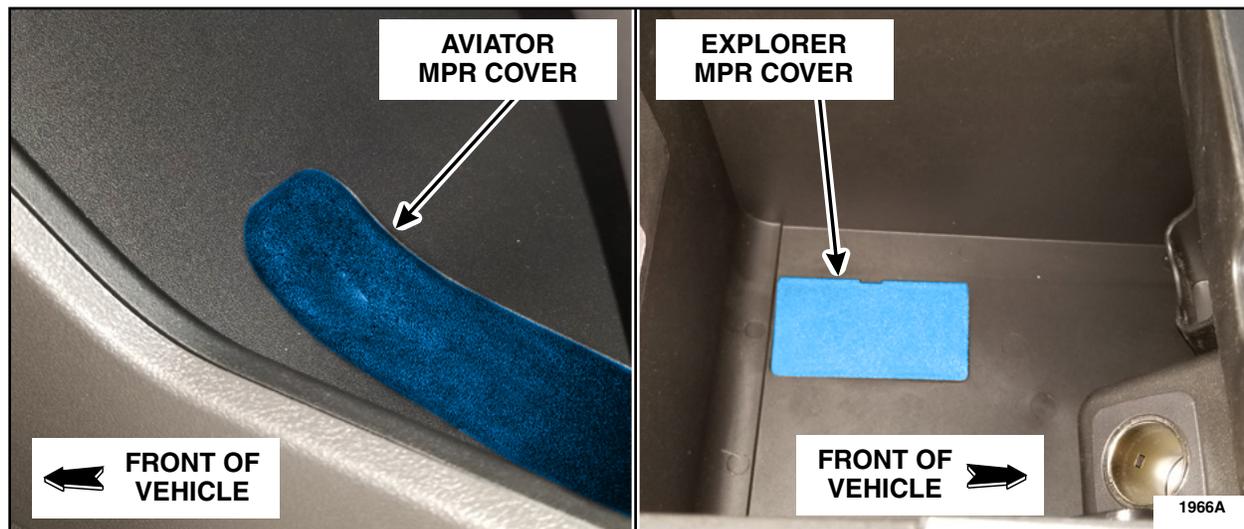
FIGURE 1

1. Locate the Manual Parking Release (MPR) cover. See Figure 1.

- Aviator Vehicles, the MPR cover is located in the center console below the radio, under mat on the driver side.
- Explorer Vehicles, the MPR cover is located in the center console storage compartment under the mat.

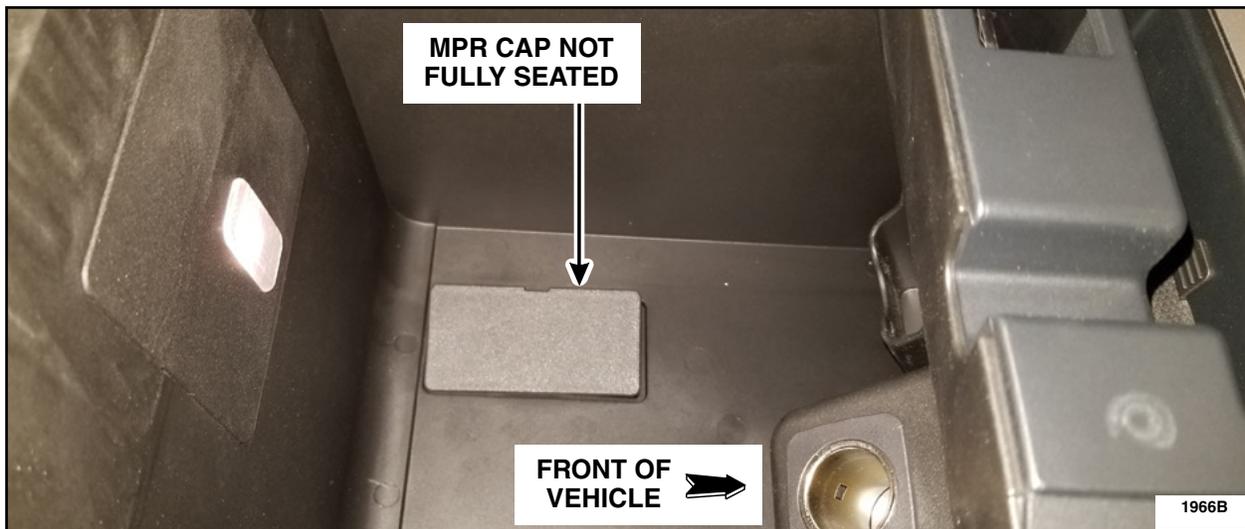
**FIGURE 2**

3. Inspect the MPR cover. Is it flush and not removable by hand? See Figure 2.

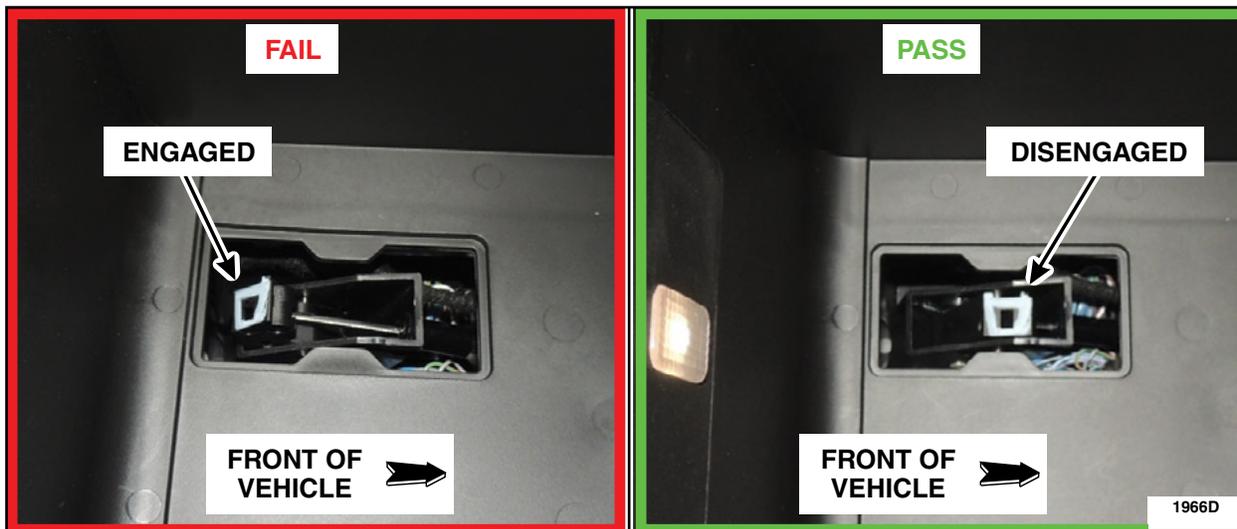
FIGURE 4

5. Is the MPR lever engaged? See Figure 4.

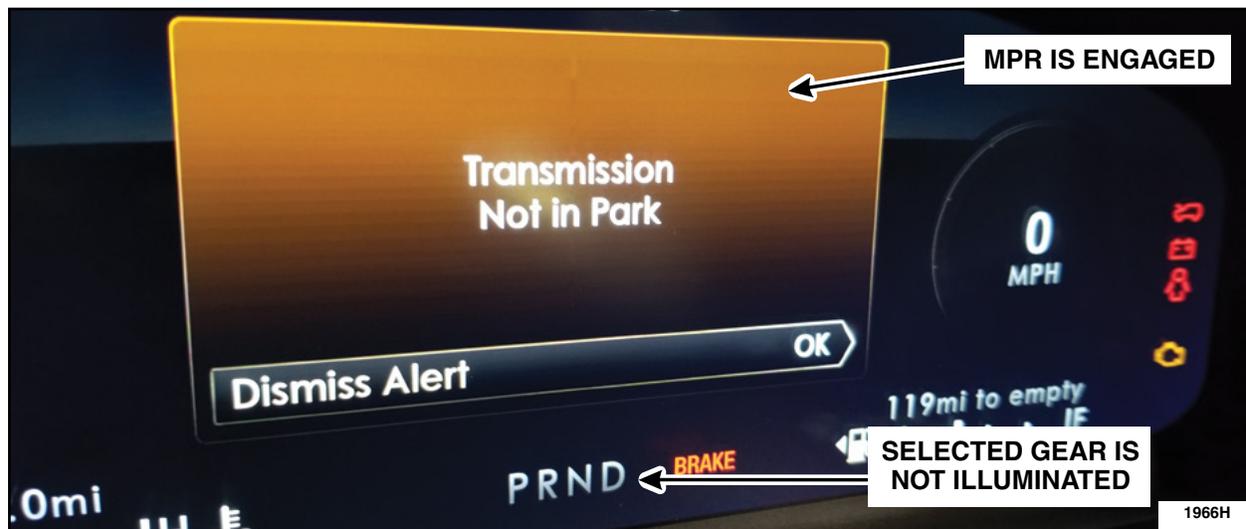
FIGURE 8

9. With driver door open and ignition on, monitor the Instrument Panel Cluster (IPC) message center. If the MPR is still engaged the warning Transmission Not in Park (P) will be displayed and selected gear will not be illuminated. If the MPR is disengaged the warning will not display and selected gear will be illuminated. Does the warning Transmission Not in Park (P) appear on the IPC message center display? See Figure 8.

- Yes - Repeat Steps 4 through 9.  
No - Proceed to Step 10.

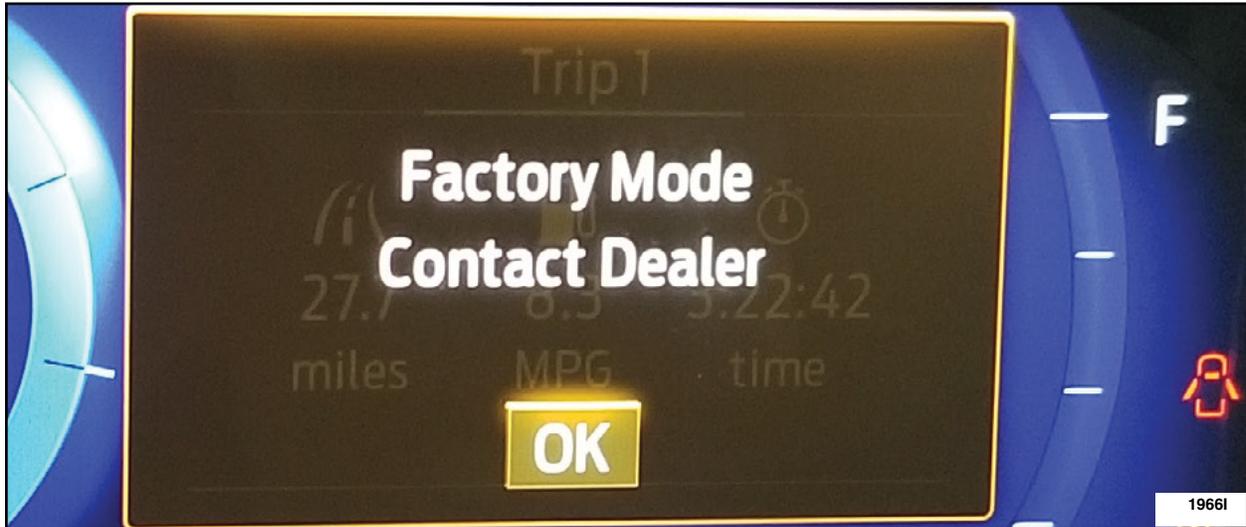
FIGURE 9

10. Cycle the ignition OFF and ON while monitoring the IPC. Does the message center display show the message "Factory Mode Contact Dealer" or "Transport Mode Contact Dealer"? See Figure 9.
