David J. Johnson
 Director
 Service Engineering Operations
 Ford Customer Service Division

August 15, 2019

**SUBJECT: NEW VEHICLE DEMONSTRATION / DELIVERY HOLD
 Compliance Recall 19C06 – Supplement #1
 Certain 2020 Model Year Explorer and Aviator Vehicles
 Factory Mode Disable and Manual Park Release Cover Inspection**

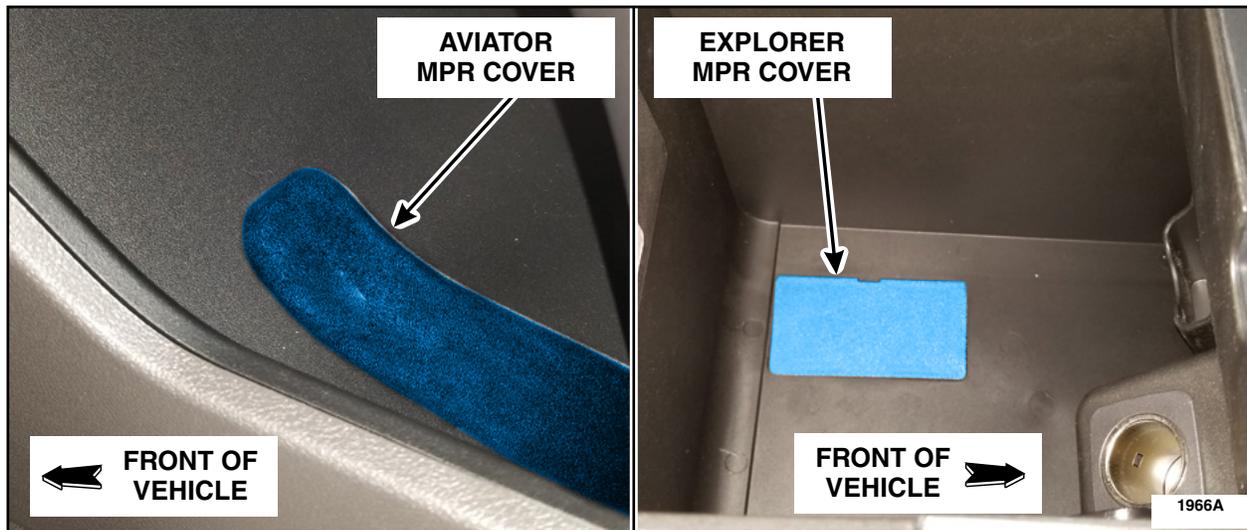
FIGURE 1

1. Locate the Manual Parking Release (MPR) cover. See Figure 1.

- Aviator Vehicles, the MPR cover is located in the center console below the radio, under mat on the driver side.
- Explorer Vehicles, the MPR cover is located in the center console storage compartment under the mat.
- *Police Interceptor Utility with a shifter on the column and not equipped with a center console does not have an MPR lever. Proceed to Step 10 and follow remaining instructions.*
- *Police Interceptor Utility with a shifter on the column and equipped with a center console does not have an MPR lever but does have a cover that requires inspection. Proceed to Step 2.*

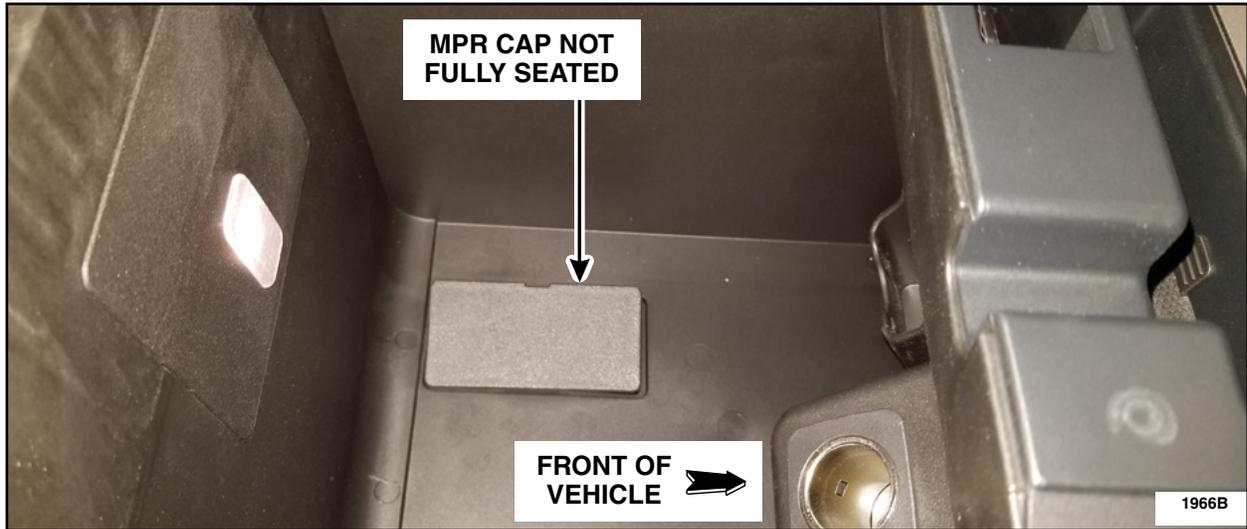
FIGURE 2

3. Inspect the MPR cover. Is it flush, fully seated and not removable by hand? See Figure 2.

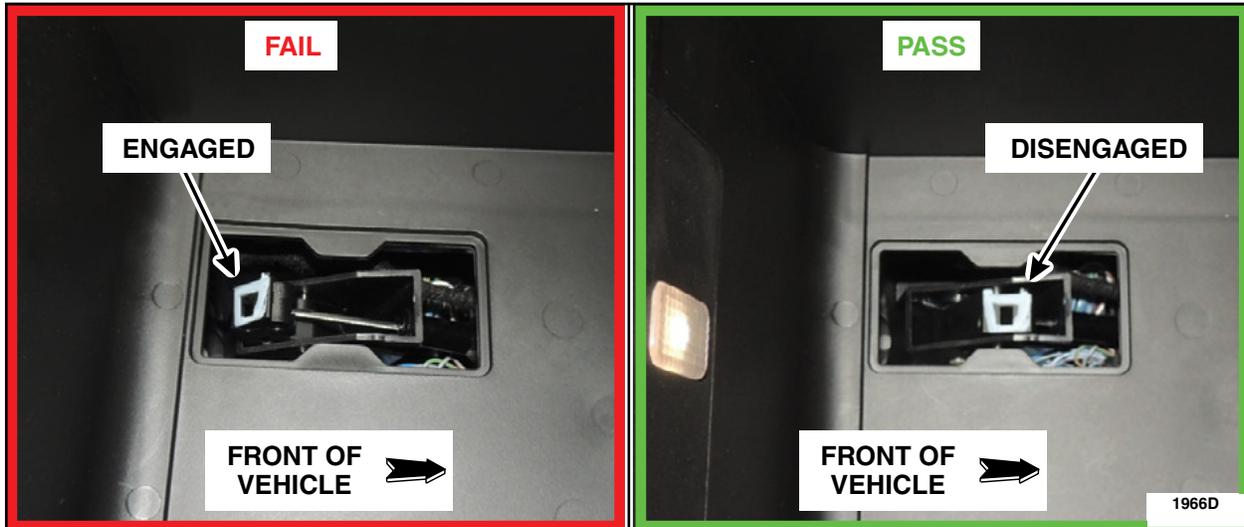
FIGURE 4

5. Is the MPR lever engaged? See Figure 4.

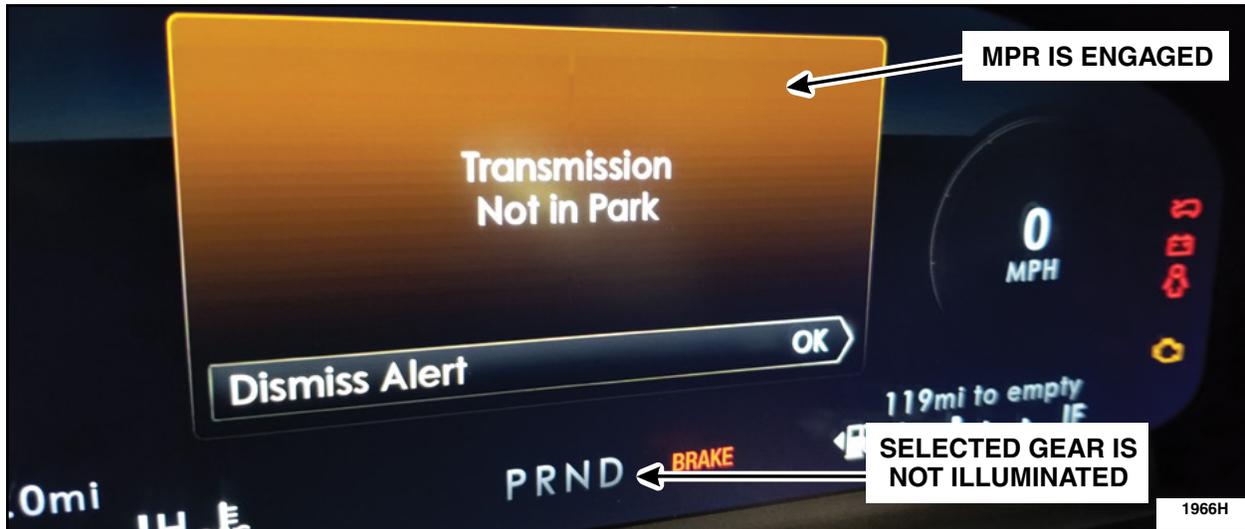
FIGURE 8

9. With driver door open and ignition on, monitor the Instrument Panel Cluster (IPC) message center. If the MPR is still engaged the warning Transmission Not in Park (P) will be displayed and selected gear will not be illuminated. If the MPR is disengaged the warning will not display and selected gear will be illuminated. Does the warning Transmission Not in Park (P) appear on the IPC message center display? See Figure 8.

Yes - Repeat Steps 4 through 9.
No - Proceed to Step 10.

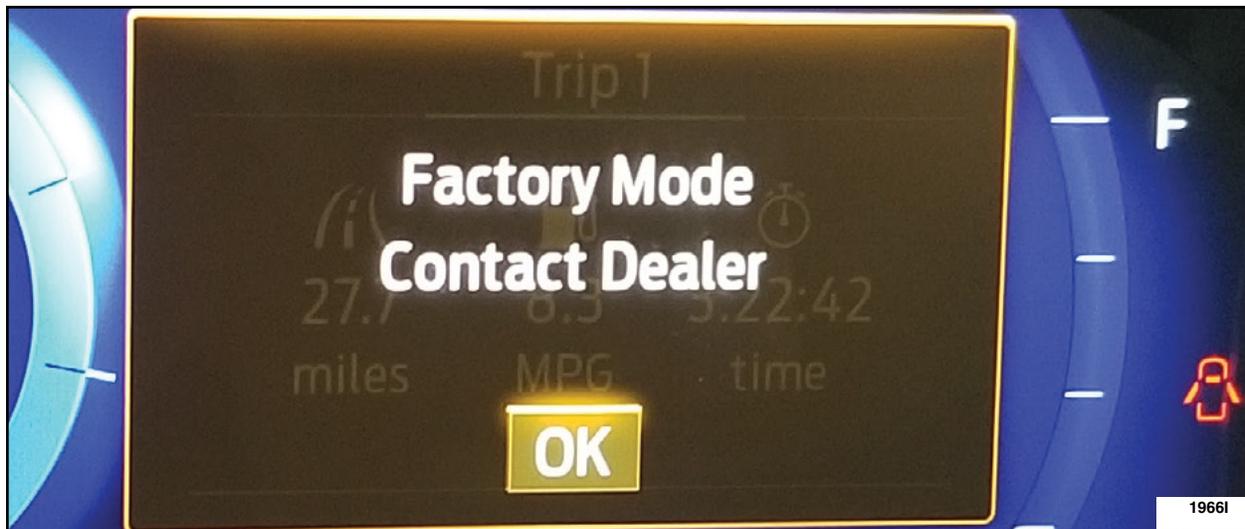
FIGURE 9

10. Cycle the ignition OFF and ON while monitoring the IPC. Does the message center display show the message "Factory Mode Contact Dealer" or "Transport Mode Contact Dealer"? See Figure 9.
