Technical Service Bulletin 19 002

Subject: Upper Shock Mounting Hardware

Applies To: Fire Truck IFS 20k and 24k Models

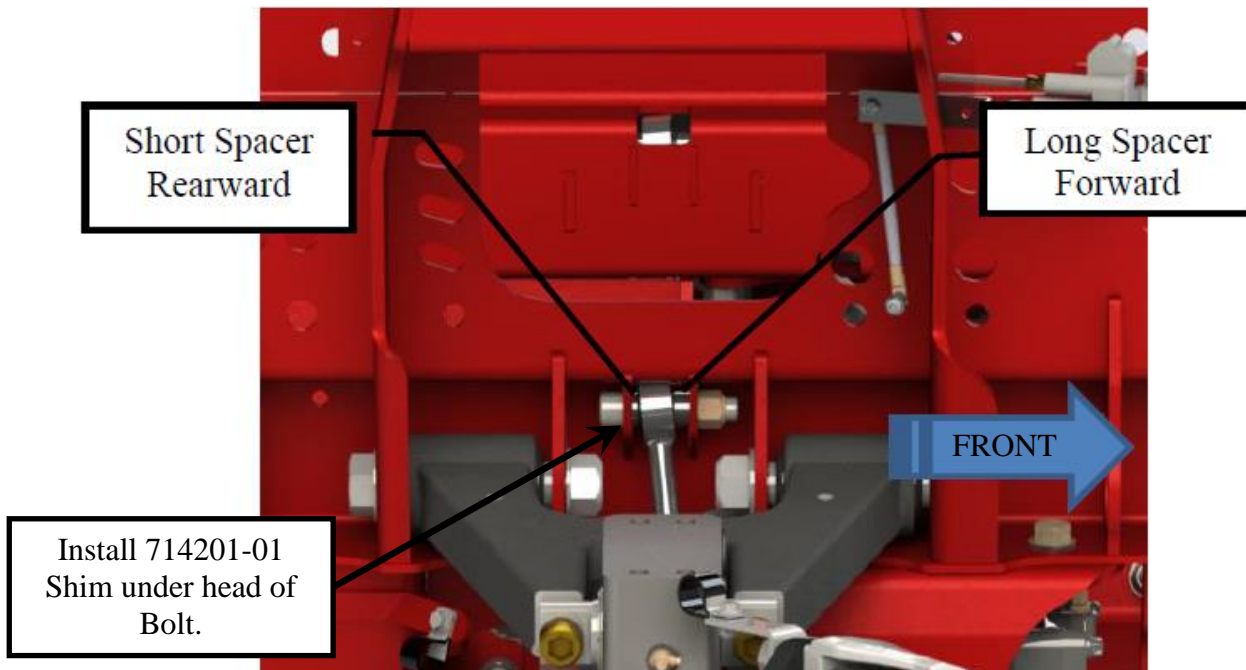
Right side assembly shown

Condition: The upper shock mounting hardware may come loose over time due improper joint clamp load.

3. Install new hardware including spacers and shims from kit #K715180 as shown below.
 - a. **Note:** One 714201-01 shims must be installed under the head of each 715176-01 Bolt.

- b. **Assembly tip:** Insert bolt through the rear tab enough to hang needed shims and short spacer, place shock in position, advance bolt to engage shock, position long spacer, push bolt through front tab, and install nut.
