IMPORTANT SAFETY RECALL

NHTSA Safety Recall No. 19V-578

MAB 732

Rotation Bearing Fastener Inspection

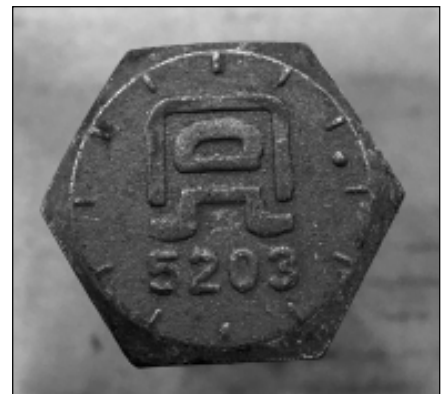
Figure 1 — 5203 Head Marking

- Look for any broken or missing fastener heads
- Look at all the fastener heads on the inner race to see if there is a 5203 below the Altec logo (refer to Figure 1)

If **any** of the fasteners have a head with the head stamp of 5203 or there is a broken or missing fastener head, **remove the unit from service.**

If fasteners marked with 5203 are found on the inner race, all of the fasteners on that race must be replaced before the unit can be returned to service. Order the replacement fastener kit from the list on Page 2 by calling 1-877-GO ALTEC (1-877-462-5832) and select Prompt 1. Refer to Section 6 in the Maintenance Manual for replacement Instructions.
