TO: Mercedes-Benz Dealer Principals, General Managers, Sales Managers, Service Managers, Parts Managers	FROM: Gregory Gunther, Department Manager, Vehicle Compliance and Analysis, Engineering Services
RE: Recall Campaign Launch Notification Rear Middle Seat Belt Anchor MY18-19 156 (GLA-Class)	DATE: September 10, 2019

Campaign No. :	NHTSA ID	Campaign Desc. :	Rear Middle Seat Belt Anchor
2019080010	19V585	19P9290002

SUBJECT: **Model GLA-Class vehicles (156 platform)**
Model Years 2018-2019
Check rear middle seat belt, correct if necessary

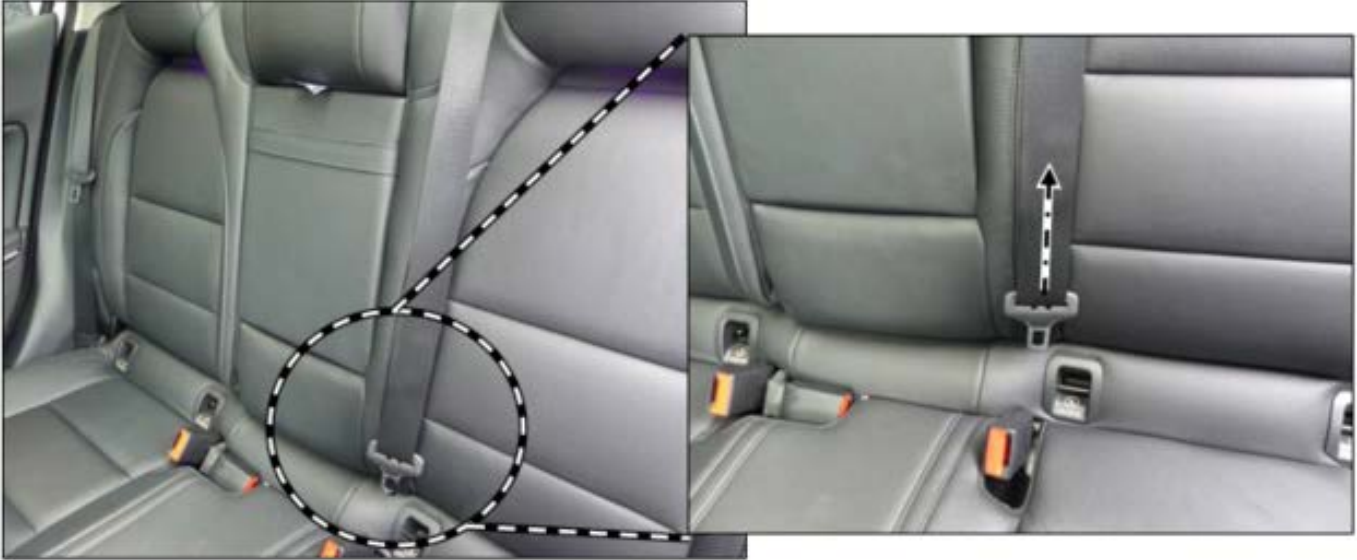
Figure 1

1.1. Grasp seat belt strap of center rear seat belt in area of rear seat cushion and rear seat backrest and pull away from rear seat (**Figure 1**).

i It is possible that the seat belt end fitting of the center rear seat belt is not attached and is just jammed.

1. Check whether seat belt end fitting of center rear seat belt is attached correctly.
