Mercedes-Benz

Campaign No. 2019080005, August 2017

SUBJECT: **Model GLE-Class vehicles, (167 platform)
Model Year 2020****Check condensation drain hoses of air conditioning system, rework if necessary**

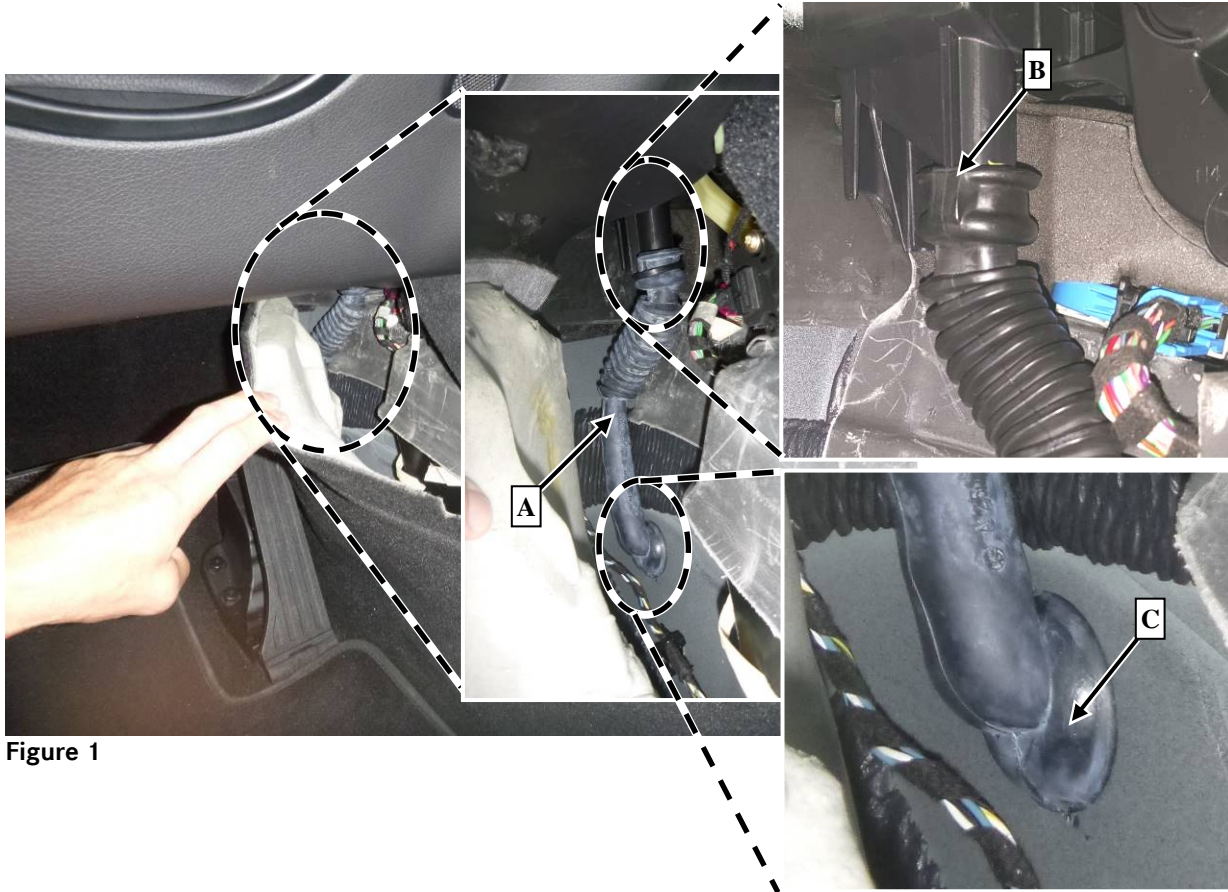
Figure 1

1. Release floor covering in footwell on driver's and front passenger side and check condensation drain hose at right and left of air conditioning system (**Figure 1**).
 - i** The condensation drain hose must be installed without creases in proper-seated position and inserted correctly on the heater box or tunnel (**C, Figure 1**).
 - i** The cutout (**B, Figure 1**) must be positioned correctly on the fitting of the heater box.
 - i** There must **not** be any visible or noticeable traces of water.

- a. Condensation drain hose **not** fastened correctly: Carry out **check/test procedure B**.
- b. Condensation drain hose fastened correctly: **End measure**.

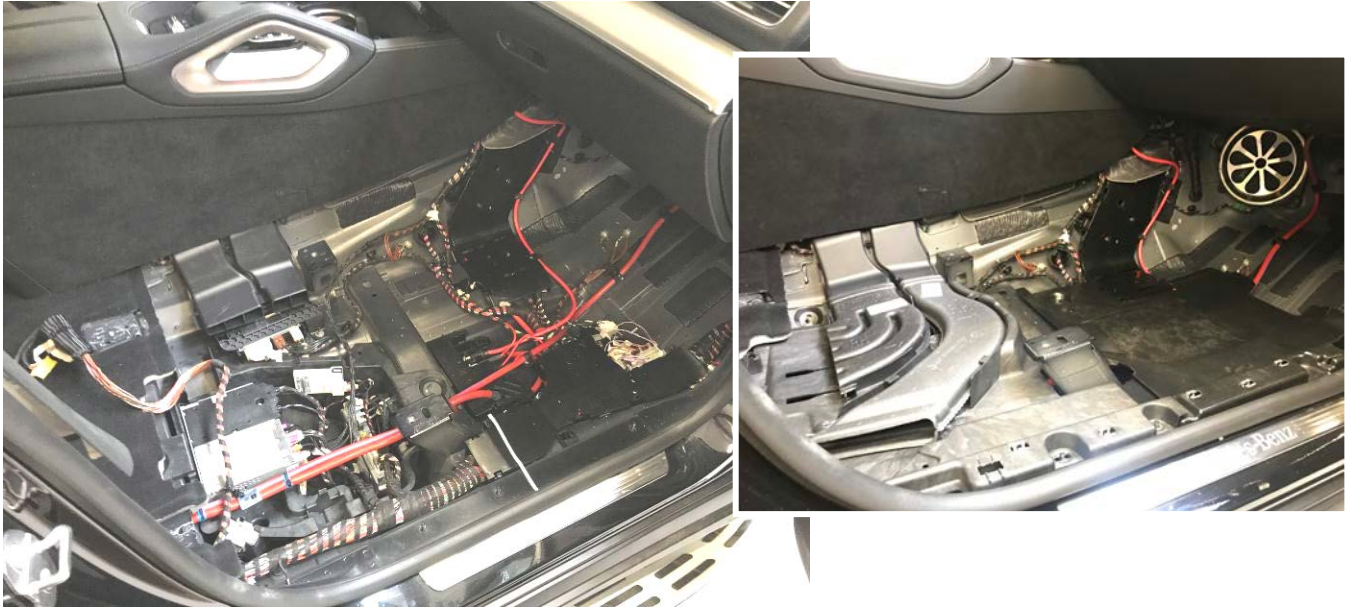
Figure 2

1. Remove front floor covering and covers above the electrical assemblies in the foot well of the incorrectly mounted drain hose.
 - i** Remove corresponding driver's seat and/or front passenger seat.
 - i** For basic data on removing the floor covering on the front passenger side, see **AR68.80-P-0008ME**.
 - i** For basic data on removing the floor covering on the front driver's side, see **AR68.80-P-0007ME**.

2. Check accessible electrical connections in the moist area for moisture and corrosion.
 - a. Condensation drain hose **not** fastened correctly and **minor** traces of water present: Carry out **work procedure A**.
 - b. Condensation drain hose **not** fastened correctly and **major** traces of water present: Carry out **work procedure B**.
