# Service Information Bulletin

B52 20 19

## RECALL 19V-600: REPLACE REAR CENTER HEADREST

E-Series	Model Description
G20	3 Series Sedan

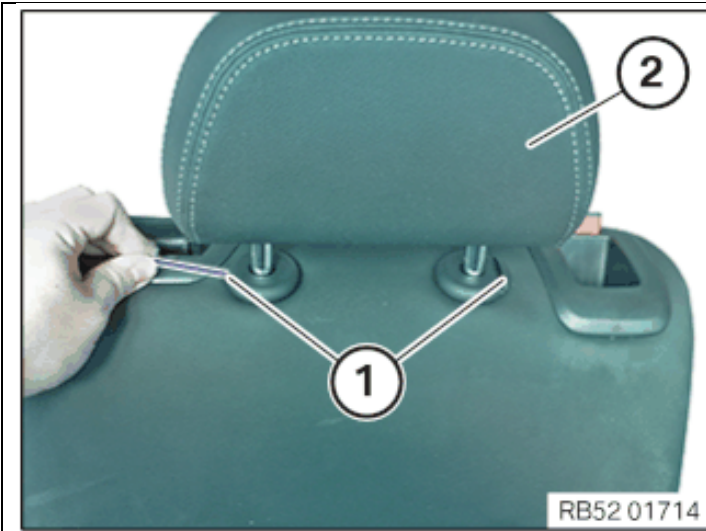
To remove the headrest:

- Unlock the locks (1) and take out the headrest (2) towards the top

To avoid mix-up with the new part which has the same appearance:

- Apply a small piece of tape, or other marking to the headrest
- Destroy and discard the original
