SIM 32 01 19

RECALL 19V-601: STEERING GEAR TIE ROD

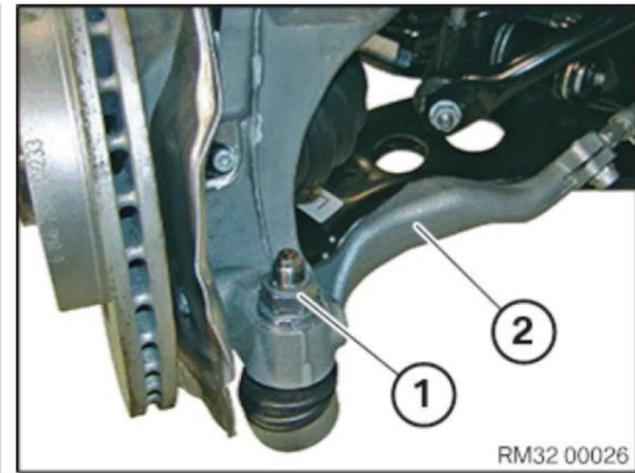
2. Loosen nut (1) on left and right swivel bearing
3. Release tie rod (2) from swivel bearings

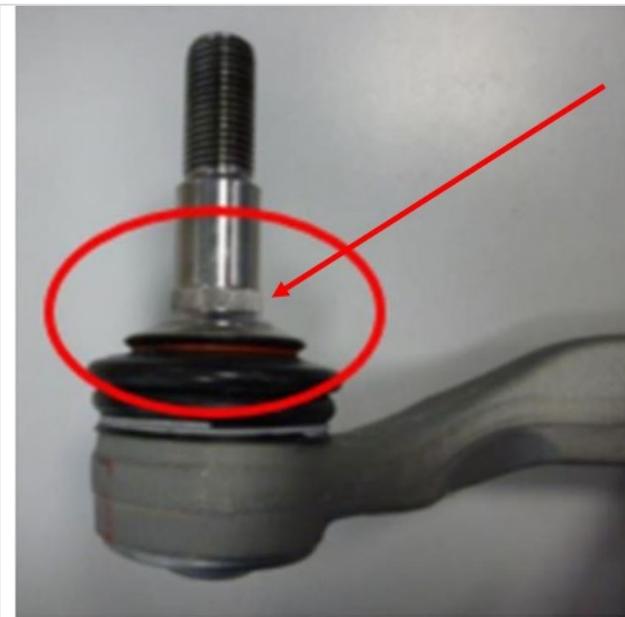
Cone collar disc installed, no knurling visible.

Cone collar disc **not** installed, knurling visible.

- Yes = No further action required, reinstall tie rod as per repair manual **RA 32 21 151** and properly torque **new** nut
- No = Proceed to next step

5. Replace the tie rod and swivel bearing as per the repair manual **RA 32 21 151** and

RA 31 21 090 and carry-out a wheel alignment procedure.
