IMPORTANT RECALL CAMPAIGN UPDATE

Campaign No. 2019090019, October 2019

SUBJECT: **Model CLS-Class vehicles (257 platform)**
Model Year 2019
Wiring Harness for Electric Coolant Pump

Order No. P-RC-2019090019

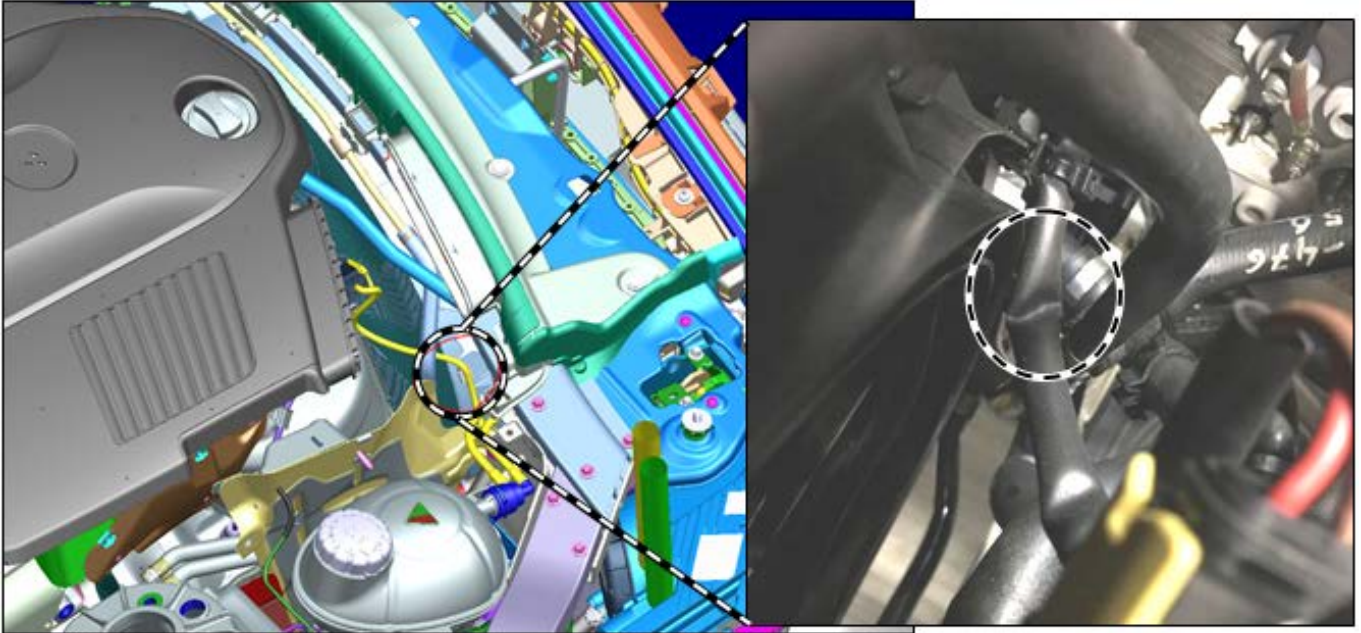
Figure 1

1. Check electrical wiring harness of electric coolant pump in area of fan for damage (figure 1).

- a. **Line insulation and protective hose of electrical wiring harness damaged:**
Perform **work procedures A and B and C.**
- b. **Only Protective hose of electrical wiring harness damaged and line insulation NOT damaged:**
Perform **work procedures B and C.**
- c. **Line insulation and protective hose of electrical wiring harness Both NOT damaged:** Perform **work procedure C.**
