T270/T370 Treadle Valve Loose Compression Fittings

Title	Recall 19KWD
Search Words	
Bulletin No.	19KWD
What's New Abstract	Safety Recall – Remedy Available. Certain compression fittings on the brake treadle valve may not have received appropriate torque. As a result, a brake application air supply hose may separate from the brake treadle valve, which may diminish vehicle braking capability and may increase the risk of a crash and injury without warning..
Supplier	Dynacraft
Description	Recall 19KWD: T270/T370 Treadle Valve Loose Compression Fittings
Release Date	
Introduction	Kenworth Truck Company has determined that a defect, which relates to motor vehicle safety, exists in certain T270 and T370 chassis manufactured between July 19, 2019 and August 1, 2019.
Situation	144 chassis (139 U.S. and 5 Canada) T270 and T370 built from 07/19/2019 through 08/01/2019 equipped with air brakes.
Resolution	<p>Service all chassis affected that enter your dealership, even if the customer has no issue with the chassis.</p> <ol style="list-style-type: none"> 1. Review the attached chassis list for your dealer code and schedule your customer(s) for service if their chassis is on the list. 2. If you

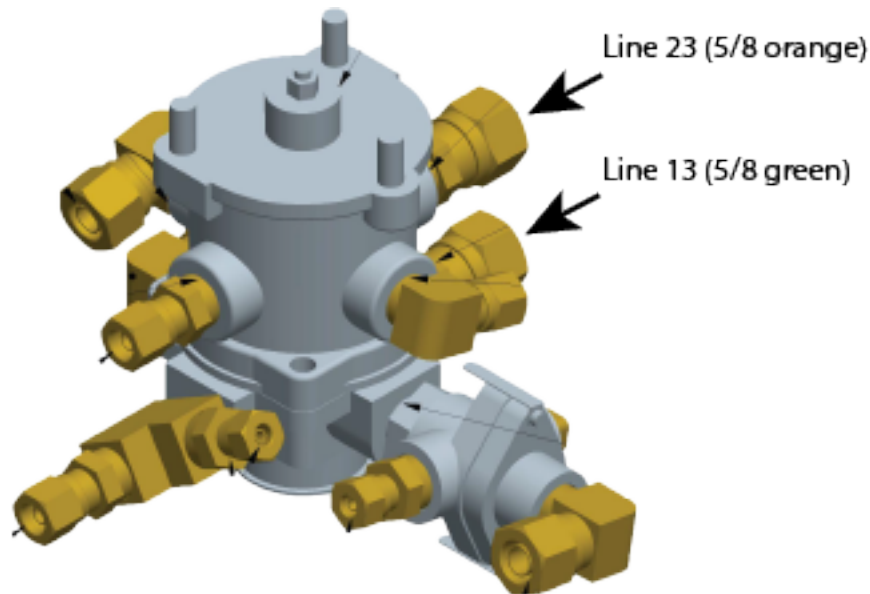
Some chassis may have a 90° fitting instead of a straight fitting as shown in the figure below.

1. Inspect the tubing at Ports 13 and 23 of the treadle valve.
 - If the tubing slides in and out of the compression fitting, push the tubing in all the way and torque the compression fitting nut to 35 lb-ft. (47.5 N·m).
 - If the tubing does not slide in and out of the fitting, continue with this procedure.

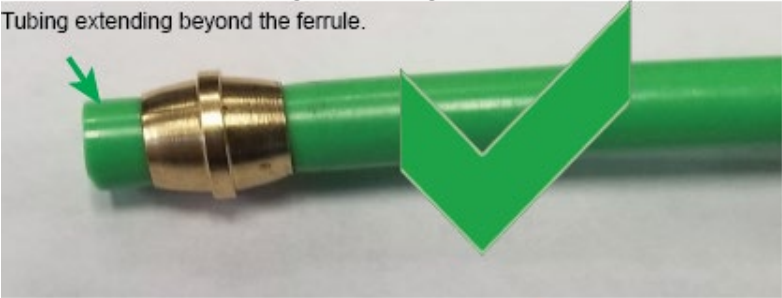
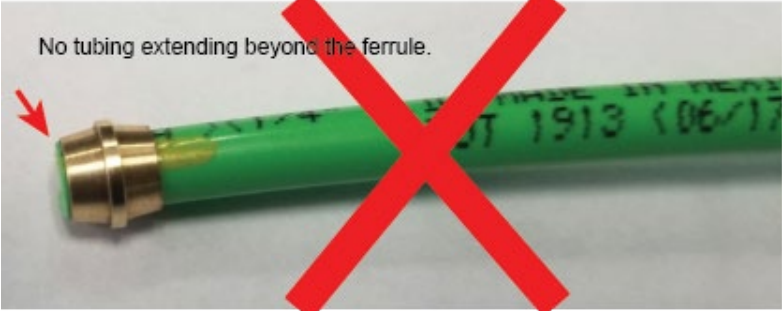
2. Remove the compression nut from the treadle valve.
3. Confirm that the ferrule meets one of the following conditions. If it does not, the tubing and ferrule must be replaced. When replacing the tubing, follow the original routing and tubing retention/clipping.
 - Condition 1: Slides easily on the tubing

<ul style="list-style-type: none"> Condition 2: Has tubing extending out of the end of it. Tubing extending beyond the ferrule.

<ol style="list-style-type: none"> Align the tubing and ferrule with the appropriate treadle valve port, start the compression nut, push the tubing into the port while tightening the compression nut to 35 lb-ft. (47.5 N·m).
Shipping	
Freight	
Contact	
Attachments	Dealer\Chassis List
