Thor Motor Coach Recall Repair Instructions

Recall #	19V-609 2019-426		
Description/Title:	BIM/BIR WIRING		
Affected Product Line(s):	Certain Model Year 2020 Chateau, Daybreak, Four Winds, Freedom Elite, Outlaw, Quantum, and Majestic motorhomes		
Service Campaign # :	RC000172	Released Date:	09/30/2019
Repair Code:	TMCRC80486V	Document Date:	09/30/2019
Time Allowed:	0.75	Document Revision:	A

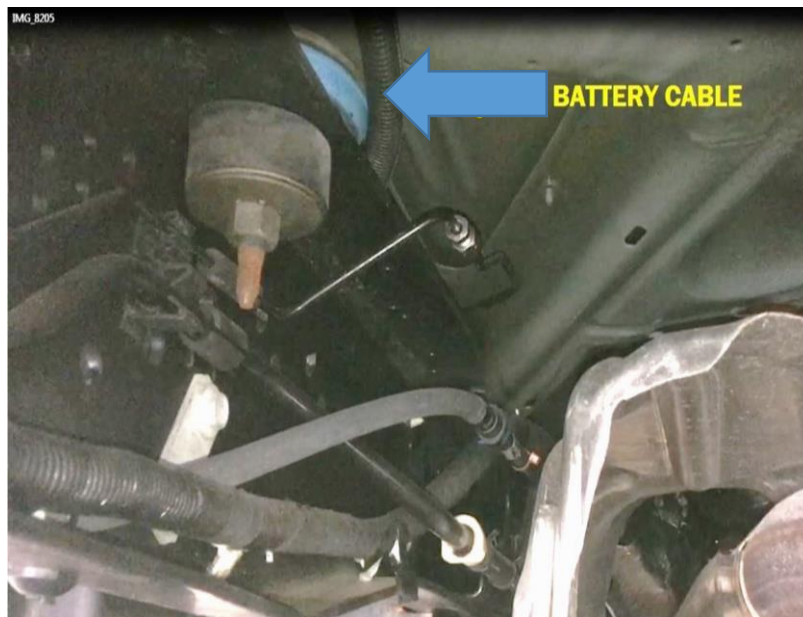
**PROPERLY
SECURED!**

Verify the 2 gauge cable that runs from the Trombetta is supported away from the engine exhaust manifold and the rest of the exhaust, covering the area under the hood to the rear of the cab. If the 2 gauge cable is not secured away from the exhaust manifold or the rest of the exhaust, secure as indicated in the following image.

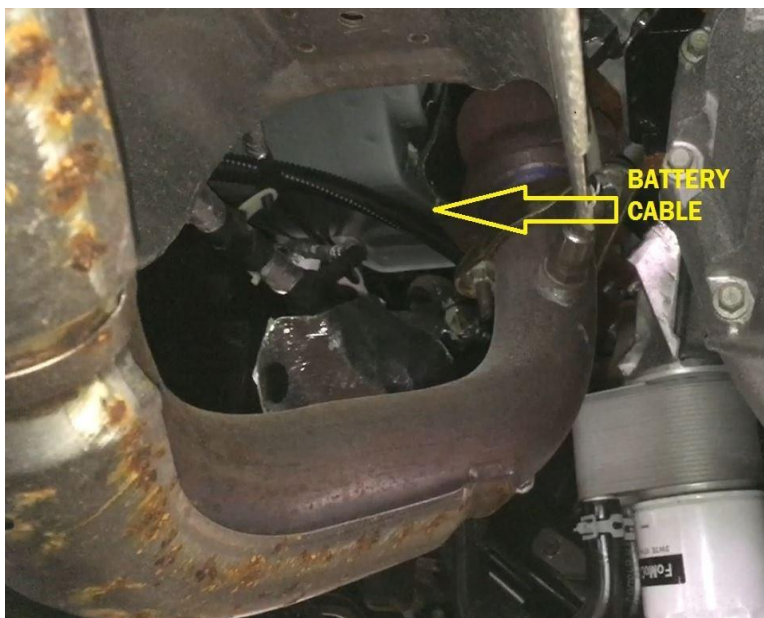
**NOT
PROPERLY
SECURED!**

Secure battery cables tight to the chassis frame. Keep battery cable away from exhaust and manifold.

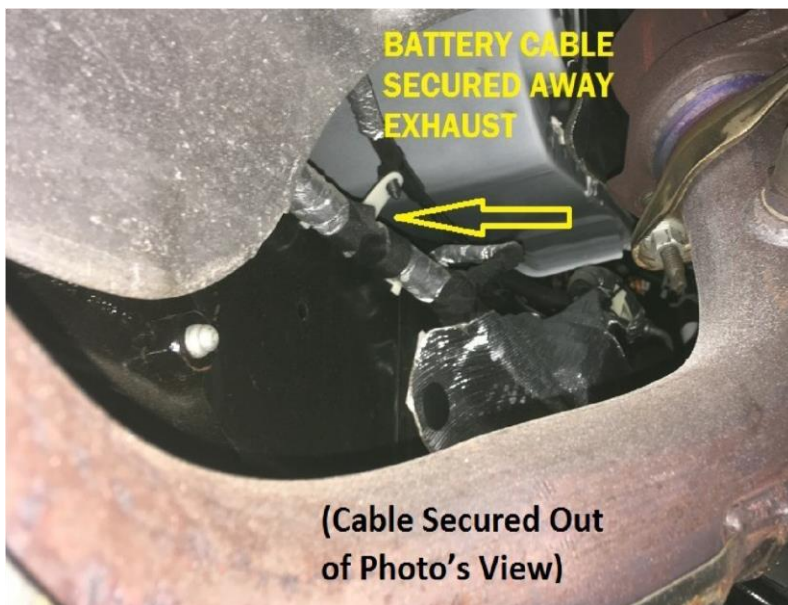
**PROPERLY
SECURED!**
