Thor Motor Coach Recall Repair Instructions

Recall #	19V-609 2019-426		
Description/Title:	BIM/BIR WIRING		
Affected Product Line(s):	Certain Model Year 2020 Chateau, Daybreak, Four Winds, Freedom Elite, Outlaw, Quantum, and Majestic Class C Ford motorhomes		
Service Campaign # :	RC000172	Released Date:	09/30/2019
Repair Code:	TMCRC80486V	Document Date:	09/30/2019
Time Allowed:	0.75	Document Revision:	A

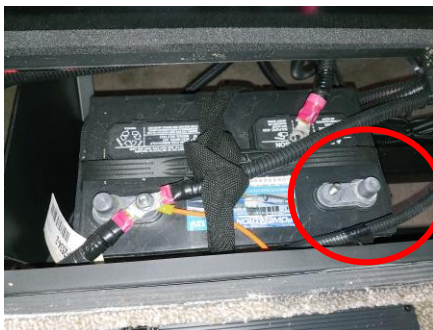
1. Disconnect battery cable on the negative post of the house battery located in the step well.

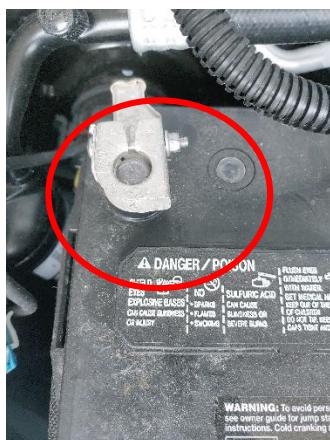
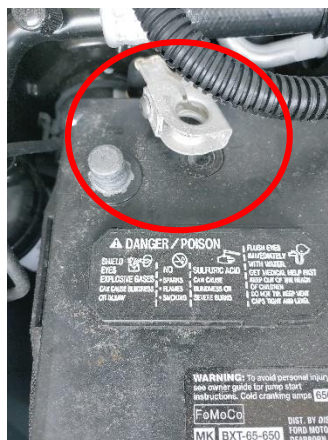
2. Disconnect battery cable from negative post of the chassis battery located under the hood.

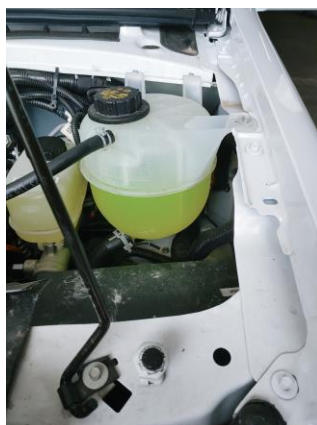
3. Remove the coolant overflow bottle – keep the screws – set the coolant overflow bottle out of the way.

Leave hoses connected.

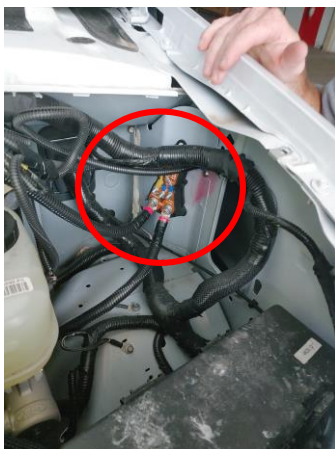
It has been discovered that on certain model year 2020 Chateau, Daybreak, Four Winds, Freedom Elite, Majestic, Outlaw, Quantum Motorhomes, a loose connection exists between the Battery Isolation Manager (BIM) or the Battery Isolation Relay (BIR) and attached battery cables. BIM/BIR are attached to battery cables and torqued per the specifications. During mounting of the BIM/BIR in the motorhome and connection of the other end of the cables to the chassis battery, there is a possibility of the battery cable becoming loose on the BIM/BIR side depending on the orientation of the BIM when mounted and the ring connectors to bend. The loose connection not only causes premature failure of the BIM/BIR, but it can also create arcing, which can lead to a fire and property damage.

4. Locate BIM/BIR mounted on driver's side inside fender.

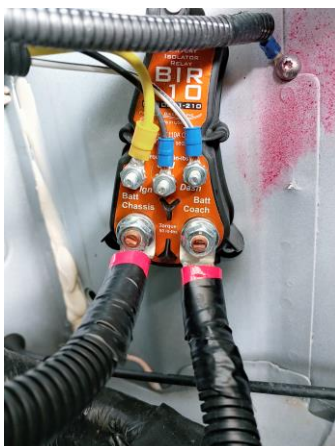
5. Remove the screws holding the BIM/BIR to the inside fender.

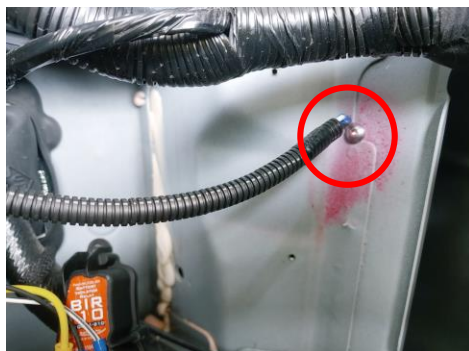
6. Remove ground wire

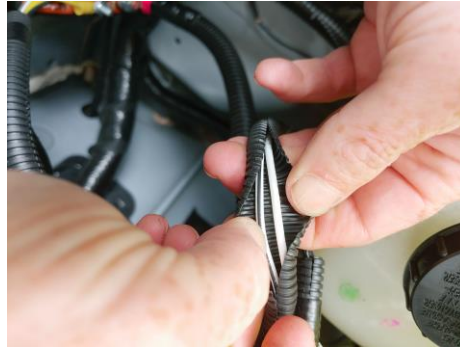
7. Open the loom for the dash switch, locate the white and white with black tracer. Cut both wires.

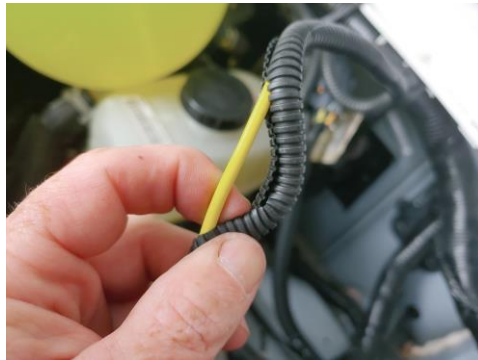
8. Open the loom for the ignition power, locate the yellow wire and cut.

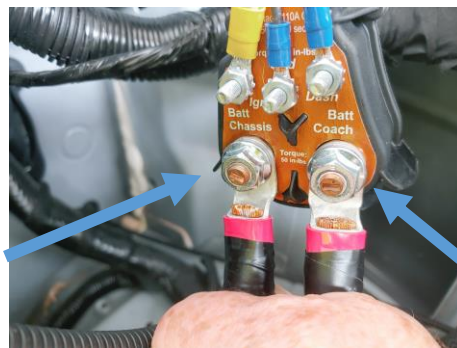
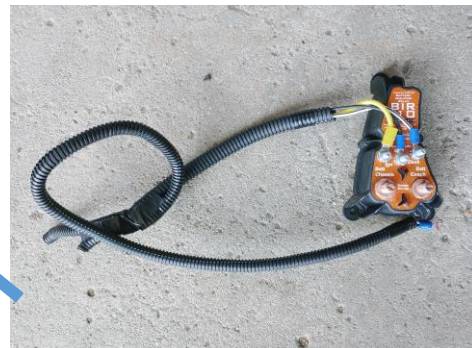
9. Remove the chassis battery cable and the house battery cable from the BIM/BIR and remove BIM/BIR.

Note: The BIM/BIR needs to be returned to Thor Motor Coach for payment of the recall repairs.

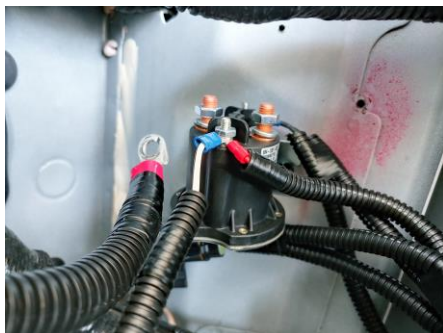
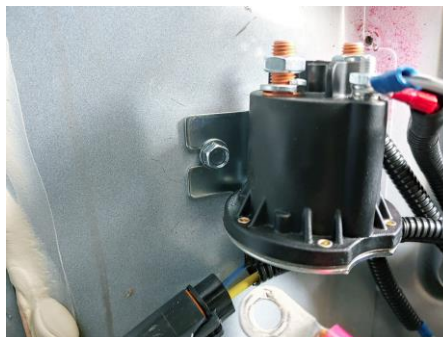
10. Measure 5 ½" up and 2 ½" in from the fender well. This is the location to mount the Trombetta solenoid.
11. Start a ¼" self-tapping hex head screw at the 5 ½" and 2 ½" mark on the fender wall. Slide Trombetta solenoid bracket into place on the self-tapping hex head screw and secure.

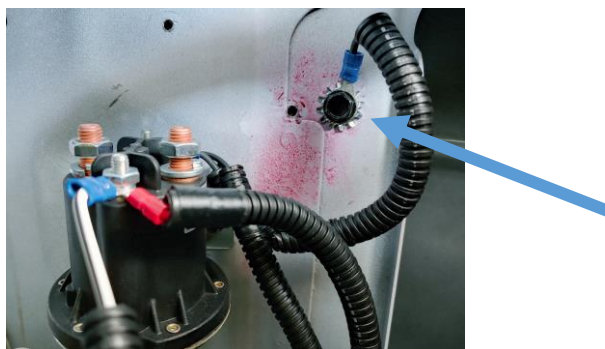
12. Install a ¼" self-tapping hex head on the other side of the bracket of the Trombetta solenoid.
13. Install ground wire, black wire with ring terminal, above Trombetta solenoid on the inside of the fender by using a ¼" self-tapping hex head using a 3/8" bit.

NOTE: Must use a star washer between the ring terminal and fender.

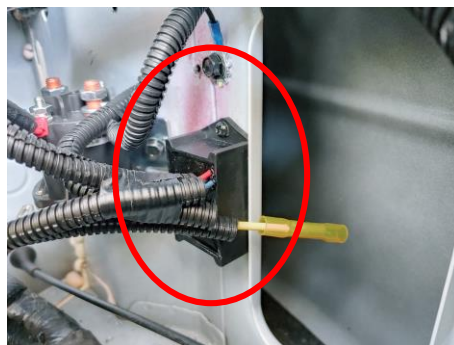
14. Mount the Isolater Relay Delay (IRD) beside the Trombetta solenoid and along the seam of the fender with 2 - #8 self-tapping pan head screws.

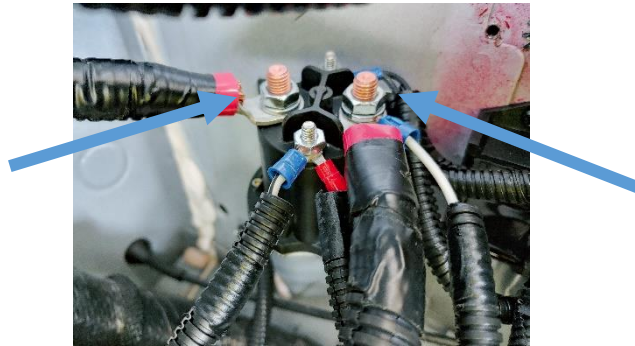
15. Verify which cable is coming from the chassis battery by tracing it back to the chassis battery. Remove the washer and nut from the Trombetta solenoid and secure the chassis battery cable to the large terminal post of the Trombetta solenoid closest to the firewall with the washer and nut.

Note: If either battery cable ring terminal is bent – straighten before securing.

16. Secure the house battery cable to the other large terminal post (towards the front) of the Trombetta solenoid – this house battery is to be secured together with the white wire of the emergency start switch. Put the battery cable on the post first, then place the white wire on top and secure with washer and nut.
17. Tighten nuts on both battery cables using a torque wrench to 45" lbs.

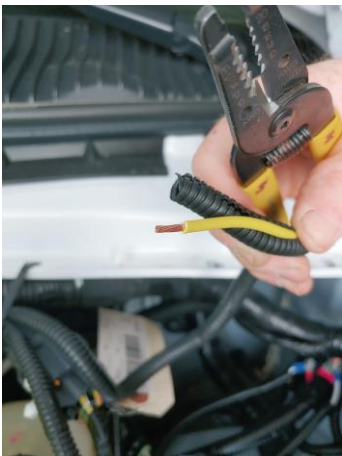
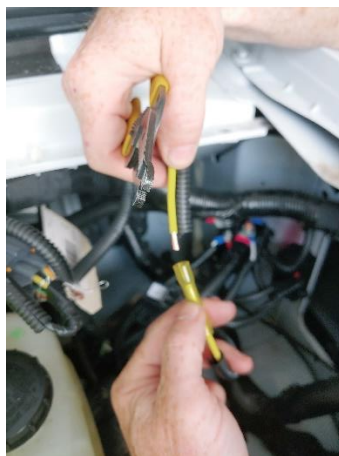
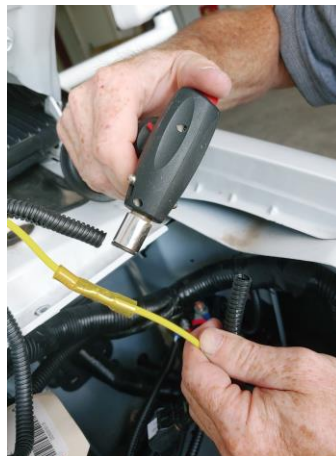
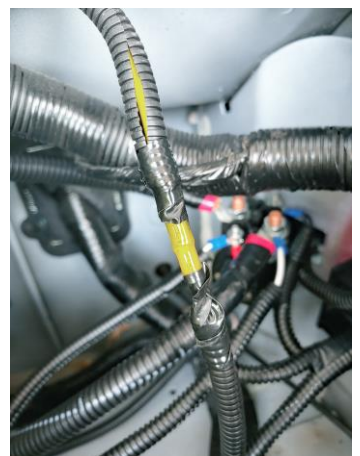
18. Locate and cut yellow ignition power wire, strip back, and connect to yellow wire w/ yellow butt connector from the fuse holder. Crimp and heat shrink using a torch or electric heat gun. Using electrical tape, tape both ends of the yellow wires.

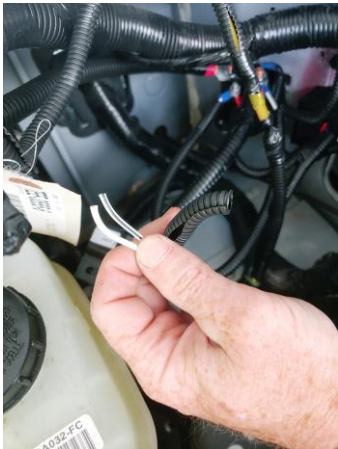
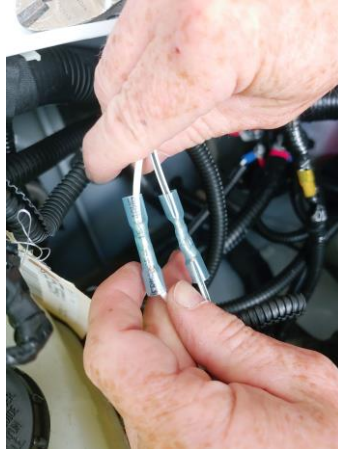
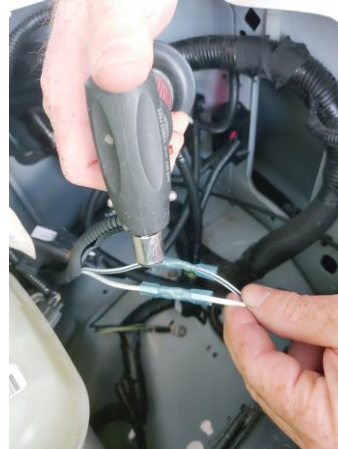
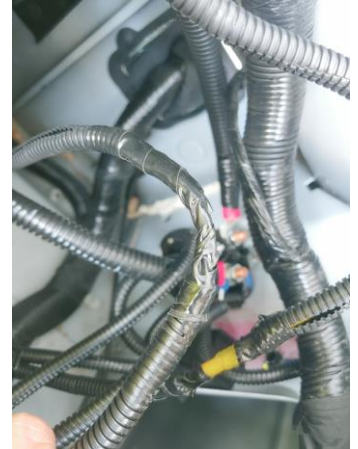
19. Locate cut white wire and white with black tracer from the emergency start switch and strip back both wires.

Connect white wires with white butt connector and white with black wires white with black butt connector.

Crimp both wires and heat shrink. Use electrical tape to tape both ends of the wires.

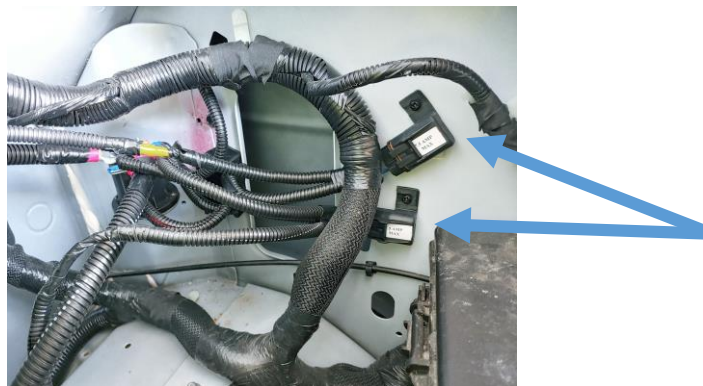
20. Mount both fuse holders to inside fender in a location where accessible with coolant overflow bottle in place.

Mount using #8 self-tapping pan head screws.

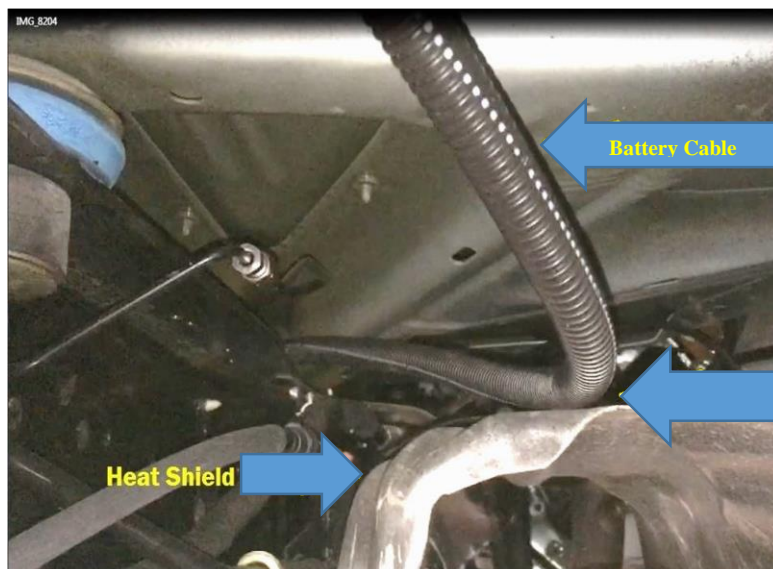
**NOT
PROPERLY
SECURED!**

Verify the 2 gauge cable that runs from the Trombetta is supported away from the engine exhaust manifold and the rest of the exhaust, covering the area under the hood to the rear of the cab. If the 2 gauge cable is not secured away from the exhaust manifold or the rest of the exhaust, secure as indicated in the following image.
