David J. Johnson
 Director
 Service Engineering Operations
 Ford Customer Service Division

SUBJECT: NEW VEHICLE DEMONSTRATION / DELIVERY HOLD

Compliance Recall 19C07 – Supplement #5

Certain 2018-2020 Model Year Escape, Explorer, F-150, Superduty, Expedition and Aviator Vehicles Equipped with Manual Reclining Seats
 Manual Recliner Seat Inspection

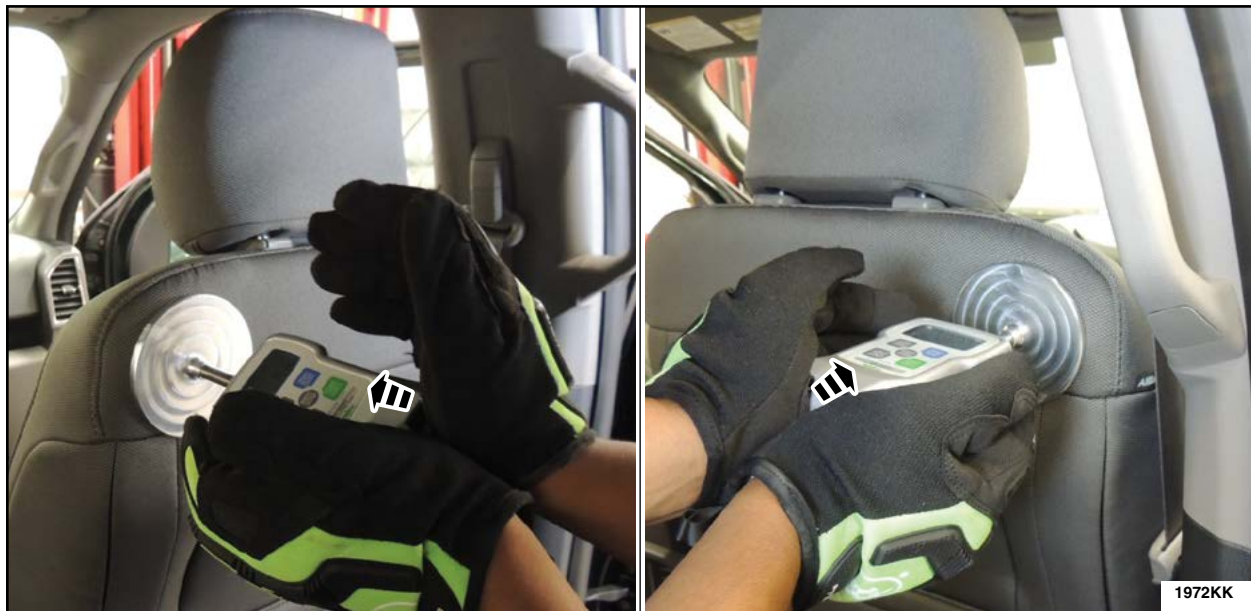
FIGURE 1

NOTE: Example video of failed recliner.

Yes - This seat has failed inspection and will require replacement. Reference Attachment VI for repair procedure and Dealer Bulletin for parts ordering information.

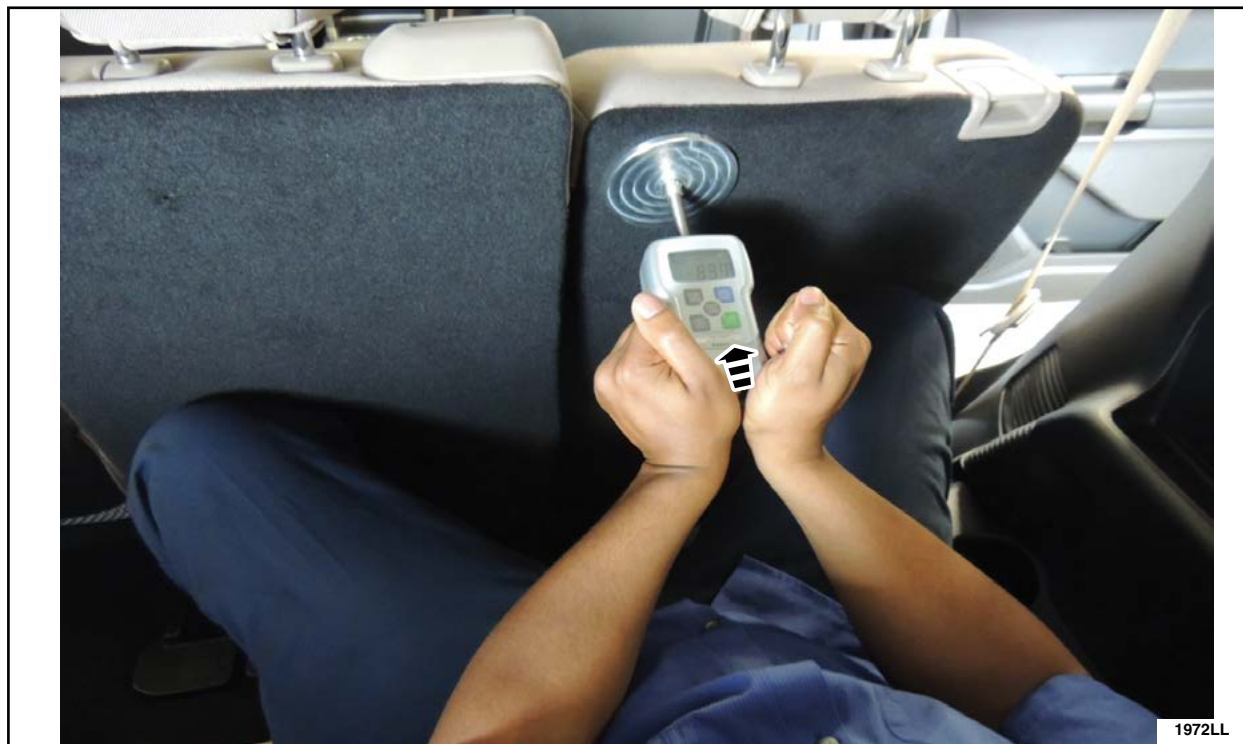
FIGURE 2

NOTE: Example video of failed recliner.

Yes - This seat has failed inspection and will require replacement. Reference Attachment VI for repair procedure and Dealer Bulletin for parts ordering information.

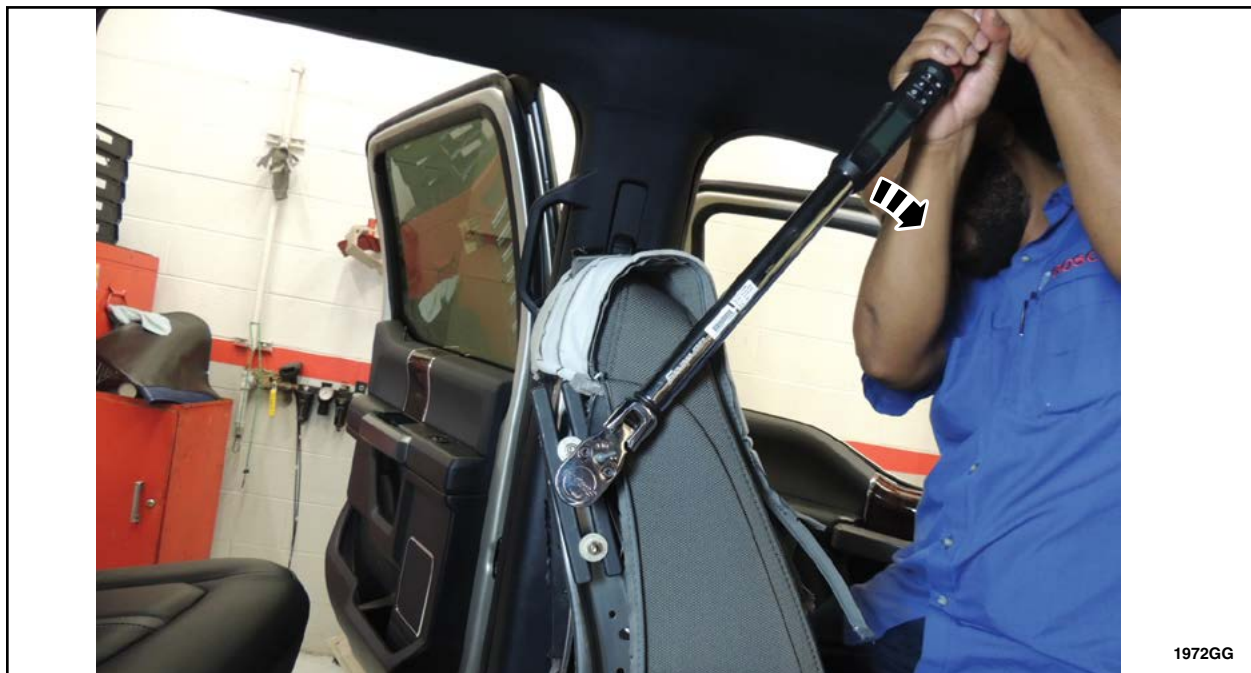
FIGURE 7

Yes - This seat has failed inspection and will require replacement. Reference Attachment VI for repair procedure and Dealer Bulletin for parts ordering information.

NOTE: Example video of failed recliner.

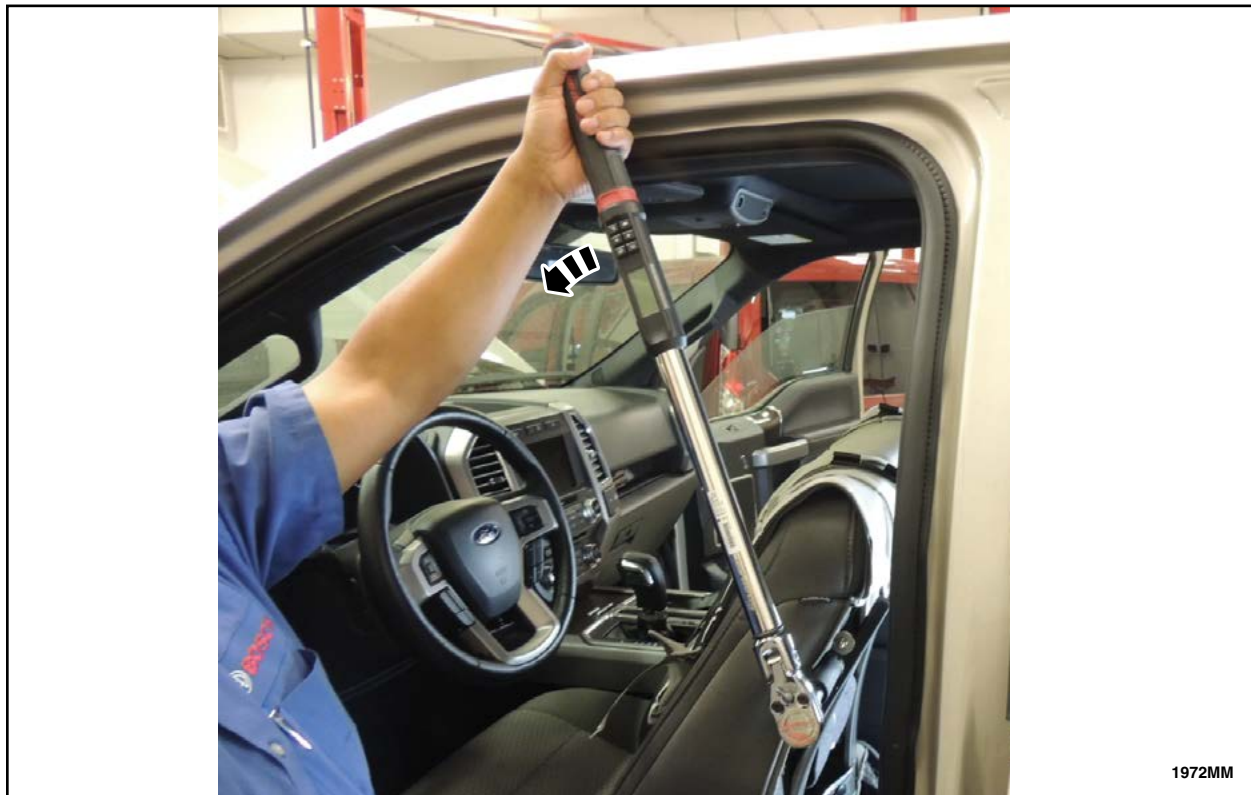
FIGURE 12

NOTE: Example video of failed recliner.

Yes - This seat has failed inspection and will require replacement. Reference Attachment VI for repair procedure and Dealer Bulletin for parts ordering information.

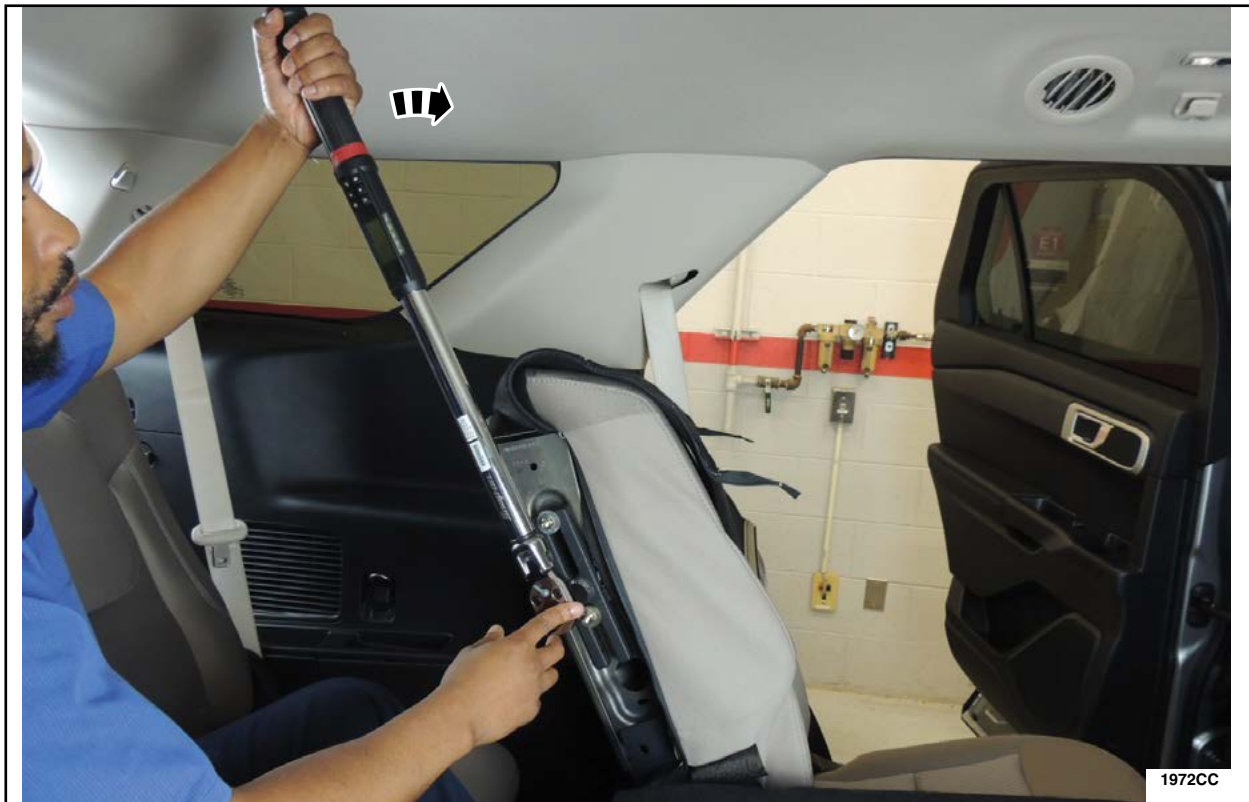
FIGURE 17

10. Was a loud ratcheting sound heard or did the seat back ratchet forward as the force was being applied to either seat backrest?

NOTE: Example video of failed recliner.

Yes - This seat has failed inspection and will require replacement. Reference Attachment VI for repair procedure and Dealer Bulletin for parts ordering information.

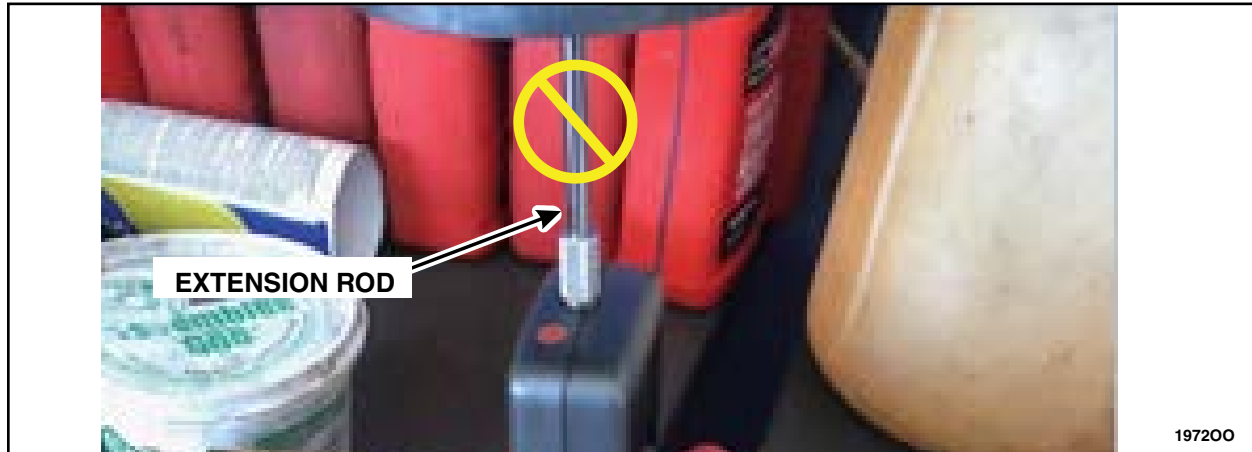
FIGURE 2

NOTE: The use of extensions on the Force Gauge can contribute to a tech applying excessive side loads on the gauges. Multiple gauges have been broken due to excessive side loads.

3. Multiple brands and styles of Force Gauges have been provided to dealers. Extension rods should only be used on Force Gauges that have threaded connections that are under-flush with the Force Gauge housing (currently only models Mecemesin - AFG-1000 and BFG-1000 require the use of an extension rod). See Figure 2.
