SUBJECT: NEW VEHICLE DEMONSTRATION / DELIVERY HOLD

Compliance Recall 19C07 – Supplement #3

Certain 2018-2020 Model Year Escape, Explorer, F-150, Superduty, Expedition and Aviator Vehicles Equipped With Manual Reclining Seats
 Manual Recliner Seat Inspection

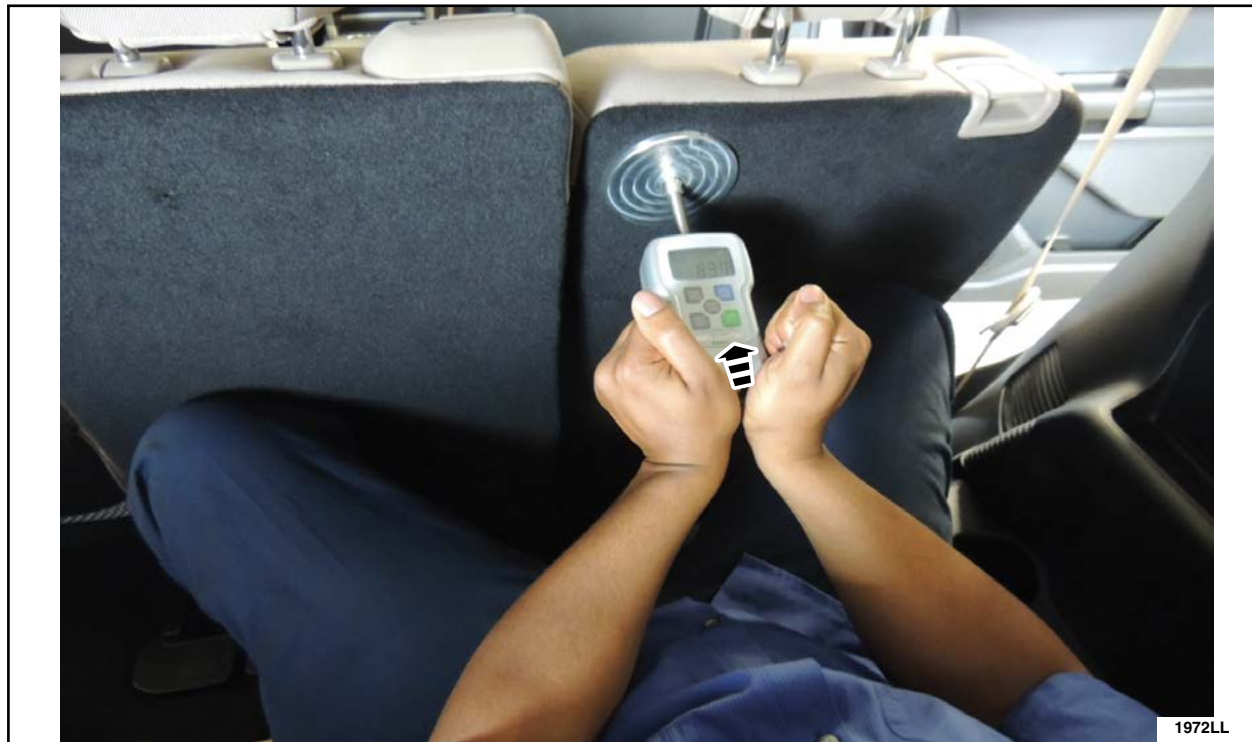
FIGURE 2

NOTE: Example video of failed recliner.

Yes - This seat has failed inspection and will require replacement. *Reference Attachment VI for repair procedure and Dealer Bulletin for parts ordering information.*
