SUBJECT: NEW VEHICLE DEMONSTRATION / DELIVERY HOLD

Compliance Recall 19C07 – Supplement #6

Certain 2018-2020 Model Year Escape, Explorer, F-150, Superduty, Expedition and Aviator Vehicles Equipped with Manual Reclining Seats
 Manual Recliner Seat Inspection

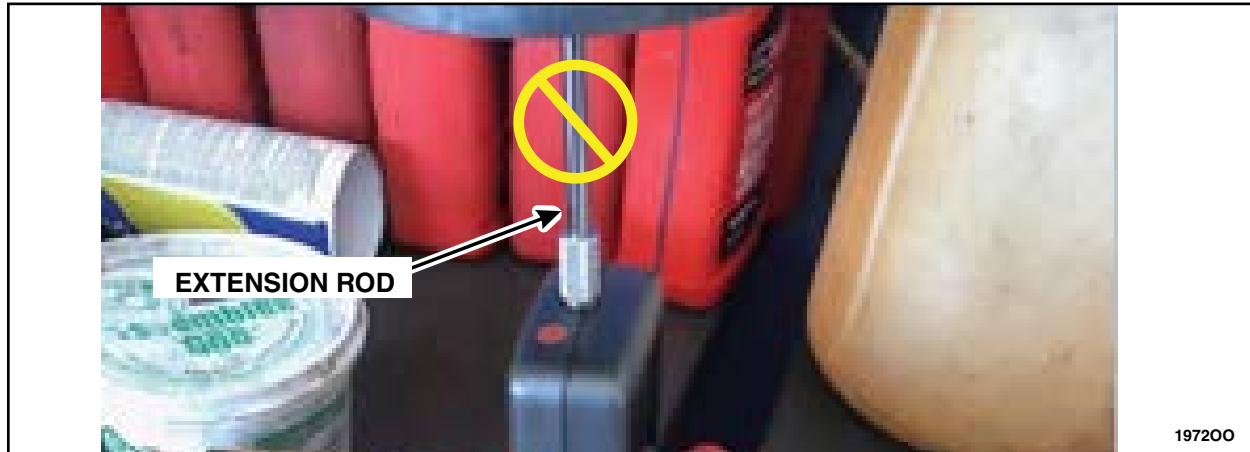
FIGURE 2

NOTE: The use of extensions on the Force Gauge can contribute to a tech applying excessive side loads on the gauges. Multiple gauges have been broken due to excessive side loads.
