SUBJECT: NEW VEHICLE DEMONSTRATION / DELIVERY HOLD

Compliance Recall 19C07 – Supplement #3

Certain 2018-2020 Model Year Escape, Explorer, F-150, Superduty, Expedition and Aviator Vehicles Equipped With Manual Reclining Seats
 Manual Recliner Seat Inspection

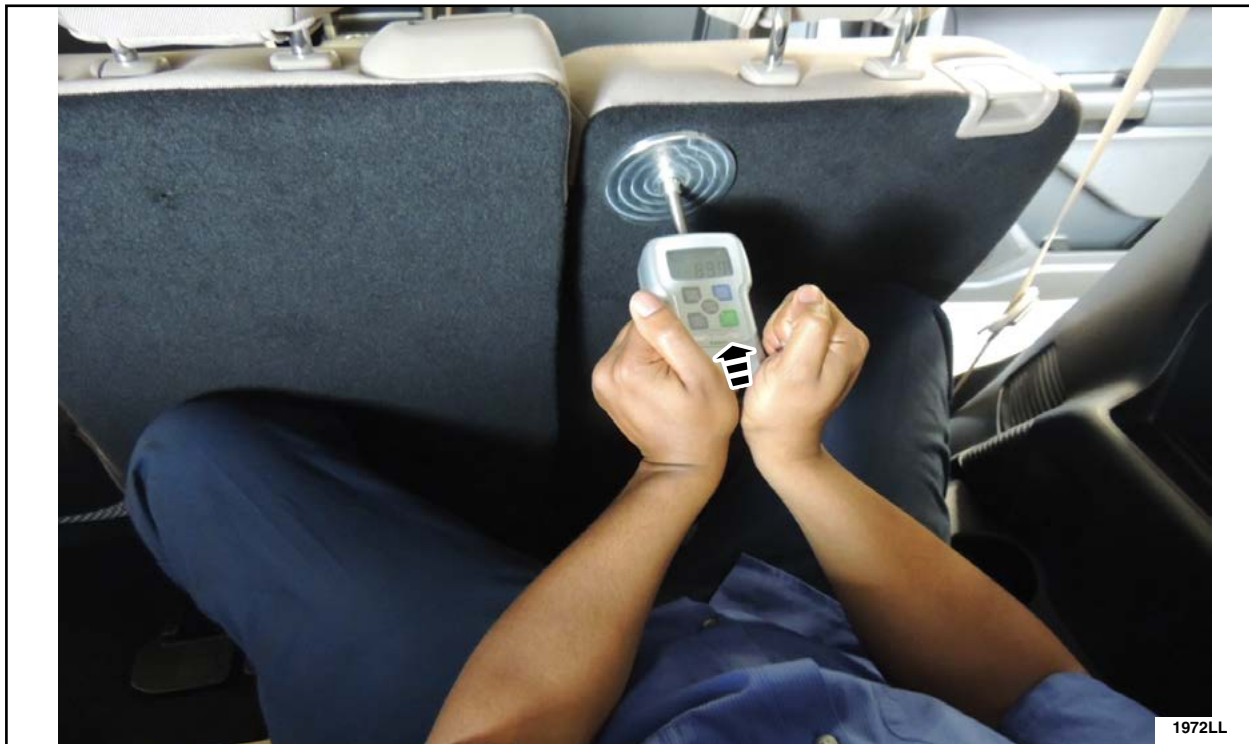
FIGURE 2

NOTICE: Do not exceed 950N (0.950kN) force, damage to the seat back could occur.

Yes - This seat has failed inspection and will require replacement. *Reference Attachment VI for repair procedure and Dealer Bulletin for parts ordering information.*
