SUBJECT: NEW VEHICLE DEMONSTRATION / DELIVERY HOLD

Compliance Recall 19C07

Certain 2018-2020 Model Year Explorer, F-150, Superduty, Expedition and Aviator Vehicles Equipped With Manual Reclining Seats
 Manual Recliner Seat Inspection

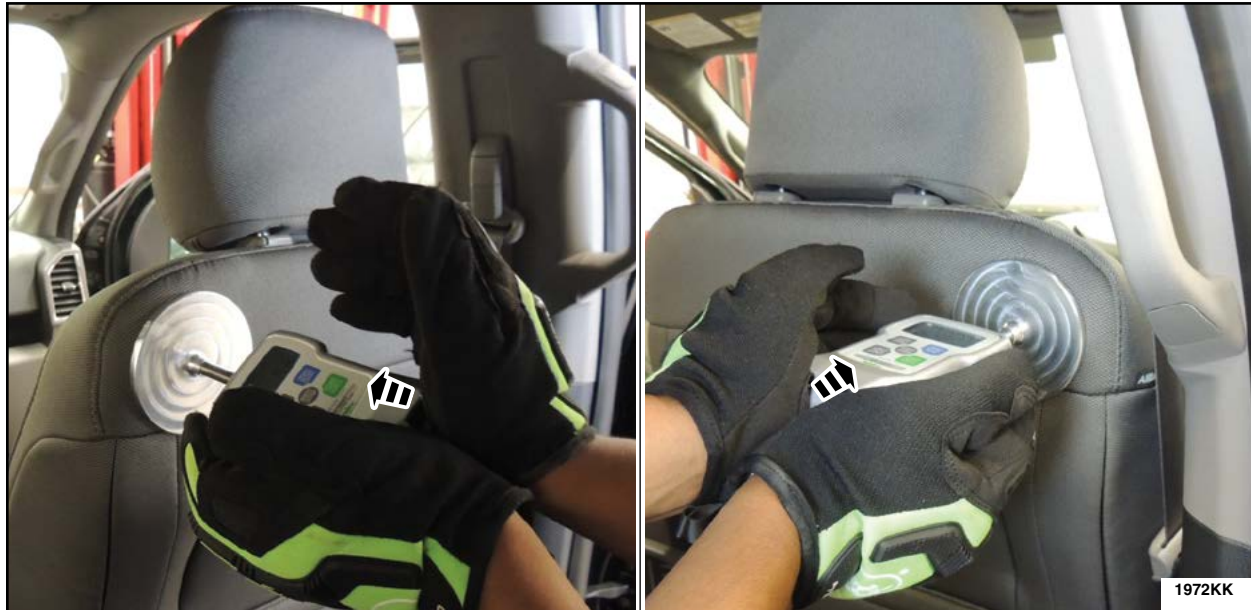
FIGURE 1

6. While sitting in the second row seat, place the Force Gauge pressure plate on the upper inboard and outboard sides of the front seat backrest, 1 inch from the top and 1 inch from the side of the backrest, and apply pressure until a minimum of 850N force is achieved or seat back ratchets forward (If the seat back ratchets there will be an audible noise). See Figure 1.

7. Was a loud ratcheting sound heard or did the seat back ratchet forward on either seat from the inboard and/or the outboard sides before 850N of force was reached?

Yes - This seat/s have failed inspection and will require replacement. Do not close the repair order, more instruction will follow in a future bulletin supplement on how to proceed with this repair.
