SUBJECT: NEW VEHICLE DEMONSTRATION / DELIVERY HOLD

Compliance Recall 19C07 – Supplement #1

Certain 2018-2020 Model Year Explorer, F-150, Superduty, Expedition and Aviator
 Vehicles Equipped With Manual Reclining Seats
 Manual Recliner Seat Inspection

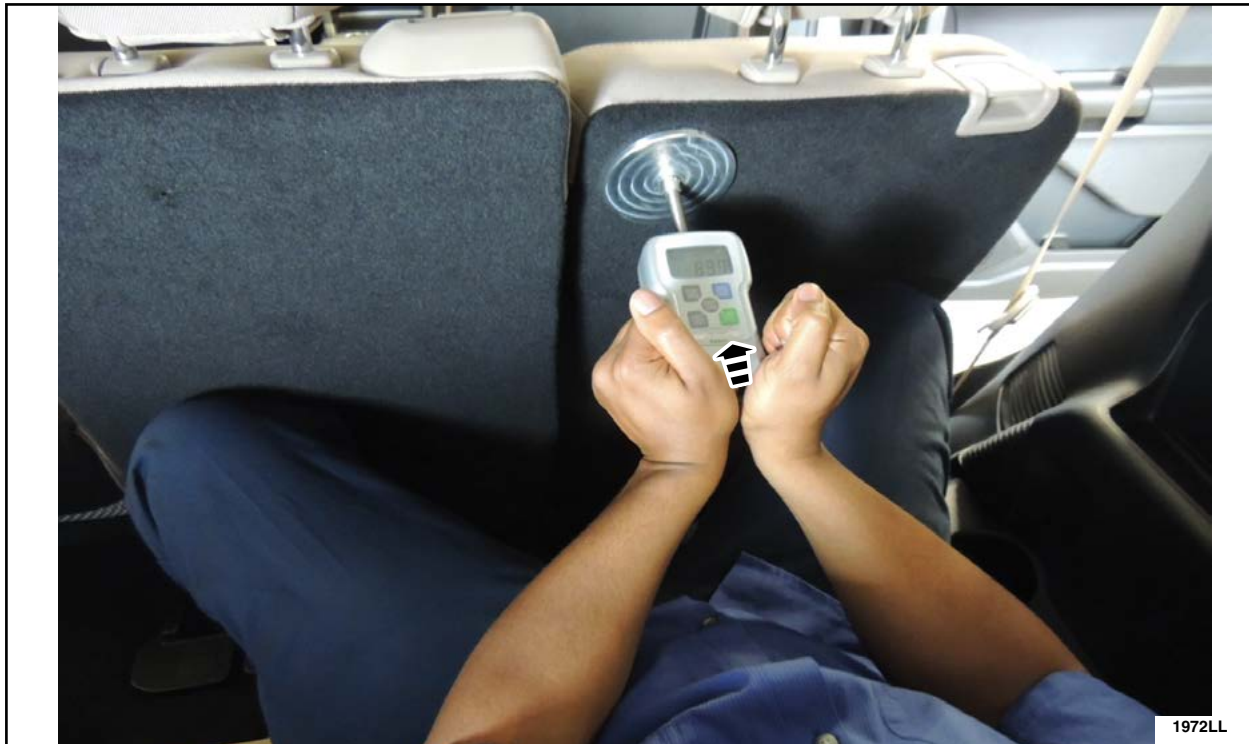
FIGURE 2

NOTICE: Do not exceed 950N force, damage to the seat back could occur.

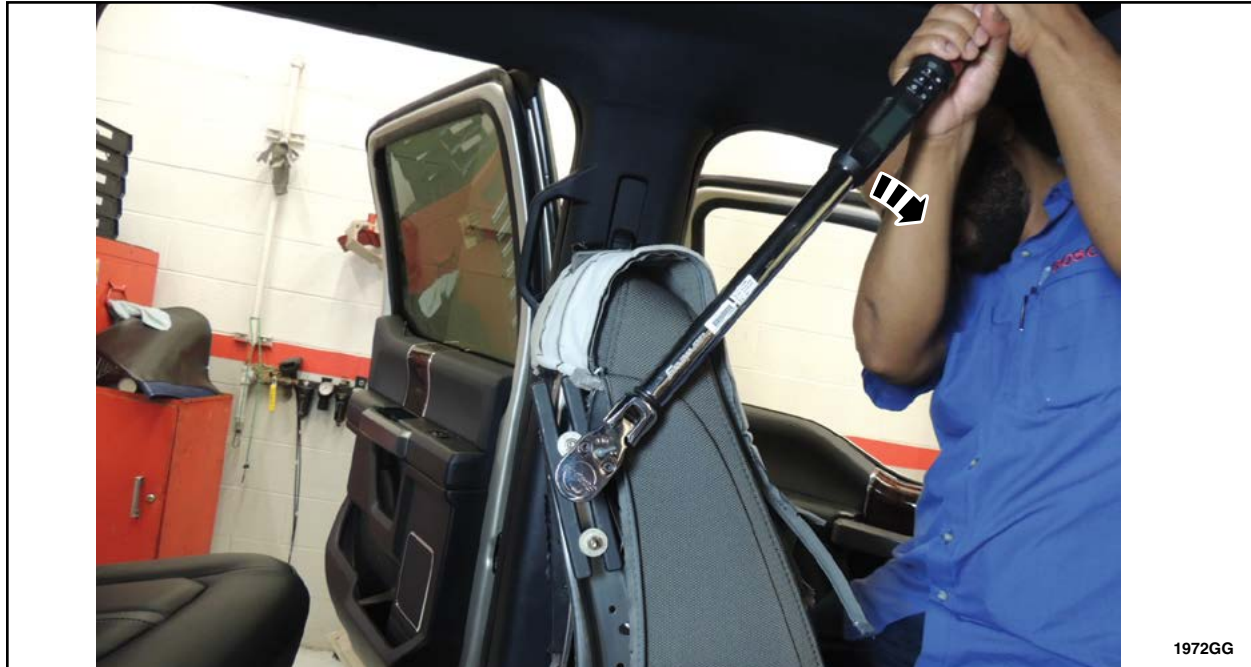
FIGURE 7

10. Repeat Step 7 a second time to ensure that the seat backrest passes inspection.

NOTE: After second inspection, if recliner does not make a ratcheting sound or ratchets forward it passes inspection go to Step 11.

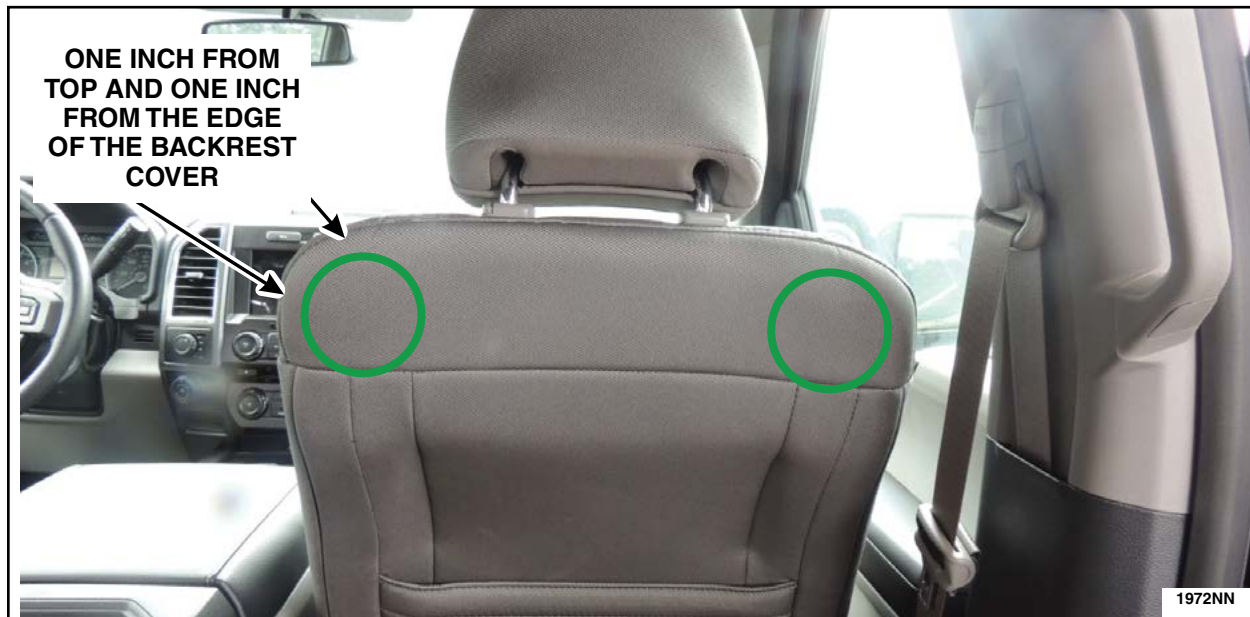
FIGURE 1

1. Set the Force Gauge to N (Newtons).
 - a. Ensure that the Force Gauge is set to N (Newtons) - Some dealers are reporting that they were unable to reach 850N with the Force Gauge and the gauge was found to be set to the wrong units.
 - b. Some Force Gauges will require reading the included instruction manuals in order to be able to select the correct units.
2. Ensure that the force plate is contacting the seat at the top corners. If the gauge is misplaced (too far in or too low), the seat frame may not be engaged and a proper reading will be difficult to obtain. See Figure 1.
