**SIM 51 02 19**  
**RECALL 19V-XXX: CRASH PAD**

2019-08-27

E-Series	Model Description	Production Date
F56	MINI Hardtop 2 Door	June 11, 2019 to August 14, 2019

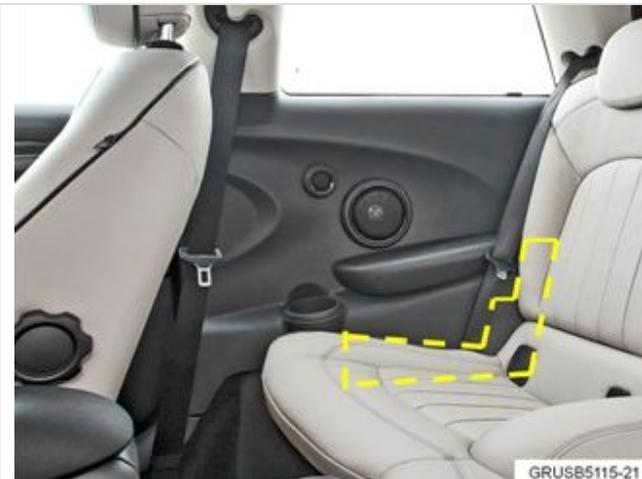
The pad is applied to the inside surface of the panel, and is not visible either from inside the vehicle nor from the outside.

The general location is indicated on this passenger side panel by the dotted line.

Install a molded structural foam pad to both the left and right rear side trim panels.
