Product Safety Recall

N192263741 Relay Fuse Box Bolt – US Only

Release Date: October 2019

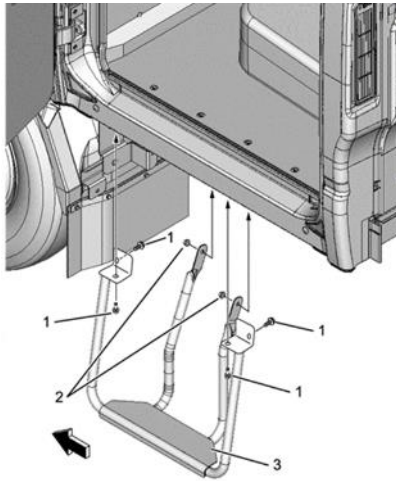
5374426

- (1) Bolt
- (2) Nut
- (3) Rear Step

3. If equipped, remove the driver side rear step. See picture above. Refer to *Step Replacement* in SI. If not proceed to the next step.

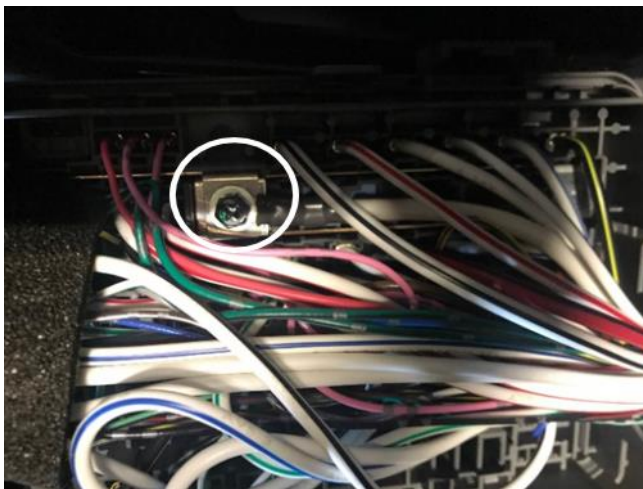
5374438

8. Inspect the relay box power wire for any damage:
 - If there is any damage, take a picture similar to the photo above and contact GM Technical Assistance Center (TAC) for further instructions.
 - If there is NO DAMAGE, continue to step 9.

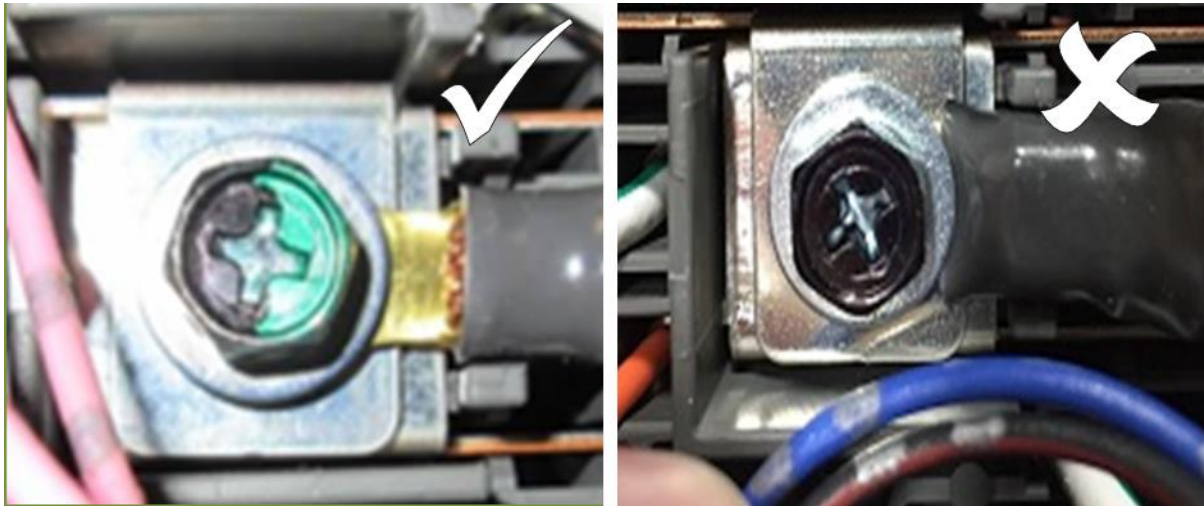
5374440

9. Inspect the wire terminal insulation for excess insulation. See picture above.
 - If the insulation is not ok, proceed to step 10.
 - If the insulation is ok, proceed to step 11.

10. Remove the terminal bolt and lift the terminal away from the fuse box. Using a razor blade, carefully trim away any excess insulation as necessary. Then reinstall the bolt.

11. Torque the power supply terminal bolt to 3.4 Nm (30.1 lb in.)
12. Install the white inner fuse box cover.
13. Install the rubber grommet and tape as necessary.
