# Campaign Service

**BULLETIN NUMBER:**  
CB19-N-002B

## IMPORTANT SAFETY RECALL

**RELAY BOX INSPECTION – 19V-647**  
(Transport Canada 2019-452)

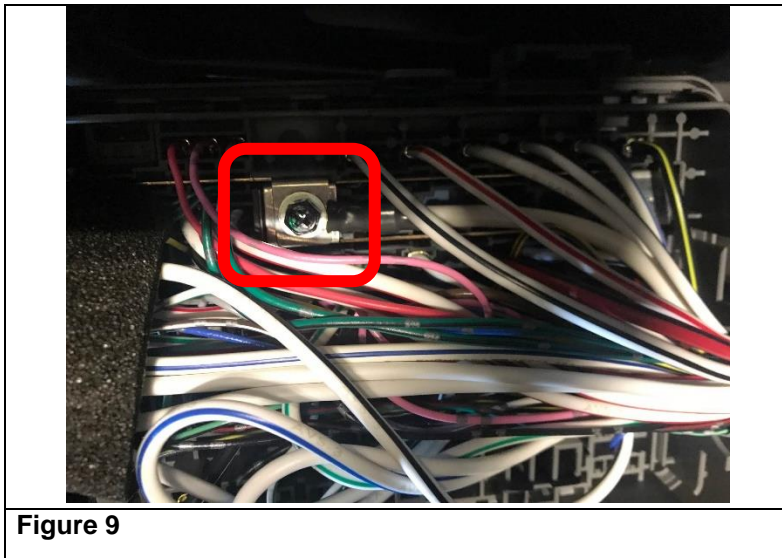
**Figure 9**

8. Inspect the condition of the relay box power wire. (See Figures 9 and 10 for OK condition.). Determine if there is any damage to the power wire and/or relay box:
  - a. If there is any damage, take a photo similar to Figure 9 and email it to [isuzuta@icta-us.com](mailto:isuzuta@icta-us.com). Then call the Isuzu Technical Assistance Line at 1-877-478-9828, Prompt 3 for further instructions. Document the TAL case number on the repair order. This will be required for claim submission.
  - b. If there is no evidence of damage from heat, continue to Step 9.
9. Inspect the wire terminal for excessive insulation. (See Figures 10 and 11.) If the insulation is OK, proceed to Step 11. If the insulation is Not OK, proceed to Step 10.

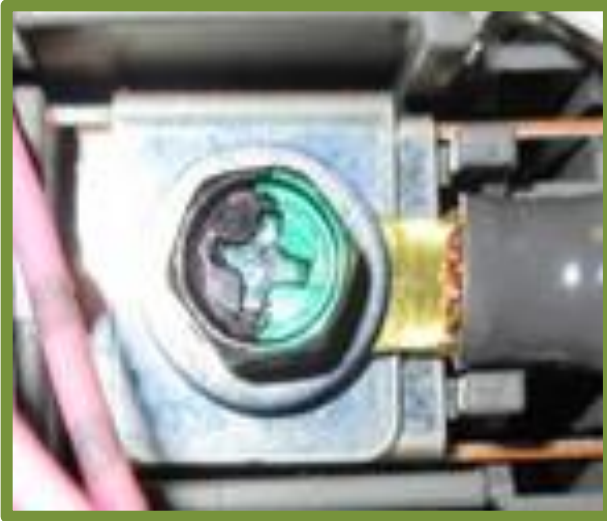
Figure 10 – OK Condition

11. Torque the power supply terminal bolt to the specified torque.  
**Tightening Torque:** 30.1 lb in. (3.4 Nm).
12. Reinstall the white inner fuse box cover.

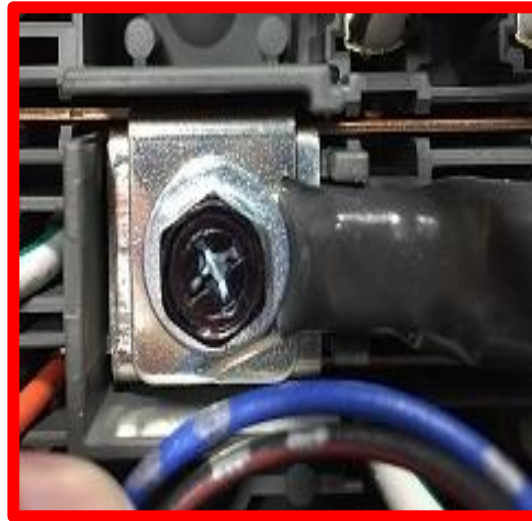
Figure 11 – Not OK Condition

10. Remove the terminal bolt and lift the terminal away from the fuse box. Using a razor blade, carefully trim away any excess insulation as necessary. Then reinstall the bolt.
