RECALL CAMPAIGN BULLETIN

Classification: EL19-039	Reference: NTB19-084	Date: October 29, 2019
-----------------------------	-------------------------	---------------------------

VOLUNTARY RECALL CAMPAIGN 2018-2019 ARMADA; DISPLAY CONTROL UNIT (INFOTAINMENT) SOFTWARE UPDATE

CAMPAIGN ID #: R1911
NHTSA #: 19V654
APPLIED VEHICLE: 2018-2019 Armada (Y62)

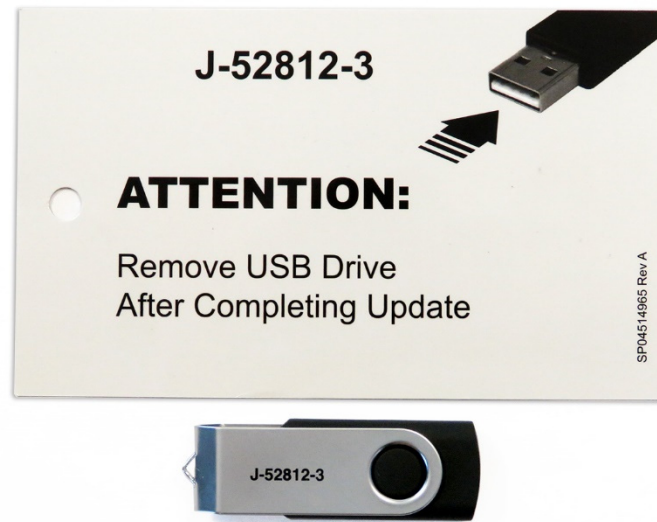
Figure 1

- One special tool USB drive J-52812-3 with ID card has been shipped to each dealer (see Figure 1).
- Additional USB drives are available from Tech•Mate: nissantechmate.com or 1-800-662-2001.

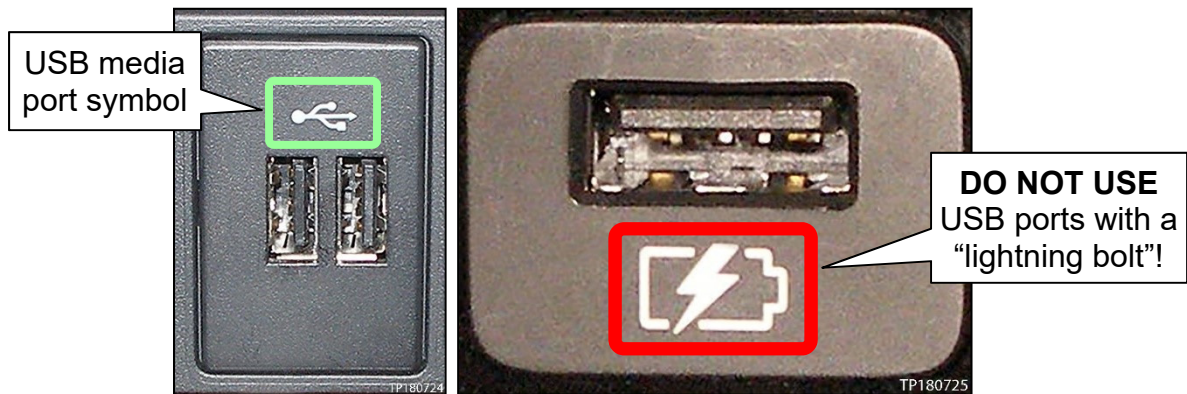
Figure 10

7. Insert special tool J-52812-3 into the vehicle's USB media port (see Figure 10).

Do not insert the USB drive into a charging port. If used, the update software and/or USB drive may become damaged. Only insert the USB drive in a USB media port.

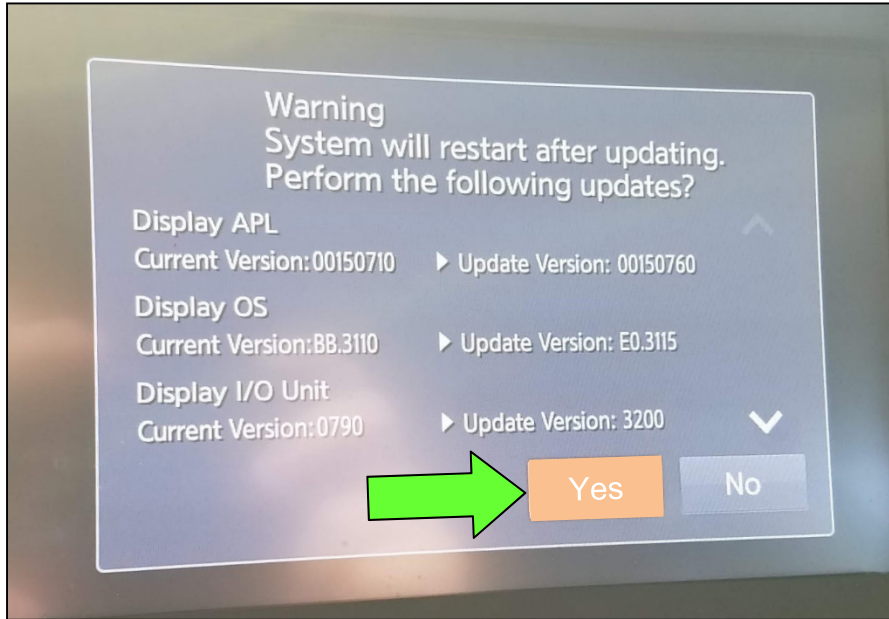
8. Wait approximately 10-30 seconds for the screen in Figure 12 or Figure 13 to appear.
 - a. If the screen shown in Figure 12 appears, proceed to step 9 below.
 - b. If the screen shown in Figure 13 appears, then no software update is available. Remove special tool J-52812-3, and then go to step 15.

9. Select **Yes** to begin the software update.

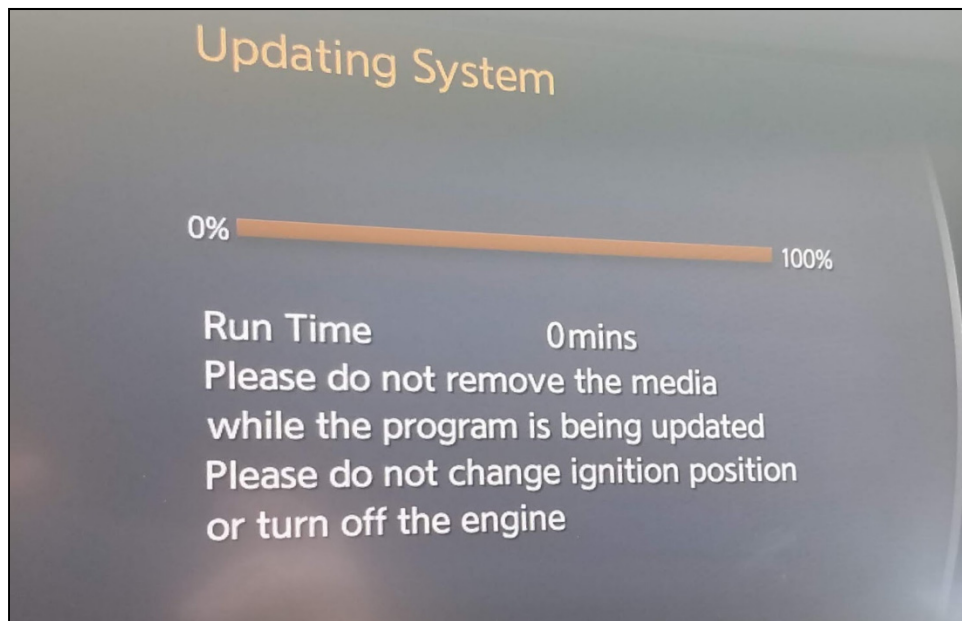
Figure 14

10. Wait for the update to complete.

HINT: The update lasts 1-2 minutes.

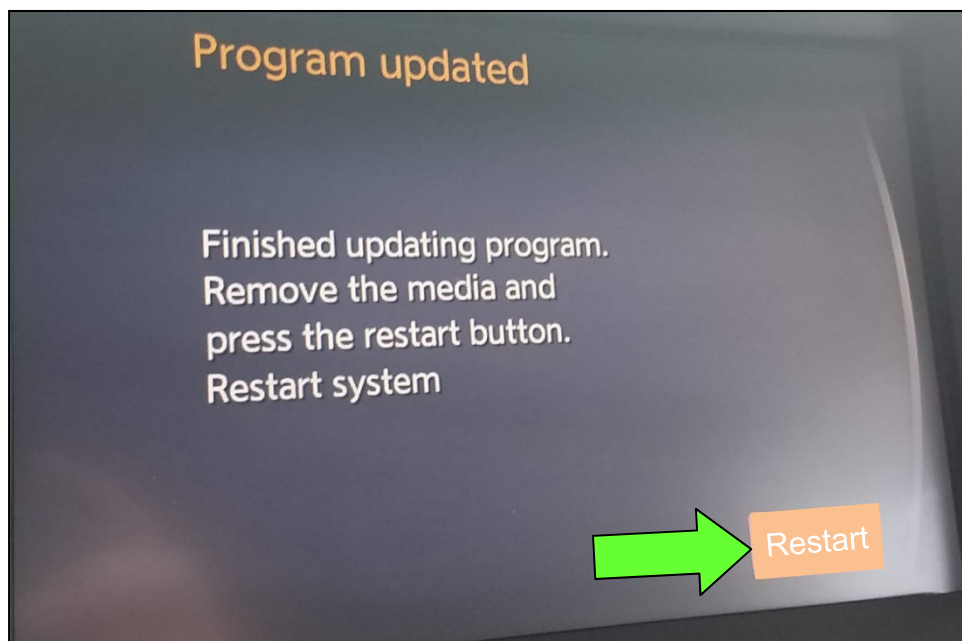
Figure 15

11. Once the update is complete, remove special tool J-52812-3, and then select **Restart**.

Steps 12-15 must be completed. If they are not completed, the update may become corrupted.

12. Allow the reboot to complete (2-5 minutes after selecting **Restart**).
13. Once the reboot has completed, turn OFF the engine, and then wait three (3) minutes.
14. Start the engine and allow the vehicle to run for two (2) minutes.
15. Turn OFF the engine.
