RECALL CAMPAIGN BULLETIN

Classification: EL19-031	Reference: NTB19-088	Date: October 29, 2019
-----------------------------	-------------------------	---------------------------

VOLUNTARY RECALL CAMPAIGN 2018-2019 ROGUE SPORT; AV CONTROL UNIT (INFOTAINMENT) SOFTWARE UPDATE

CAMPAIGN ID #: R1911
NHTSA #: 19V-654
APPLIED VEHICLES: 2018-2019 Rogue Sport (J11)

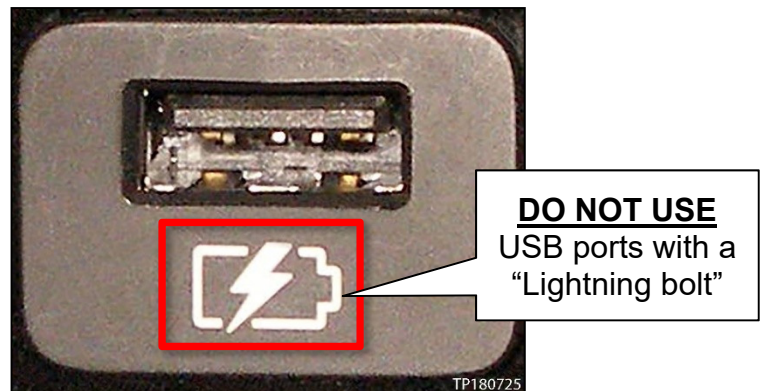
Figure 7

DO NOT insert the USB drive into a charging port (see Figure 7). Charging ports are marked in the vehicle with a “lightning bolt” symbol. If used, the software update and/or USB drive may become damaged. Only insert the USB drive in a USB media port.

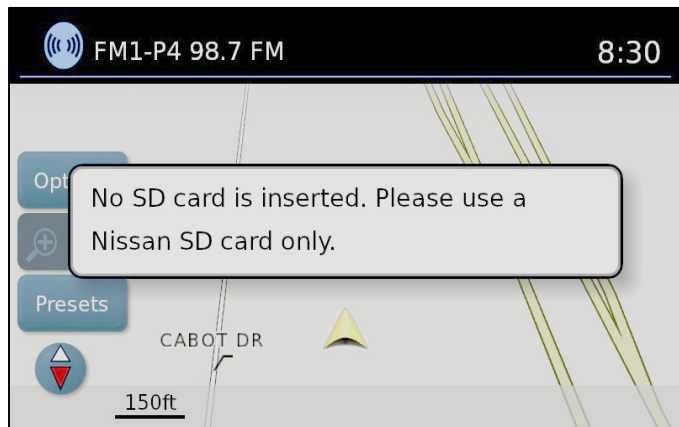
Figure 13

- If the message “No SD card is inserted. Please use a Nissan SD card only” is displayed (Figure 13), proceed to step 17 on page 9.

17. Remove and reinsert the map SD card from the card slot.
- After the map SD card is reinserted, the **APPLICATION** screen will display (Figure 15).

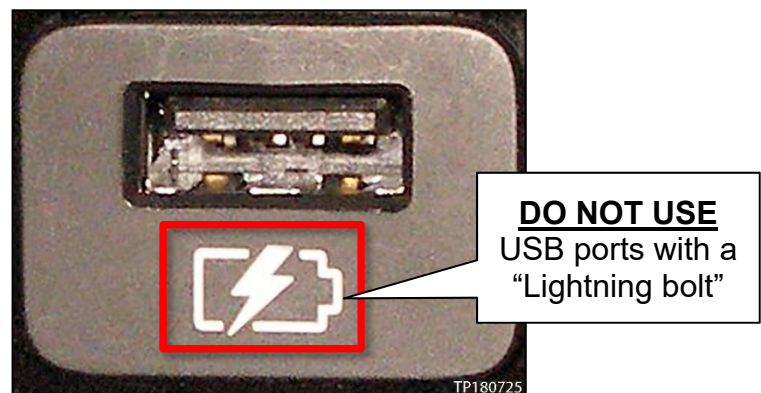
Figure 20

DO NOT insert the USB drive into a charging port (see Figure 20). Charging ports are marked in the vehicle with a “lightning bolt” symbol. If used, the software update and/or USB drive may become damaged. Only insert the USB drive in a USB media port.
