RECALL CAMPAIGN BULLETIN

| Classification: EL19-035a | Reference: NTB19-096a | Date: November 19, 2019 |

VOLUNTARY RECALL CAMPAIGN 2018-2019 VERSA SEDAN; AV CONTROL UNIT (INFOTAINMENT) SOFTWARE UPDATE

CAMPAIGN ID #: R1911
NHTSA #: 19V654
APPLIED VEHICLES: 2018 – 2019 Versa Sedan (N17)

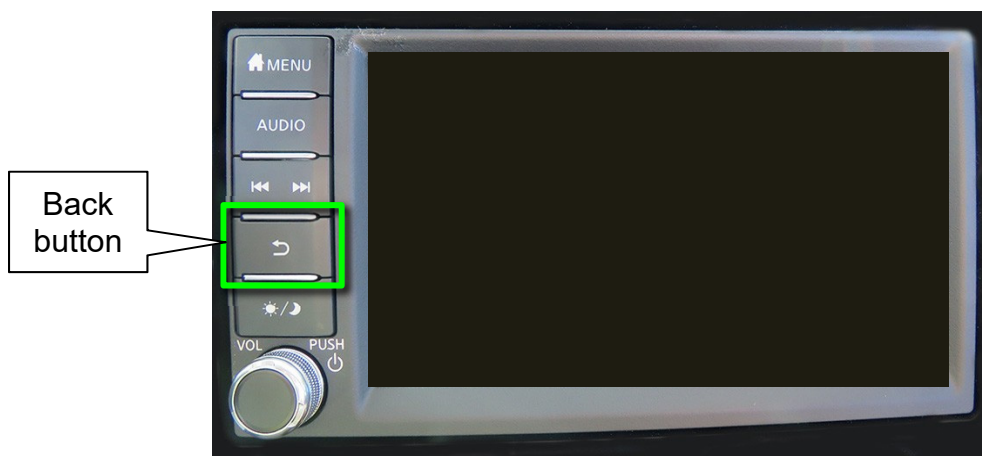
Figure 1

1. Determine if the audio system present in the vehicle is the type shown in Figure 1.
 - If the audio system is **NOT** shown in Figure 1, proceed to step 2 on page 4.
 - If the audio system is shown in Figure 1, **this bulletin does not apply**. Software and repair procedures will be available in December 2019. DO NOT submit any claims on these vehicles.
